Profile/Photo Observation Report

Date:	04/20/2018	Weather:		Coding:	PACP 6.0
Pipe Length (ft):	273.5	Owner:	NA	Pre Clean:	Not Known
P.O.#:		Surveyor:	Byrd Fitzgerald	PSR:	P-504-082-020
Customer:		Clean Date:	01/01/1900	Shape:	C

Street:	N WISCONSIN ST	Flow Control:	Not Controlled
City:	Hobart, IN	Year Renewed:	
Location:	Light Highway	Tape/Media #:	
Purpose:	Not Known	Dia/Height:	10"
Use:	Sanitary	Material:	VCP
Drain Area:	NA	Lining:	
Category:	NA		
Comment:

Location Details:		Direction of Survey:	Downstream
US MH:	M-504-020	DS MH:	M-604-082
		Total Length Surveyed (ft):	269.4

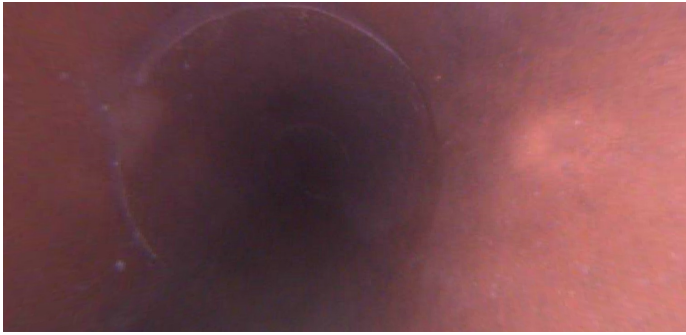
Code: **AMH**
Description: **Manhole**

Distance (ft): **.0**
Structural Grade: **0**
O&M Grade: **0**
Clock Start/From:
Clock To:
1st Value:
2nd Value:
Value Percent:
Continuous Index:
Within 8" of Joint: **NO**
Remarks: **M-504-020**

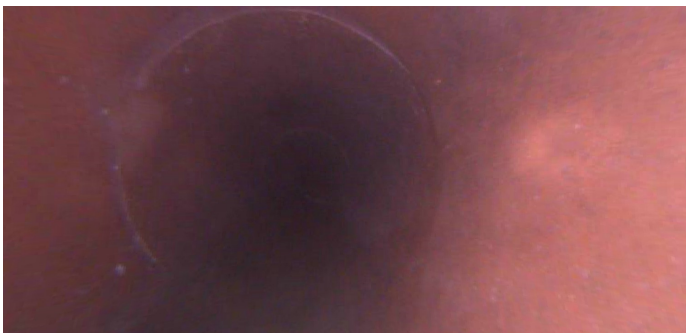
Code: **MWL**
Description: **Water Level**

Distance (ft): **.0**
Structural Grade: **0**
O&M Grade: **0**
Clock Start/From:
Clock To:
1st Value:
2nd Value:
Value Percent: **5.000**
Continuous Index:
Within 8" of Joint: **NO**
Remarks:

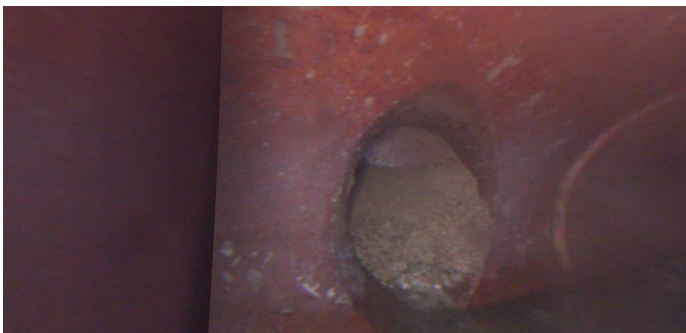
Code: **TFC**
Description: **Tap Factory Capped**

Distance (ft): **36.3**
Structural Grade: **0**
O&M Grade: **0**
Clock Start/From: **3**
Clock To:
1st Value: **4.000**
2nd Value:
Value Percent:
Continuous Index:
Within 8" of Joint: **YES**
Remarks:

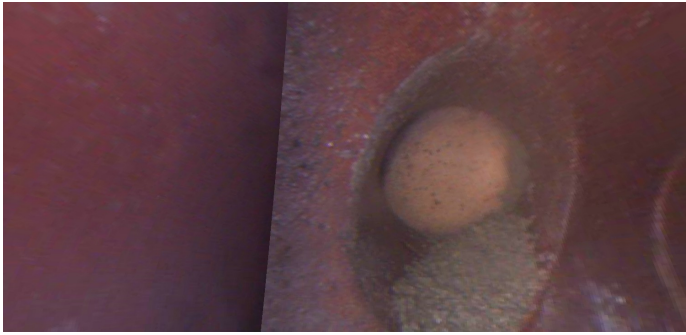
Code: **TFC**
Description: **Tap Factory Capped**

Distance (ft): **60.3**
Structural Grade: **0**
O&M Grade: **0**
Clock Start/From: **2**
Clock To:
1st Value: **4.000**
2nd Value:
Value Percent:
Continuous Index:
Within 8" of Joint: **YES**
Remarks:

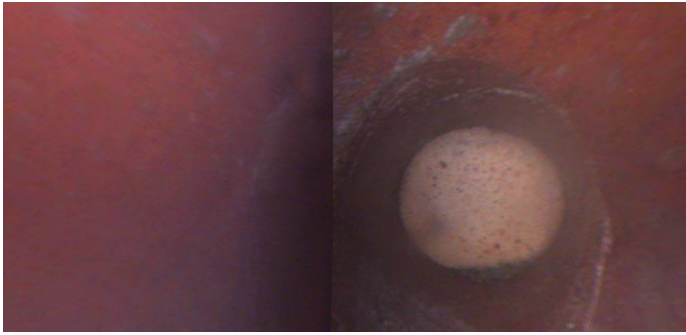
Code: **TFC**
Description: **Tap Factory Capped**

Distance (ft): **86.1**
Structural Grade: **0**
O&M Grade: **0**
Clock Start/From: **2**
Clock To:
1st Value: **4.000**
2nd Value:
Value Percent:
Continuous Index:
Within 8" of Joint: **YES**
Remarks:

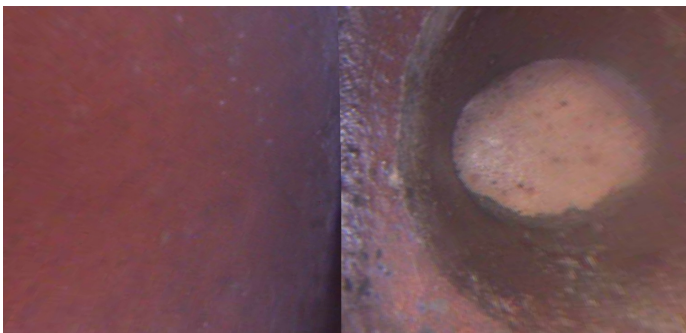
Code: **TFC**
Description: **Tap Factory Capped**

Distance (ft): **110.2**
Structural Grade: **0**
O&M Grade: **0**
Clock Start/From: **2**
Clock To:
1st Value: **4.000**
2nd Value:
Value Percent:
Continuous Index:
Within 8" of Joint: **YES**
Remarks:

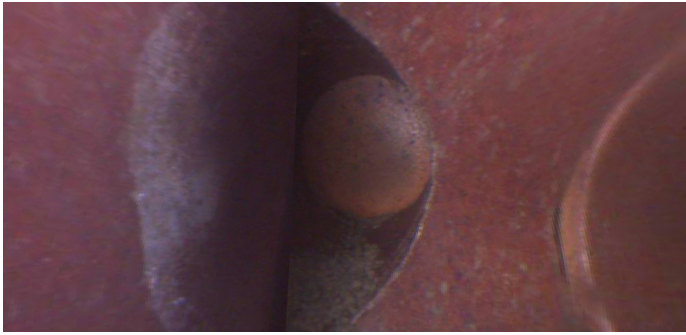
Code: **TFC**
Description: **Tap Factory Capped**

Distance (ft): **134.1**
Structural Grade: **0**
O&M Grade: **0**
Clock Start/From: **2**
Clock To:
1st Value: **4.000**
2nd Value:
Value Percent:
Continuous Index:
Within 8" of Joint: **YES**
Remarks:

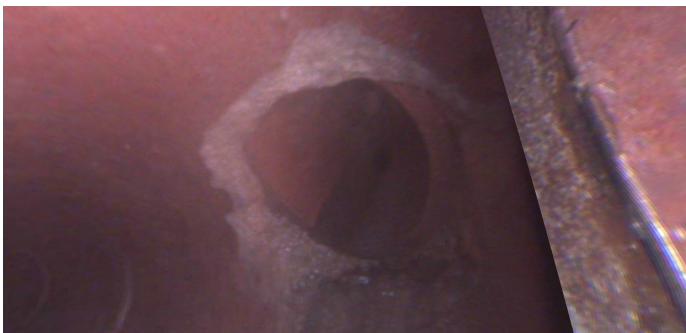
Code: **TB**
Description: **Tap Break-in**

Distance (ft): **135.5**
Structural Grade: **0**
O&M Grade: **0**
Clock Start/From: **2**
Clock To:
1st Value: **4.000**
2nd Value:
Value Percent:
Continuous Index:
Within 8" of Joint:
Remarks:

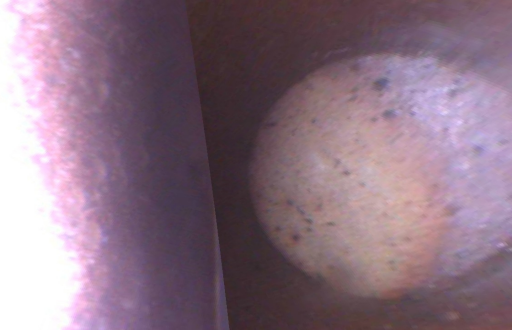
Code: **TFC**
Description: **Tap Factory Capped**

Distance (ft): **158.5**
Structural Grade: **0**
O&M Grade: **0**
Clock Start/From: **2**
Clock To:
1st Value: **4.000**
2nd Value:
Value Percent:
Continuous Index:
Within 8" of Joint: **YES**
Remarks:

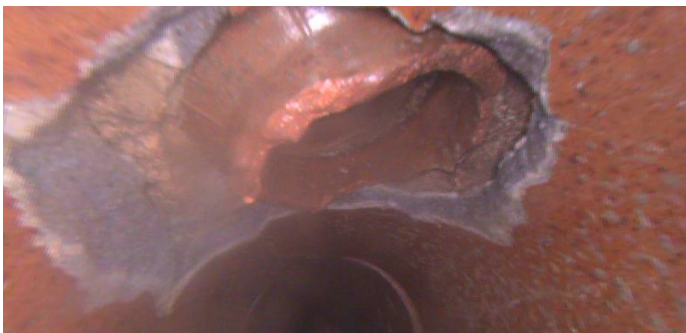
Code: **TB**
Description: **Tap Break-in**

Distance (ft): **173.6**
Structural Grade: **0**
O&M Grade: **0**
Clock Start/From: **12**
Clock To:
1st Value: **4.000**
2nd Value:
Value Percent:
Continuous Index:
Within 8" of Joint:
Remarks:

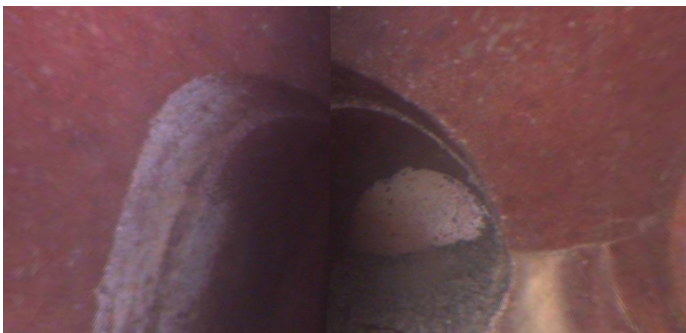
Code: **TFC**
Description: **Tap Factory Capped**

Distance (ft): **184.6**
Structural Grade: **0**
O&M Grade: **0**
Clock Start/From: **2**
Clock To:
1st Value: **4.000**
2nd Value:
Value Percent:
Continuous Index:
Within 8" of Joint: **YES**
Remarks:

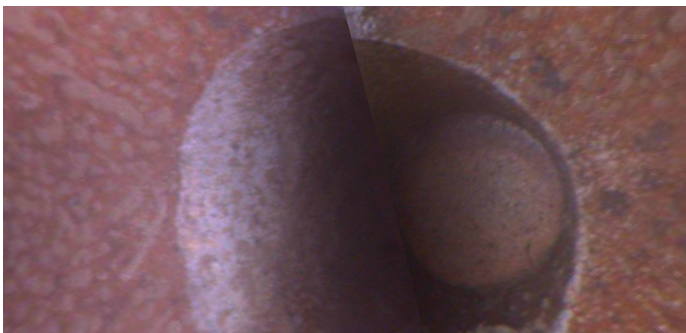
Code: **TFC**
Description: **Tap Factory Capped**

Distance (ft): **209.0**
Structural Grade: **0**
O&M Grade: **0**
Clock Start/From: **2**
Clock To:
1st Value: **4.000**
2nd Value:
Value Percent:
Continuous Index:
Within 8" of Joint: **YES**
Remarks:

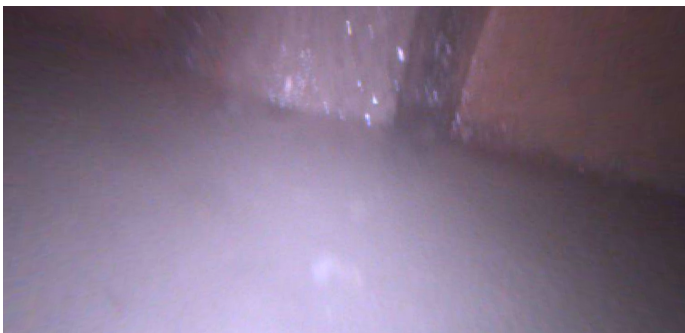
Code: **AMH**
Description: **Manhole**

Distance (ft): **269.4**
Structural Grade: **0**
O&M Grade: **0**
Clock Start/From:
Clock To:
1st Value:
2nd Value:
Value Percent:
Continuous Index:
Within 8" of Joint: **NO**
Remarks: **M-604-082**
