Profile/Photo Observation Report

Date:	04/20/2018	Weather:		Coding:	PACP 6.0
Pipe Length (ft):	273.5	Owner:	NA	Pre Clean:	Not Known
P.O.#:		Surveyor:	Byrd Fitzgerald	PSR:	P-504-082-020
Customer:		Clean Date:	01/01/1900	Shape:	C

Street:	Summerlin	Flow Control:	Not Controlled
City:	Hobart, IN	Year Renewed:	
Location:	Light Highway	Tape/Media #:	
Purpose:	Not Known	Dia/Height:	10"
Use:	Sanitary	Material:	VCP
Drain Area:	NA	Lining:	
Category:	NA		
Comment:

Location Details:		Direction of Survey:	Downstream
US MH:	M-504-020	DS MH:	M-604-082
		Total Length Surveyed (ft):	269.4

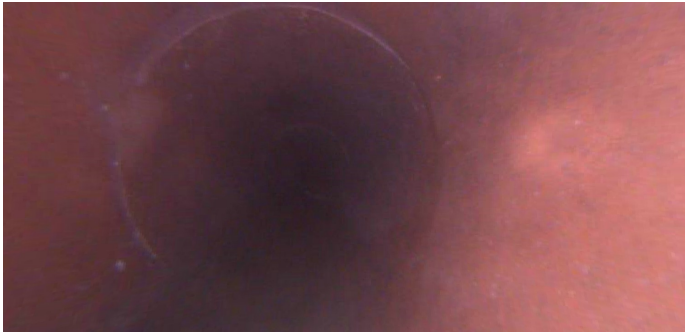
Code: **AMH**
Description: **Manhole**

Distance (ft): **.0**
Structural Grade: **0**
O&M Grade: **0**
Clock Start/From:
Clock To:
1st Value:
2nd Value:
Value Percent:
Continuous Index:
Within 8" of Joint: **NO**
Remarks: **M-504-020**

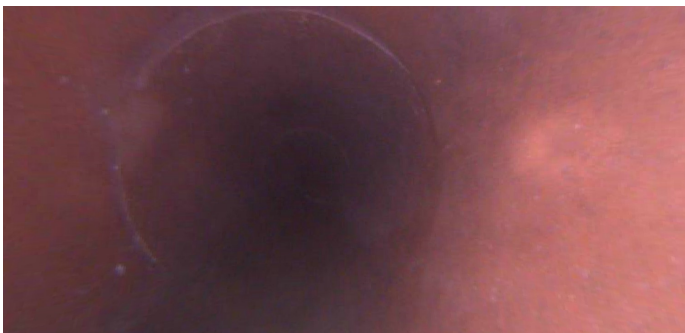
Code: **MWL**
Description: **Water Level**

Distance (ft): **.0**
Structural Grade: **0**
O&M Grade: **0**
Clock Start/From:
Clock To:
1st Value:
2nd Value:
Value Percent: **5.000**
Continuous Index:
Within 8" of Joint: **NO**
Remarks:

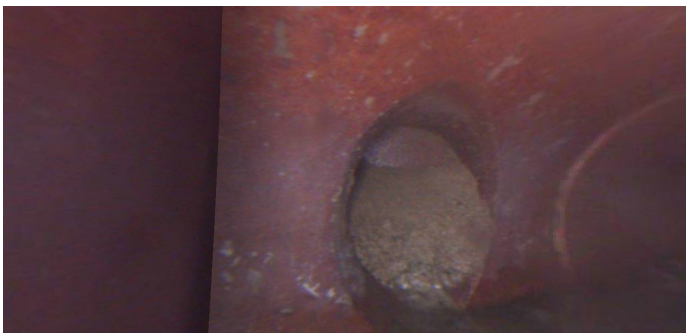
Code: **TFC**
Description: **Tap Factory Capped**

Distance (ft): **36.3**
Structural Grade: **0**
O&M Grade: **0**
Clock Start/From: **3**
Clock To:
1st Value: **4.000**
2nd Value:
Value Percent:
Continuous Index:
Within 8" of Joint: **YES**
Remarks:

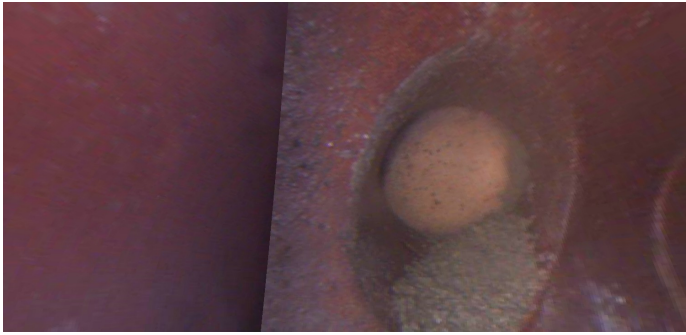
Code: **TFC**
Description: **Tap Factory Capped**

Distance (ft): **60.3**
Structural Grade: **0**
O&M Grade: **0**
Clock Start/From: **2**
Clock To:
1st Value: **4.000**
2nd Value:
Value Percent:
Continuous Index:
Within 8" of Joint: **YES**
Remarks:

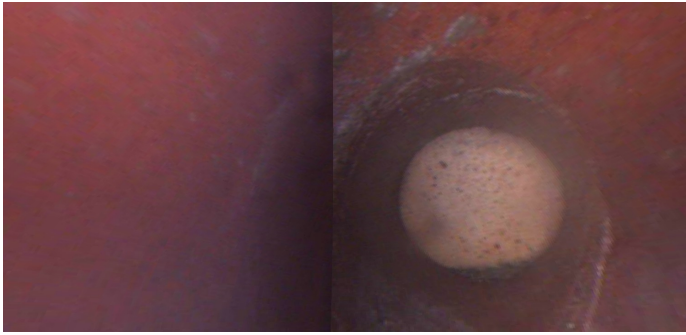
Code: **TFC**
Description: **Tap Factory Capped**

Distance (ft): **86.1**
Structural Grade: **0**
O&M Grade: **0**
Clock Start/From: **2**
Clock To:
1st Value: **4.000**
2nd Value:
Value Percent:
Continuous Index:
Within 8" of Joint: **YES**
Remarks:

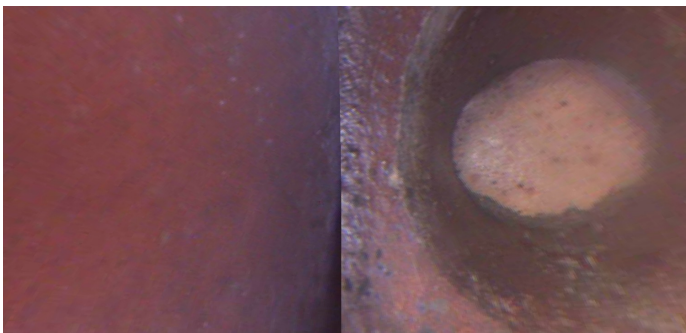
Code: **TFC**
Description: **Tap Factory Capped**

Distance (ft): **110.2**
Structural Grade: **0**
O&M Grade: **0**
Clock Start/From: **2**
Clock To:
1st Value: **4.000**
2nd Value:
Value Percent:
Continuous Index:
Within 8" of Joint: **YES**
Remarks:

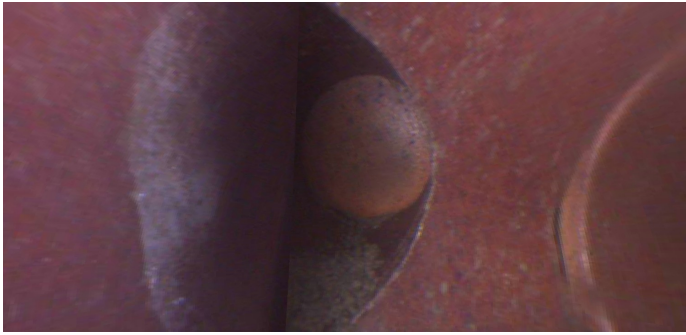
Code: **TFC**
Description: **Tap Factory Capped**

Distance (ft): **134.1**
Structural Grade: **0**
O&M Grade: **0**
Clock Start/From: **2**
Clock To:
1st Value: **4.000**
2nd Value:
Value Percent:
Continuous Index:
Within 8" of Joint: **YES**
Remarks:

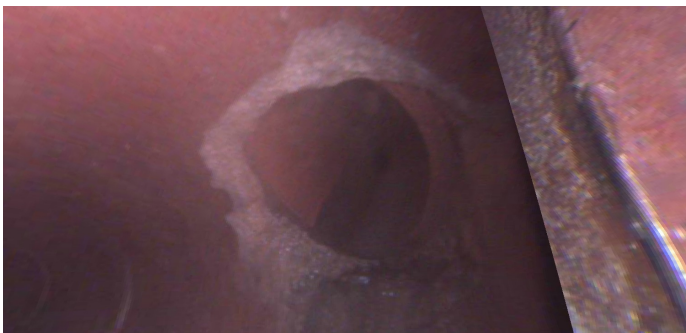
Code: **TB**
Description: **Tap Break-in**

Distance (ft): **135.5**
Structural Grade: **0**
O&M Grade: **0**
Clock Start/From: **2**
Clock To:
1st Value: **4.000**
2nd Value:
Value Percent:
Continuous Index:
Within 8" of Joint:
Remarks:

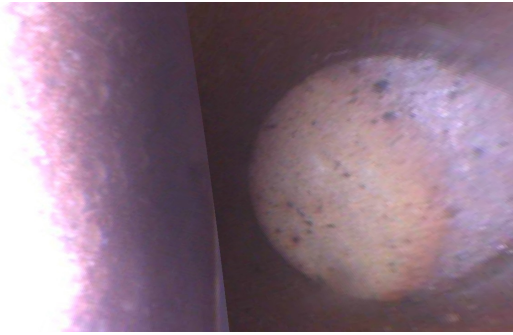
Code: **TFC**
Description: **Tap Factory Capped**

Distance (ft): **158.5**
Structural Grade: **0**
O&M Grade: **0**
Clock Start/From: **2**
Clock To:
1st Value: **4.000**
2nd Value:
Value Percent:
Continuous Index:
Within 8" of Joint: **YES**
Remarks:

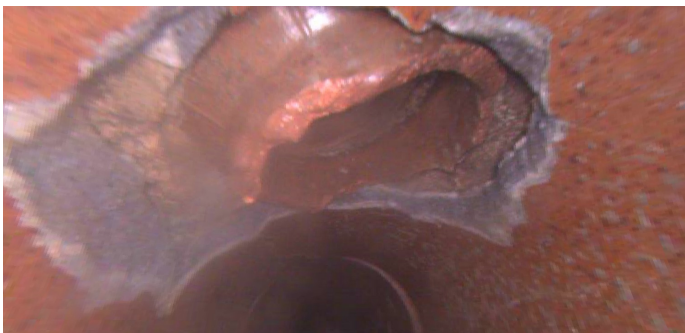
Code: **TB**
Description: **Tap Break-in**

Distance (ft): **173.6**
Structural Grade: **0**
O&M Grade: **0**
Clock Start/From: **12**
Clock To:
1st Value: **4.000**
2nd Value:
Value Percent:
Continuous Index:
Within 8" of Joint:
Remarks:

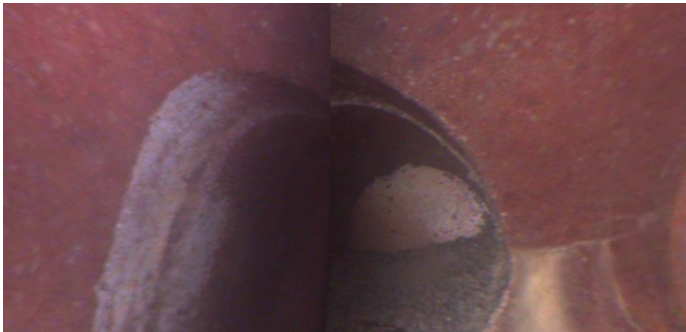
Code: **TFC**
Description: **Tap Factory Capped**

Distance (ft): **184.6**
Structural Grade: **0**
O&M Grade: **0**
Clock Start/From: **2**
Clock To:
1st Value: **4.000**
2nd Value:
Value Percent:
Continuous Index:
Within 8" of Joint: **YES**
Remarks:

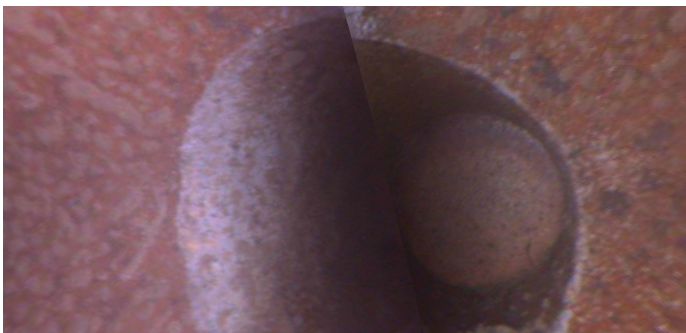
Code: **TFC**
Description: **Tap Factory Capped**

Distance (ft): **209.0**
Structural Grade: **0**
O&M Grade: **0**
Clock Start/From: **2**
Clock To:
1st Value: **4.000**
2nd Value:
Value Percent:
Continuous Index:
Within 8" of Joint: **YES**
Remarks:

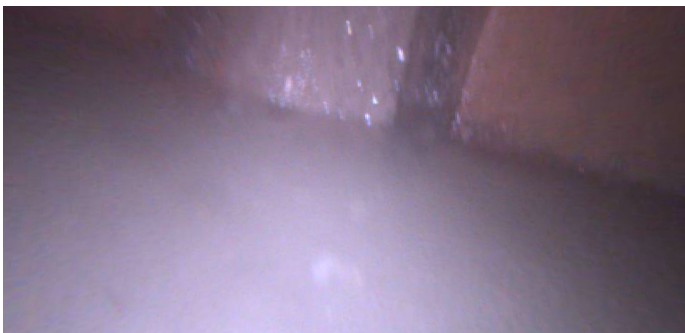
Code: **AMH**
Description: **Manhole**

Distance (ft): **269.4**
Structural Grade: **0**
O&M Grade: **0**
Clock Start/From:
Clock To:
1st Value:
2nd Value:
Value Percent:
Continuous Index:
Within 8" of Joint: **NO**
Remarks: **M-604-082**
