Profile/Photo Observation Report

Date:	11/01/2021	Weather:		Coding:	PACP 7.0
Pipe Length (ft):	171.7	Owner:	City of Hobart	Pre Clean:	Heavy Cleaning
P.O.#:	YES502259	Surveyor:	S. Bucklin	PSR:	P-504-030-023
Customer:	City of Hobart	Clean Date:	10/28/2021	Shape:	C

Street:	North Colorado Street	Flow Control:	Not Controlled
City:	Hobart, IN	Year Renewed:	
Location:	Alley	Tape/Media #:	
Purpose:	Routine Assessment	Dia/Height:	12"
Use:	Sanitary Sewage Pipe	Material:	VCP
Drain Area:		Lining:	None
Category:	NA		
Comment:			
Location Details:		Direction of Survey:	Upstream
US MH:	M-504-023	DS MH:	M-504-030
		Total Length Surveyed (ft):	171.7

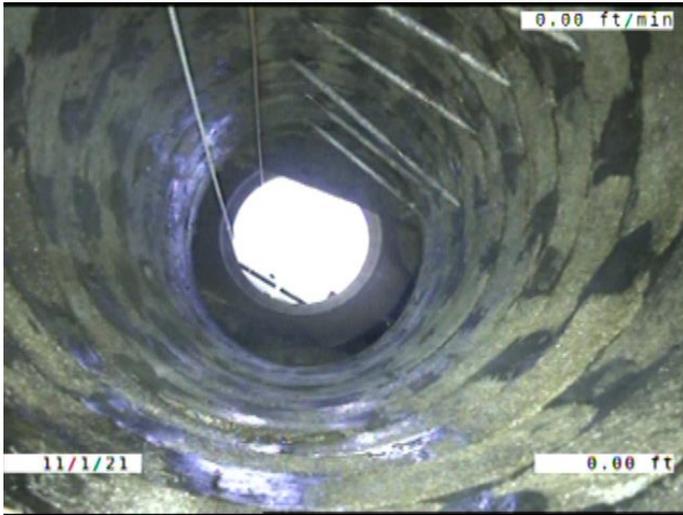
Code: **AMH**
Description: **Manhole**

Distance (ft): **.0**
Structural Grade: **0**
O&M Grade: **0**
Clock Start/From:
Clock To:
1st Value:
2nd Value:
Value Percent:
Continuous Index:
Within 8" of Joint: **NO**
Remarks: **M-504-030**

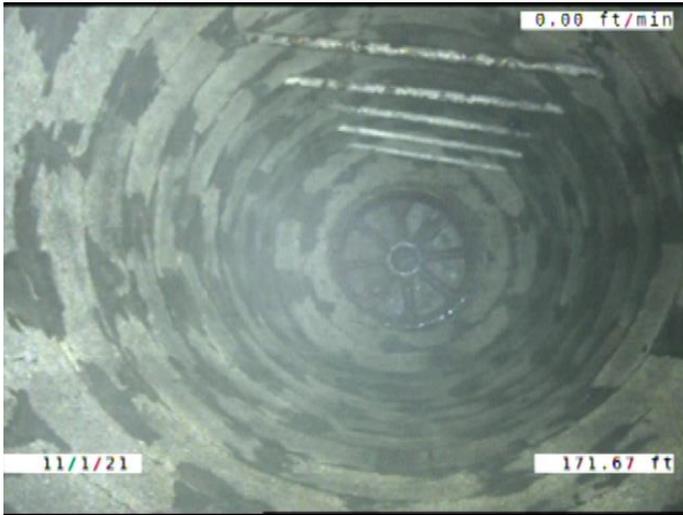
Code: **AMH**
Description: **Manhole**

Distance (ft): **171.7**
Structural Grade: **0**
O&M Grade: **0**
Clock Start/From:
Clock To:
1st Value:
2nd Value:
Value Percent:
Continuous Index:
Within 8" of Joint: **NO**
Remarks: **M-504-023**
