RedZone  
ROBOTICS

| Street: | North Colorado Street | | Flow Control: | Not Controlled | |
| City: | Hobart, IN | | Year Renewed: | | |
| US MH: | M-504-024 | DS MH: | M-504-038 | Total Length Surveyed (ft): | 155.9 |

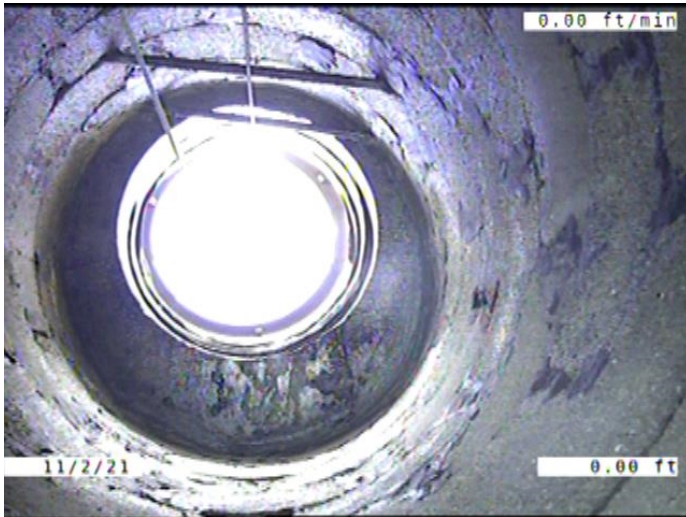
Code: **AMH**  
Description: **Manhole**

Distance (ft): **.0**  
Structural Grade: **0**  
O&M Grade: **0**  
Clock Start/From:  
Clock To:  
1st Value:  
2nd Value:  
Value Percent:  
Continuous Index:  
Within 8" of Joint: **NO**  
Remarks: **M-504-024**

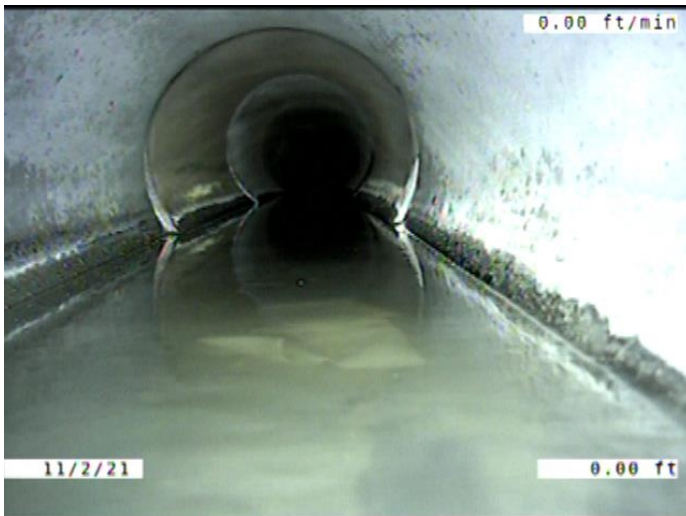
Code: **MWL**  
Description: **Miscellaneous Water Level**

Distance (ft): **.0**  
Structural Grade: **0**  
O&M Grade: **0**  
Clock Start/From:  
Clock To:  
1st Value:  
2nd Value:  
Value Percent: **5.000**  
Continuous Index:  
Within 8" of Joint: **NO**  
Remarks:

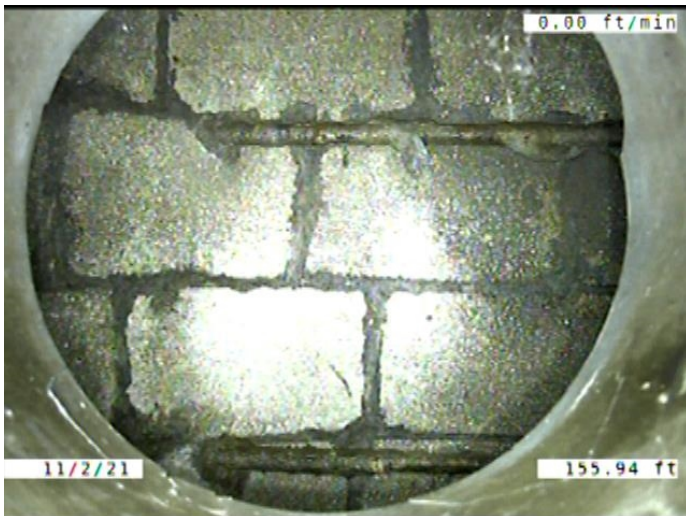
Code: **AMH**  
 Description: **Manhole**

Distance (ft): **155.9**  
 Structural Grade: **0**  
 O&M Grade: **0**  
 Clock Start/From:  
 Clock To:  
 1st Value:  
 2nd Value:  
 Value Percent:  
 Continuous Index:  
 Within 8" of Joint: **NO**  
 Remarks: **M-504-038**
