## Profile/Photo Observation Report

Date:	<b>01/27/2025</b>	Weather:		Coding:	<b>PACP 7.0</b>
Pipe Length (ft):	<b>166.0</b>	Owner:	<b>City of Hobart</b>	Pre Clean:	<b>Heavy Cleaning</b>
P.O.#:	<b>YES502259</b>	Surveyor:	<b>S. Bucklin</b>	PSR:	<b>P-504-024-057</b>
Customer:	<b>City of Hobart</b>	Clean Date:	<b>01/06/2025</b>	Shape:	<b>C</b>

Street:	<b>South Colorado Street</b>	Flow Control:	<b>Not Controlled</b>
City:	<b>Hobart, IN</b>	Year Renewed:	
Location:	<b>Local rural streets with light traffic, t</b>	Tape/Media #:	
Purpose:	<b>Sewer System Evaluation Survey (SS</b>	Dia/Height:	<b>18"</b>
Use:	<b>Sanitary Sewage Pipe</b>	Material:	<b>VCP</b>
Drain Area:		Lining:	<b>None</b>
Category:	<b>NA</b>		
Comment:			
Location Details:		Direction of Survey:	<b>Downstream</b>
US MH:	<b>M-504-024</b>	DS MH:	<b>M-505-057</b>
		Total Length Surveyed (ft):	<b>166.2</b>

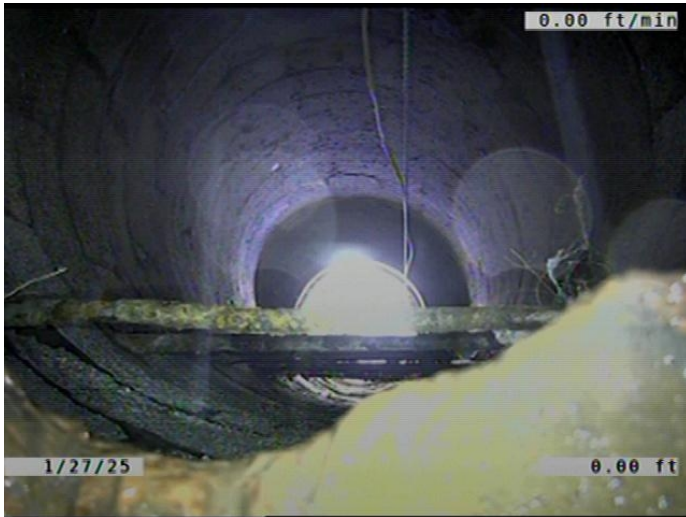
Code: **AMH**  
Description: **Manhole**

Distance (ft): **.0**  
Structural Grade: **0**  
O&M Grade: **0**  
Clock Start/From:  
Clock To:  
1st Value:  
2nd Value:  
Value Percent:  
Continuous Index:  
Within 8" of Joint: **NO**  
Remarks: **M-504-024**

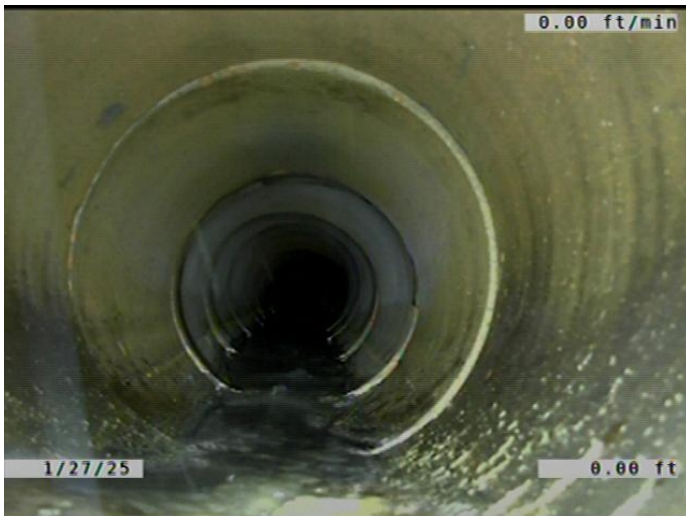
Code: **MWL**  
Description: **Miscellaneous Water Level**

Distance (ft): **.0**  
Structural Grade: **0**  
O&M Grade: **0**  
Clock Start/From:  
Clock To:  
1st Value:  
2nd Value:  
Value Percent: **5.000**  
Continuous Index:  
Within 8" of Joint: **NO**  
Remarks:

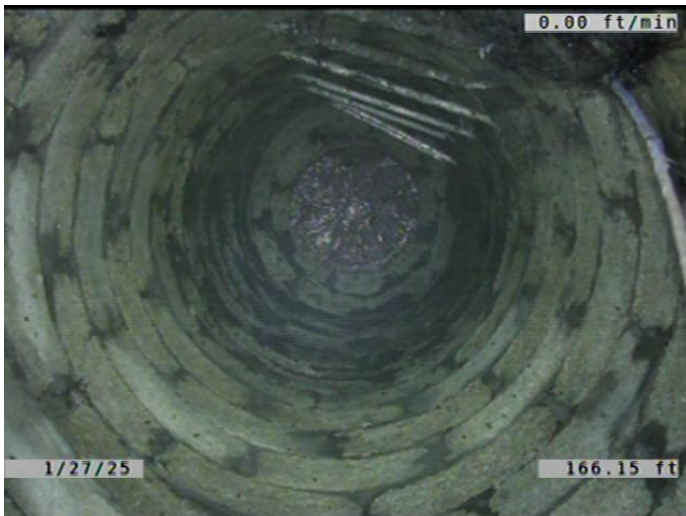
Code: **AMH**  
 Description: **Manhole**

Distance (ft): **166.2**  
 Structural Grade: **0**  
 O&M Grade: **0**  
 Clock Start/From:  
 Clock To:  
 1st Value:  
 2nd Value:  
 Value Percent:  
 Continuous Index:  
 Within 8" of Joint: **NO**  
 Remarks: **M-505-057**
