Profile/Photo Observation Report

Date:	09/16/2021	Weather:		Coding:	PACP 7.0
Pipe Length (ft):	326.7	Owner:	City of Hobart	Pre Clean:	Light Cleaning
P.O.#:	YES502259	Surveyor:	S. Bucklin	PSR:	P-504-052-027
Customer:	City of Hobart	Clean Date:	09/07/2021	Shape:	C

Street:	North Guyer Street	Flow Control:	Not Controlled
City:	Hobart, IN	Year Renewed:	
Location:	Alley	Tape/Media #:	
Purpose:	Routine Assessment	Dia/Height:	12"
Use:	Sanitary Sewage Pipe	Material:	CP
Drain Area:		Lining:	None
Category:	NA		
Comment:			
Location Details:		Direction of Survey:	Downstream
US MH:	M-504-027	DS MH:	M-504-052
		Total Length Surveyed (ft):	326.7

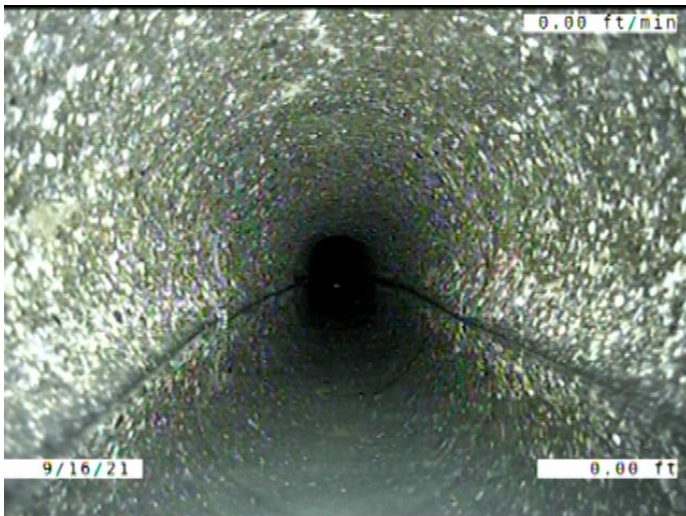
Code: **AMH**
 Description: **Manhole**

Distance (ft): **.0**
 Structural Grade: **0**
 O&M Grade: **0**
 Clock Start/From:
 Clock To:
 1st Value:
 2nd Value:
 Value Percent:
 Continuous Index:
 Within 8" of Joint: **NO**
 Remarks: **M-504-027**

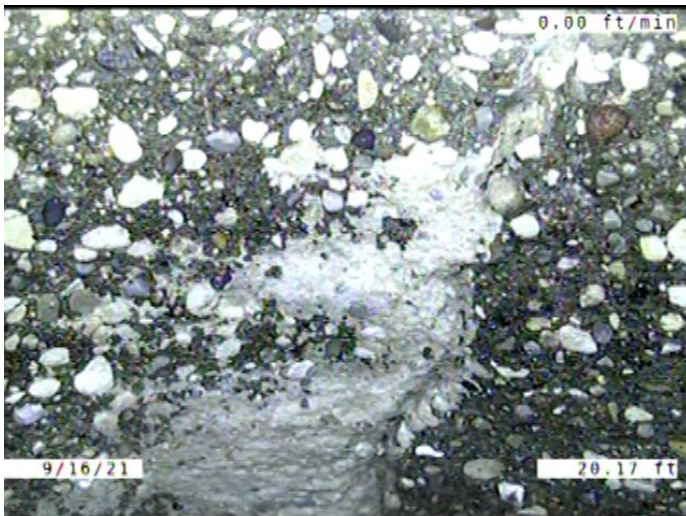
Code: **DAE**
 Description: **Deposits Attached Encrustation**

Distance (ft): **10.8**
 Structural Grade: **0**
 O&M Grade: **2**
 Clock Start/From: **1**
 Clock To: **2**
 1st Value:
 2nd Value:
 Value Percent: **5.000**
 Continuous Index:
 Within 8" of Joint: **NO**
 Remarks:

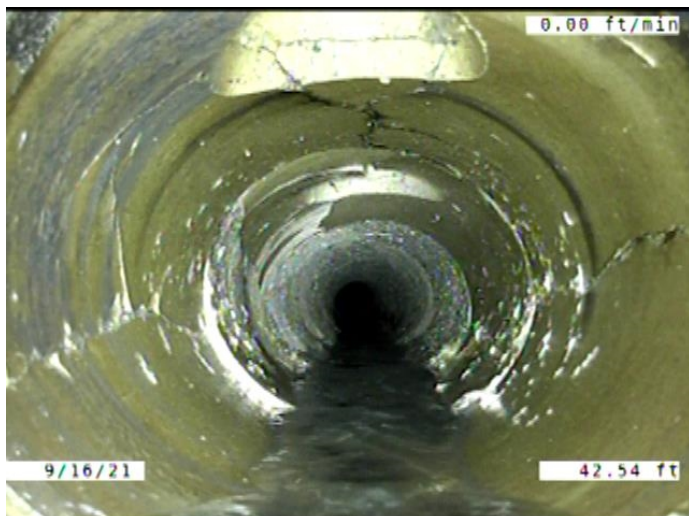
Code: **TBI**
 Description: **Tap Break-in Intruding**

Distance (ft): **34.6**
 Structural Grade: **0**
 O&M Grade: **2**
 Clock Start/From: **1**
 Clock To:
 1st Value: **4.000**
 2nd Value: **1.000**
 Value Percent:
 Continuous Index:
 Within 8" of Joint: **YES**
 Remarks:

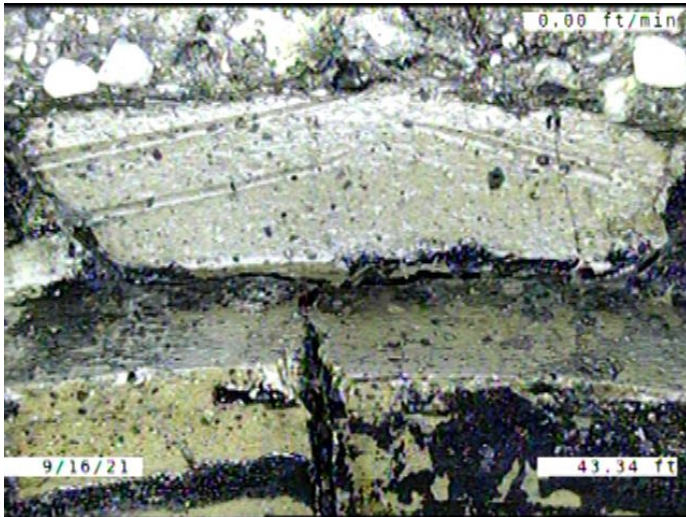
Code: **MWLS**
 Description: **Miscellaneous Water Level Sag**

Distance (ft): **42.5**
 Structural Grade: **2**
 O&M Grade: **0**
 Clock Start/From:
 Clock To:
 1st Value:
 2nd Value:
 Value Percent: **15.000**
 Continuous Index: **F04**
 Within 8" of Joint: **NO**
 Remarks:

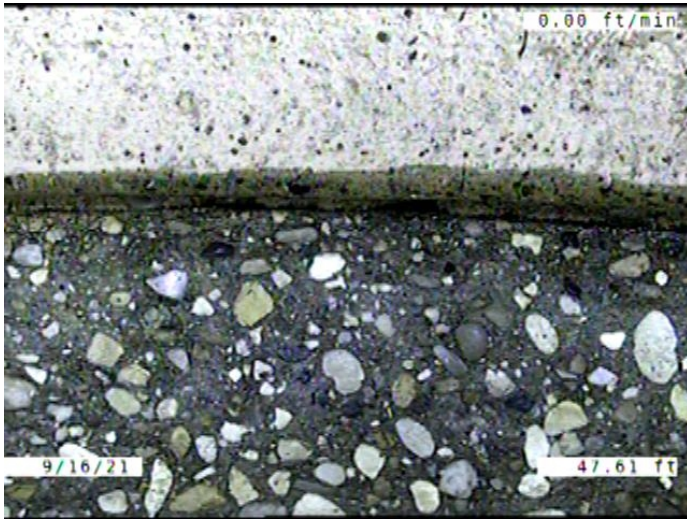
Code: **TFD**
 Description: **Tap Factory Defective**

Distance (ft): **46.7**
 Structural Grade: **0**
 O&M Grade: **3**
 Clock Start/From: **12**
 Clock To:
 1st Value: **4.000**
 2nd Value:
 Value Percent:
 Continuous Index:
 Within 8" of Joint: **YES**
 Remarks: **Defective**

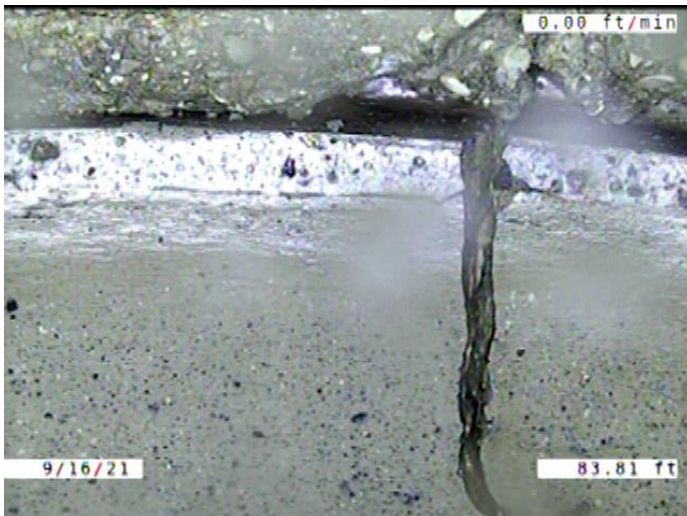
Code: **TBI**
 Description: **Tap Break-in Intruding**

Distance (ft): **79.0**
 Structural Grade: **0**
 O&M Grade: **2**
 Clock Start/From: **1**
 Clock To:
 1st Value: **4.000**
 2nd Value: **1.000**
 Value Percent:
 Continuous Index:
 Within 8" of Joint: **YES**
 Remarks: **CONSTANTLY RUNNING WATER. SOIL VISIBLE AROUND THE TAP CONNECT**

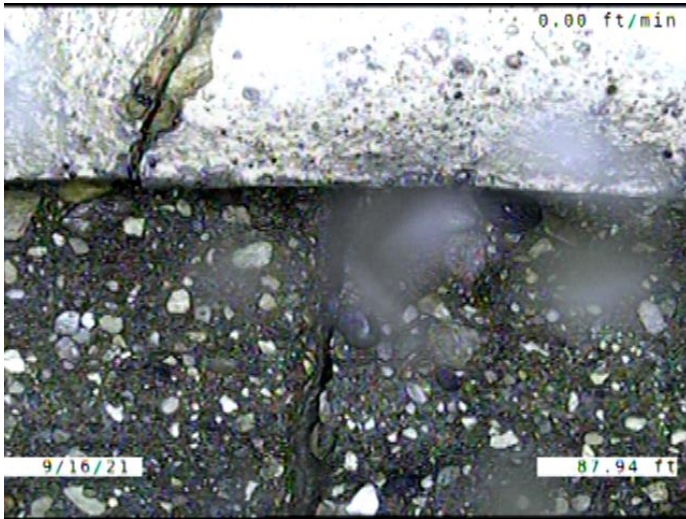
Code: **TFD**
 Description: **Tap Factory Defective**

Distance (ft): **86.9**
 Structural Grade: **0**
 O&M Grade: **3**
 Clock Start/From: **12**
 Clock To:
 1st Value: **4.000**
 2nd Value:
 Value Percent:
 Continuous Index:
 Within 8" of Joint: **YES**
 Remarks: **Defective**

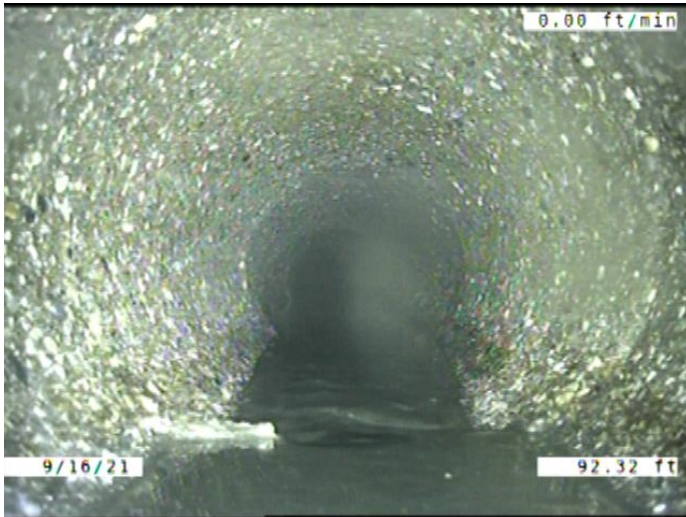
Code: **TBD**
Description: **Tap Break-in/Hammer Defective**

Distance (ft): **88.8**
Structural Grade: **0**
O&M Grade: **3**
Clock Start/From: **1**
Clock To:
1st Value: **4.000**
2nd Value:
Value Percent:
Continuous Index:
Within 8" of Joint: **YES**
Remarks: **Defective**

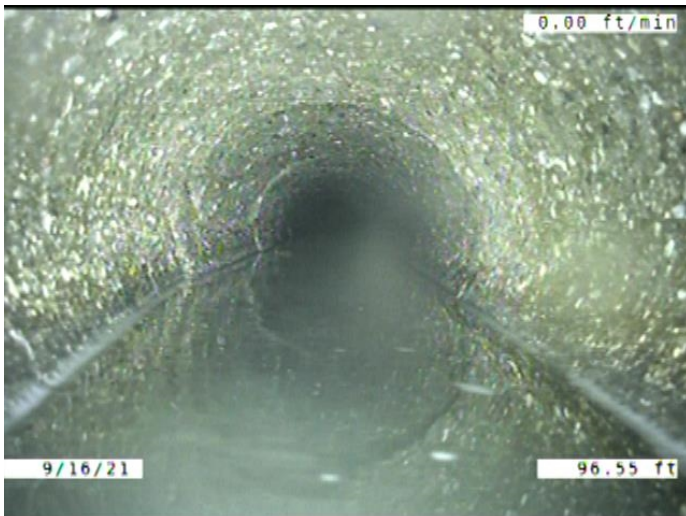
Code:	DAE
Description:	Deposits Attached Encrustation
Distance (ft):	92.3
Structural Grade:	0
O&M Grade:	2
Clock Start/From:	8
Clock To:	4
1st Value:	
2nd Value:	
Value Percent:	5.000
Continuous Index:	F03
Within 8" of Joint:	YES
Remarks:

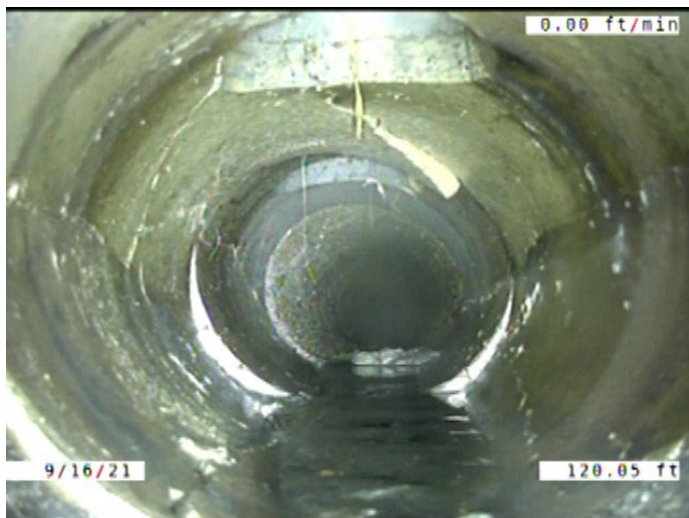
Code: **B**
 Description: **Broken**

Distance (ft): **118.9**
 Structural Grade: **4**
 O&M Grade: **0**
 Clock Start/From: **6**
 Clock To: **3**
 1st Value:
 2nd Value:
 Value Percent:
 Continuous Index:
 Within 8" of Joint: **NO**
 Remarks:

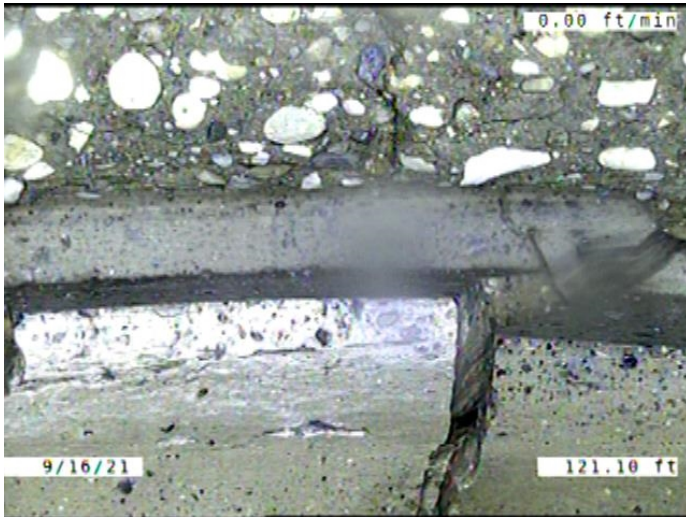
Code: **MWLS**
 Description: **Miscellaneous Water Level Sag**

Distance (ft): **120.1**
 Structural Grade: **2**
 O&M Grade: **0**
 Clock Start/From:
 Clock To:
 1st Value:
 2nd Value:
 Value Percent: **15.000**
 Continuous Index: **F06**
 Within 8" of Joint: **NO**
 Remarks:

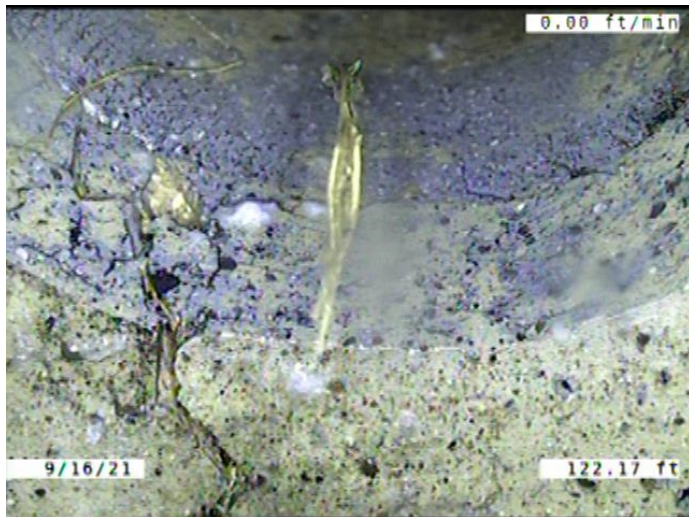
Code: **TFD**
Description: **Tap Factory Defective**

Distance (ft): **122.2**
Structural Grade: **0**
O&M Grade: **3**
Clock Start/From: **12**
Clock To:
1st Value: **4.000**
2nd Value:
Value Percent:
Continuous Index:
Within 8" of Joint: **YES**
Remarks: **Defective**

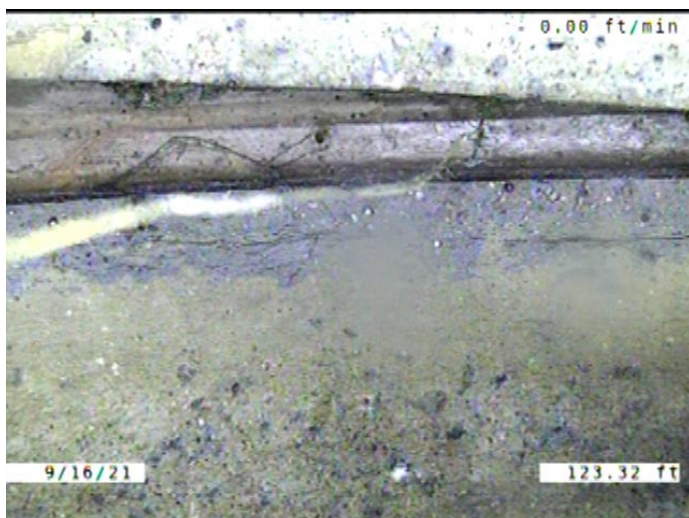
Code: **RFL**
 Description: **Roots Fine Lateral**

Distance (ft): **122.2**
 Structural Grade: **0**
 O&M Grade: **1**
 Clock Start/From: **12**
 Clock To:
 1st Value:
 2nd Value:
 Value Percent:
 Continuous Index:
 Within 8" of Joint: **NO**
 Remarks:

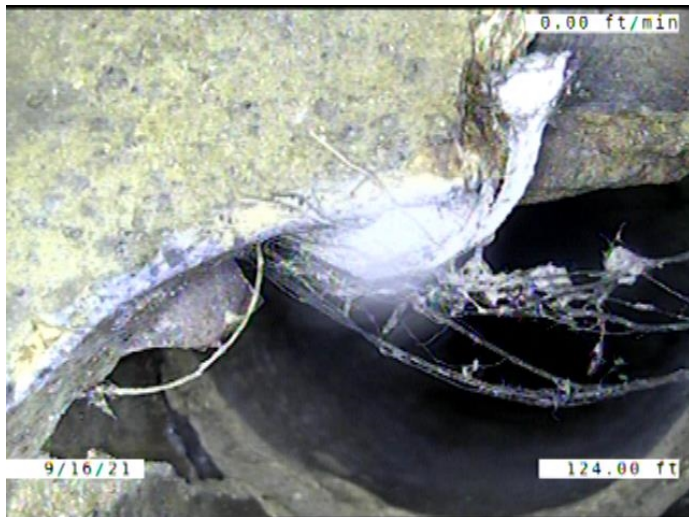
Code: **RFJ**
 Description: **Roots Fine Joint**

Distance (ft): **123.3**
 Structural Grade: **0**
 O&M Grade: **1**
 Clock Start/From: **9**
 Clock To: **3**
 1st Value:
 2nd Value:
 Value Percent:
 Continuous Index:
 Within 8" of Joint: **YES**
 Remarks:

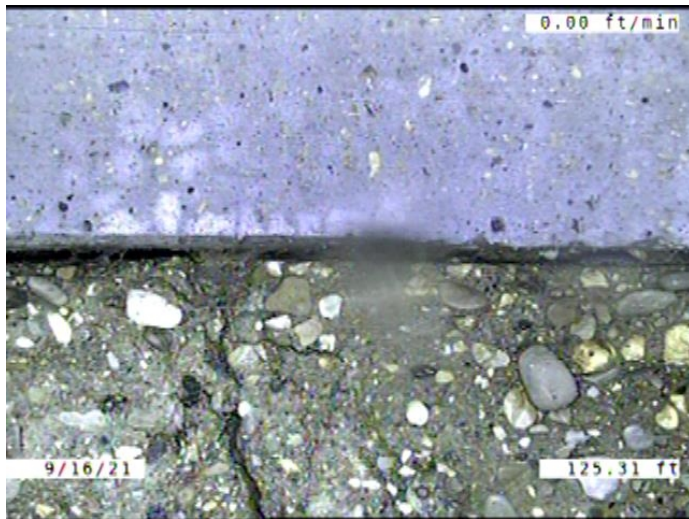
Code: **TFD**
 Description: **Tap Factory Defective**

Distance (ft): **124.2**
 Structural Grade: **0**
 O&M Grade: **3**
 Clock Start/From: **12**
 Clock To:
 1st Value: **4.000**
 2nd Value:
 Value Percent:
 Continuous Index:
 Within 8" of Joint: **YES**
 Remarks: **SOIL VISIBLE AROUND THE TAP**

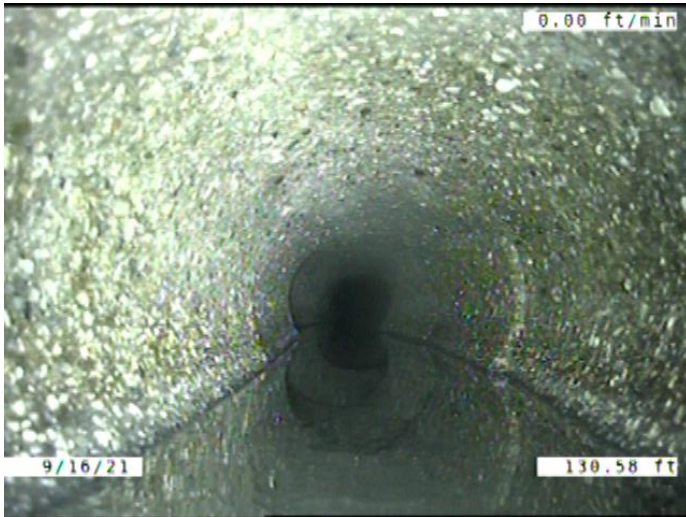
Code:	DAE
Description:	Deposits Attached Encrustation
Distance (ft):	127.1
Structural Grade:	0
O&M Grade:	2
Clock Start/From:	8
Clock To:	9
1st Value:	
2nd Value:	
Value Percent:	5.000
Continuous Index:	S08
Within 8" of Joint:	YES
Remarks:

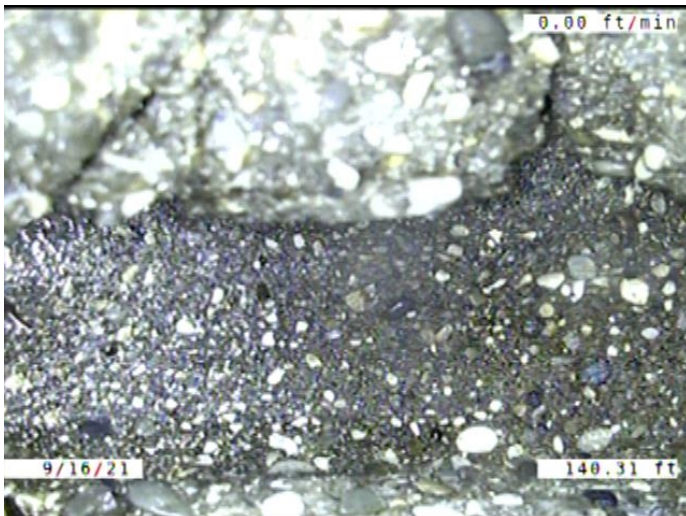
Code: **LR**
 Description: **Line Right**

Distance (ft): **139.7**
 Structural Grade: **0**
 O&M Grade: **1**
 Clock Start/From:
 Clock To:
 1st Value:
 2nd Value:
 Value Percent: **5.000**
 Continuous Index:
 Within 8" of Joint: **NO**
 Remarks:

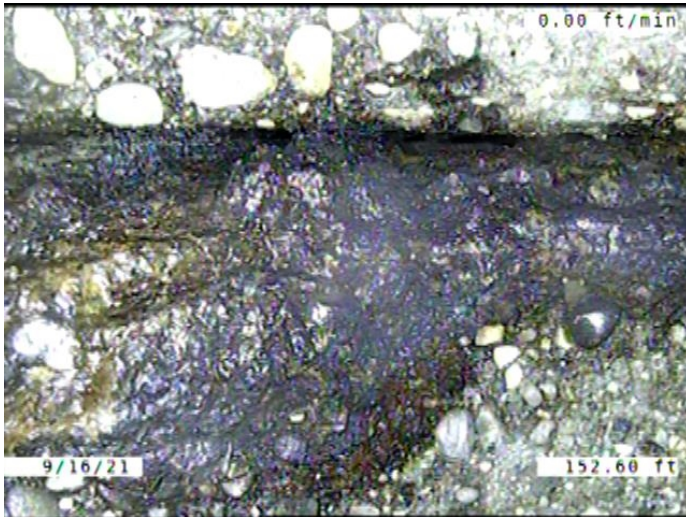
Code: **JAM**
 Description: **Joint Angular Medium**

Distance (ft): **140.3**
 Structural Grade: **3**
 O&M Grade: **0**
 Clock Start/From:
 Clock To:
 1st Value:
 2nd Value:
 Value Percent:
 Continuous Index:
 Within 8" of Joint: **NO**
 Remarks:

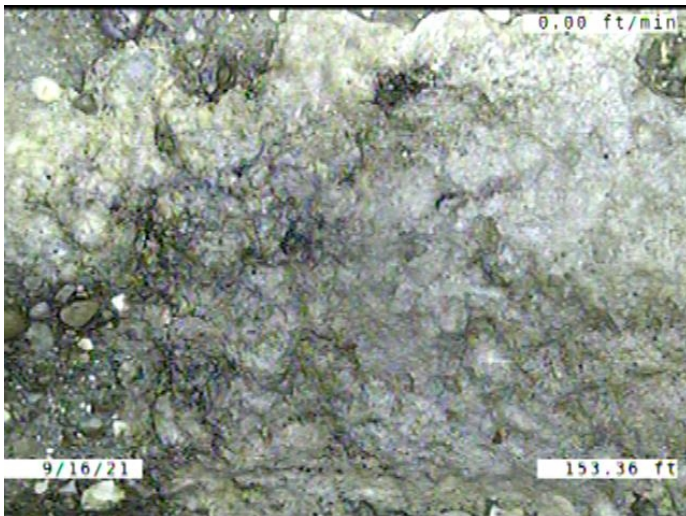
Code: **DAE**
 Description: **Deposits Attached Encrustation**

Distance (ft): **152.6**
 Structural Grade: **0**
 O&M Grade: **2**
 Clock Start/From: **8**
 Clock To: **10**
 1st Value:
 2nd Value:
 Value Percent: **5.000**
 Continuous Index:
 Within 8" of Joint: **YES**
 Remarks:

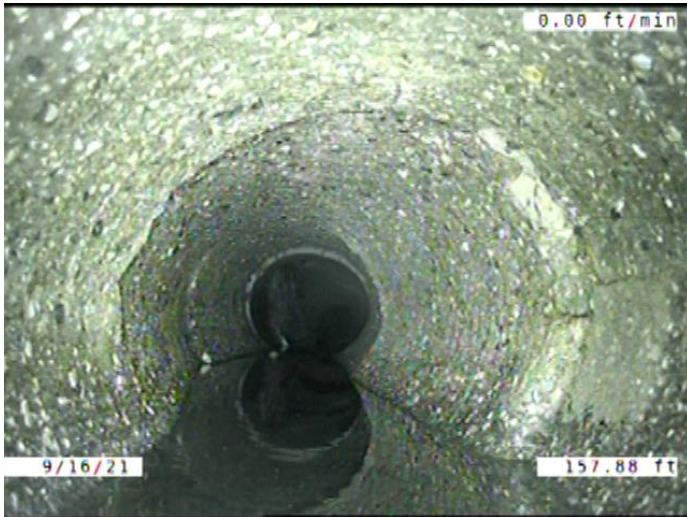
Code: **DAE**
 Description: **Deposits Attached Encrustation**

Distance (ft): **153.4**
 Structural Grade: **0**
 O&M Grade: **2**
 Clock Start/From: **8**
 Clock To: **4**
 1st Value:
 2nd Value:
 Value Percent: **5.000**
 Continuous Index: **S09**
 Within 8" of Joint: **YES**
 Remarks:

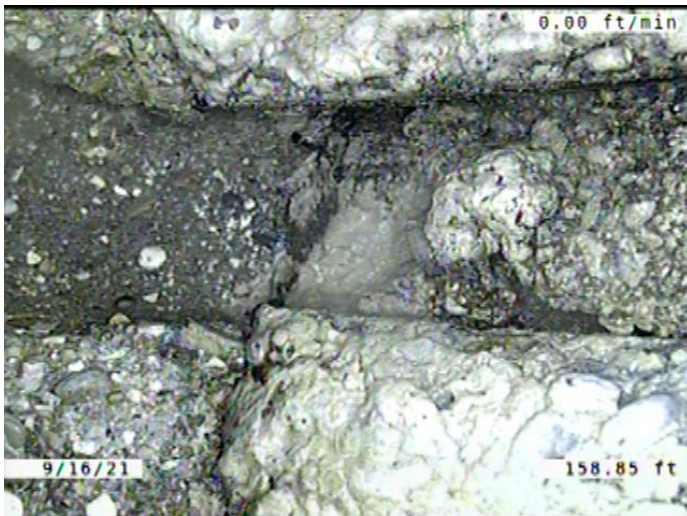
Code: **LL**
 Description: **Line Left**

Distance (ft): **157.9**
 Structural Grade: **0**
 O&M Grade: **1**
 Clock Start/From:
 Clock To:
 1st Value:
 2nd Value:
 Value Percent: **5.000**
 Continuous Index:
 Within 8" of Joint: **NO**
 Remarks:

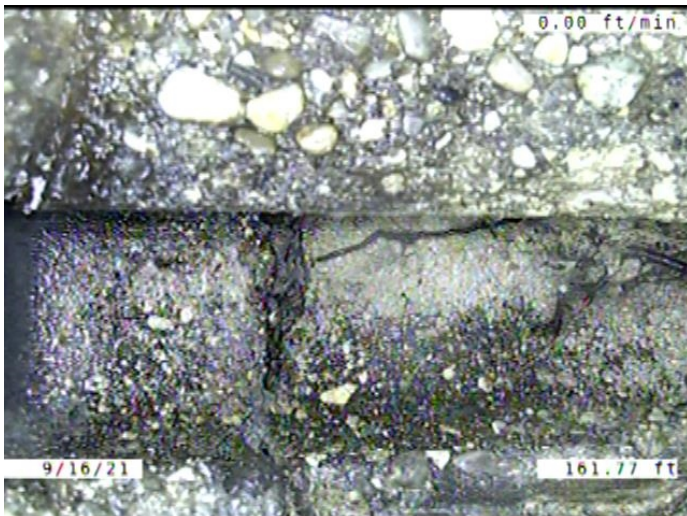
Code: **BSV**
 Description: **Broken Soil Visible**

Distance (ft): **158.9**
 Structural Grade: **5**
 O&M Grade: **0**
 Clock Start/From: **11**
 Clock To: **12**
 1st Value:
 2nd Value:
 Value Percent:
 Continuous Index:
 Within 8" of Joint: **YES**
 Remarks:

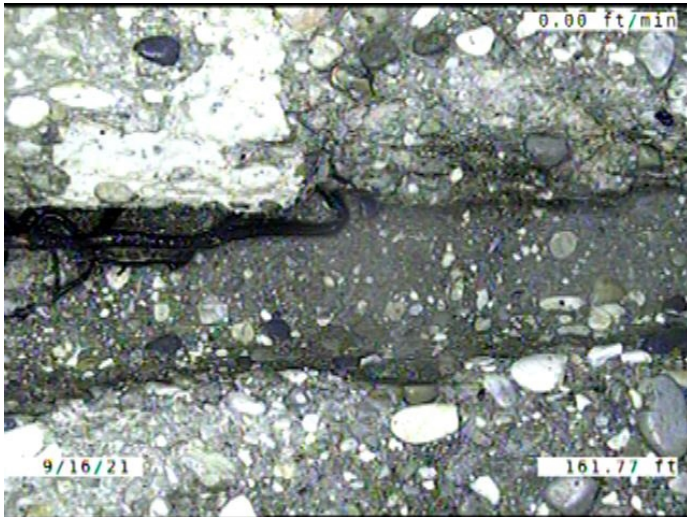
Code: **JAM**
 Description: **Joint Angular Medium**

Distance (ft): **161.8**
 Structural Grade: **3**
 O&M Grade: **0**
 Clock Start/From:
 Clock To:
 1st Value:
 2nd Value:
 Value Percent:
 Continuous Index:
 Within 8" of Joint: **NO**
 Remarks:

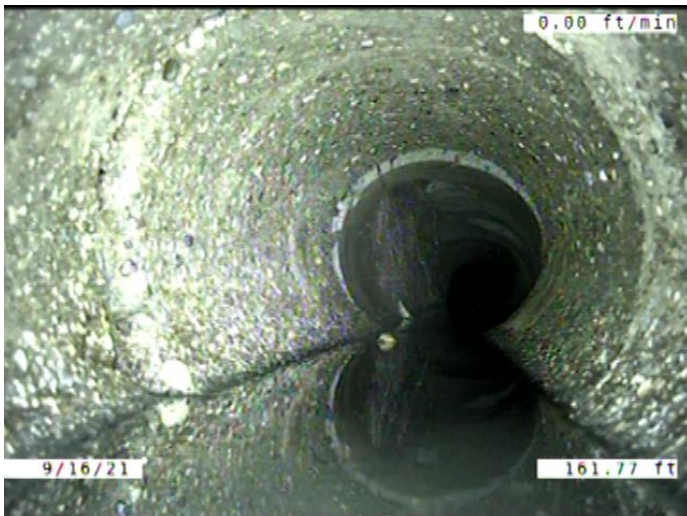
Code: **RFJ**
 Description: **Roots Fine Joint**

Distance (ft): **161.8**
 Structural Grade: **0**
 O&M Grade: **1**
 Clock Start/From: **9**
 Clock To: **11**
 1st Value:
 2nd Value:
 Value Percent:
 Continuous Index:
 Within 8" of Joint: **YES**
 Remarks:

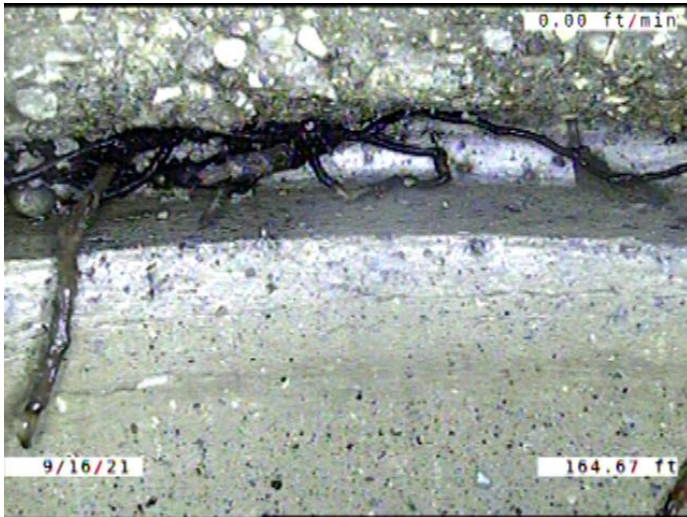
Code: **H**
 Description: **Hole**

Distance (ft): **164.7**
 Structural Grade: **5**
 O&M Grade: **0**
 Clock Start/From: **4**
 Clock To: **5**
 1st Value:
 2nd Value:
 Value Percent:
 Continuous Index:
 Within 8" of Joint: **YES**
 Remarks:

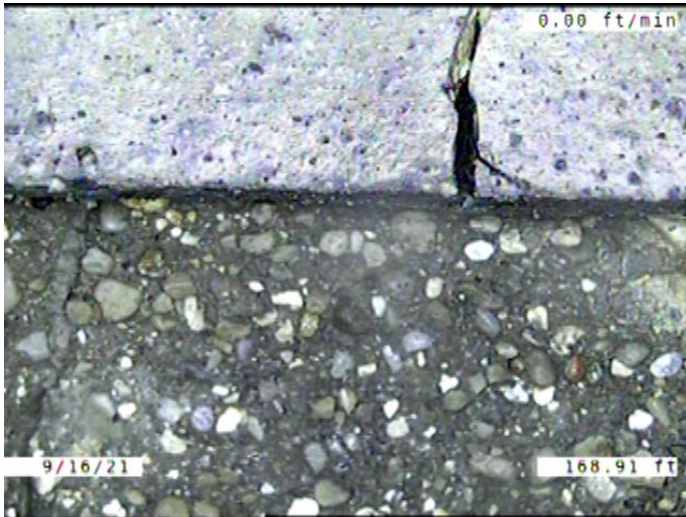
Code: **TFD**
 Description: **Tap Factory Defective**

Distance (ft): **168.0**
 Structural Grade: **0**
 O&M Grade: **3**
 Clock Start/From: **1**
 Clock To:
 1st Value: **4.000**
 2nd Value:
 Value Percent:
 Continuous Index:
 Within 8" of Joint: **YES**
 Remarks: **Defective**

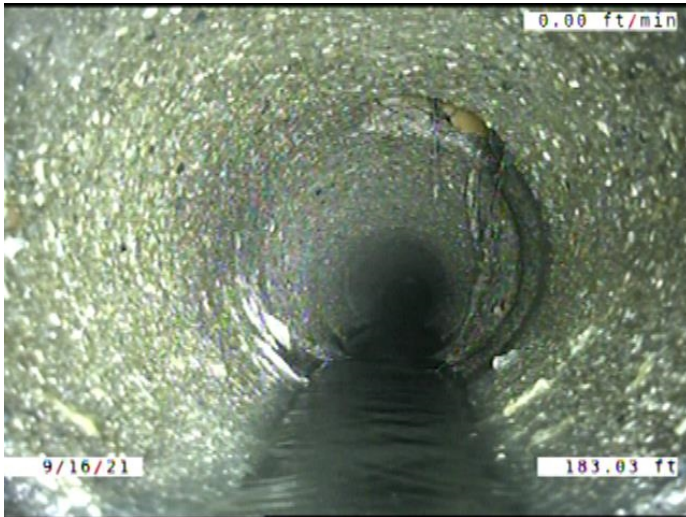
Code: **MWLS**
 Description: **Miscellaneous Water Level Sag**

Distance (ft): **171.8**
 Structural Grade: **2**
 O&M Grade: **0**
 Clock Start/From:
 Clock To:
 1st Value:
 2nd Value:
 Value Percent: **10.000**
 Continuous Index: **S10**
 Within 8" of Joint: **NO**
 Remarks:

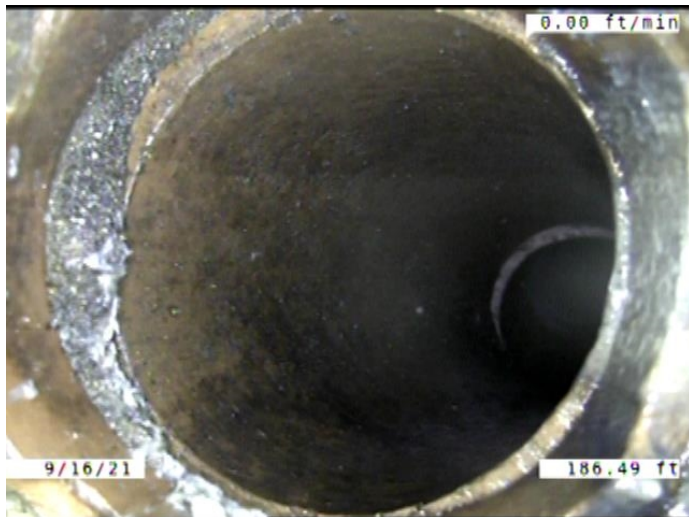
Code: **RFL**
 Description: **Roots Fine Lateral**

Distance (ft): **186.1**
 Structural Grade: **0**
 O&M Grade: **1**
 Clock Start/From: **12**
 Clock To: **2**
 1st Value:
 2nd Value:
 Value Percent:
 Continuous Index:
 Within 8" of Joint: **NO**
 Remarks:

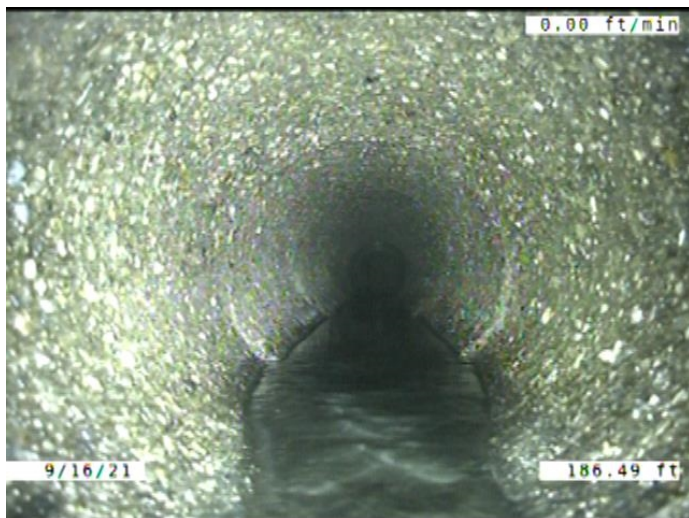
Code: **TB**
 Description: **Tap Break-in/Hammer**

Distance (ft): **186.5**
 Structural Grade: **0**
 O&M Grade: **0**
 Clock Start/From: **1**
 Clock To:
 1st Value: **4.000**
 2nd Value:
 Value Percent:
 Continuous Index:
 Within 8" of Joint: **YES**
 Remarks:

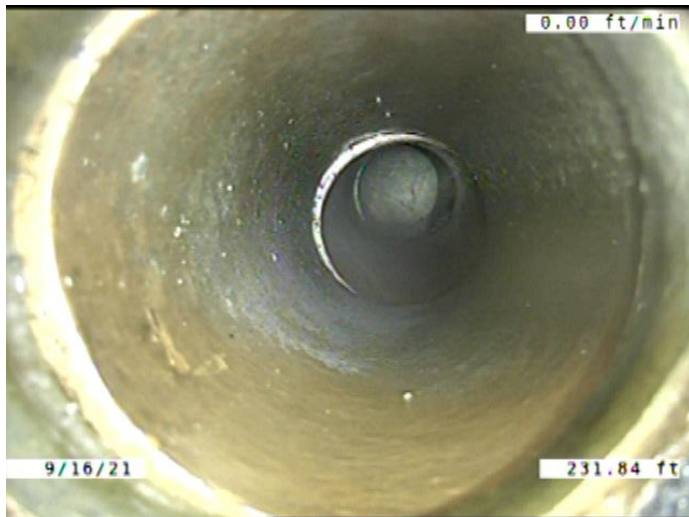
Code: **MWLS**
 Description: **Miscellaneous Water Level Sag**

Distance (ft): **221.8**
 Structural Grade: **2**
 O&M Grade: **0**
 Clock Start/From:
 Clock To:
 1st Value:
 2nd Value:
 Value Percent: **10.000**
 Continuous Index: **S11**
 Within 8" of Joint: **NO**
 Remarks:

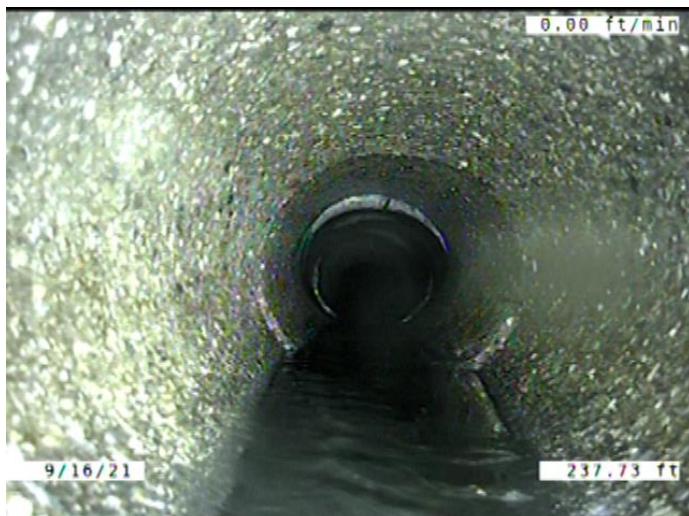
Code: **TBI**
 Description: **Tap Break-in Intruding**

Distance (ft): **231.8**
 Structural Grade: **0**
 O&M Grade: **2**
 Clock Start/From: **12**
 Clock To:
 1st Value: **4.000**
 2nd Value: **1.000**
 Value Percent:
 Continuous Index:
 Within 8" of Joint: **YES**
 Remarks:

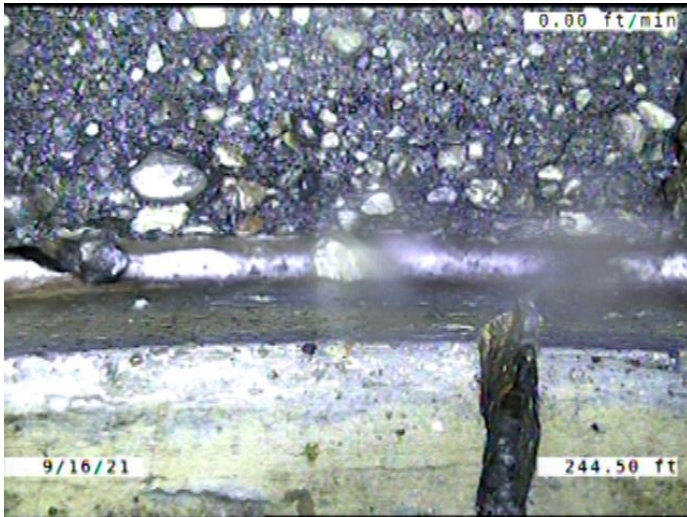
Code: **MWLS**
 Description: **Miscellaneous Water Level Sag**

Distance (ft): **237.7**
 Structural Grade: **2**
 O&M Grade: **0**
 Clock Start/From:
 Clock To:
 1st Value:
 2nd Value:
 Value Percent: **10.000**
 Continuous Index: **F11**
 Within 8" of Joint: **NO**
 Remarks:

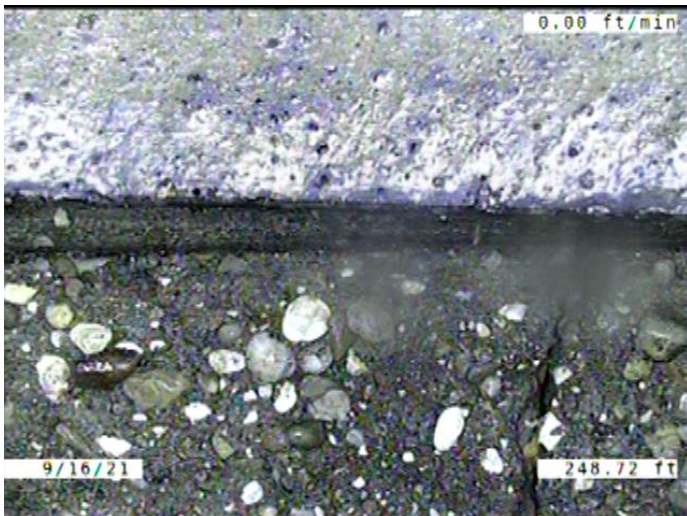
Code:	TFD
Description:	Tap Factory Defective
Distance (ft):	247.8
Structural Grade:	0
O&M Grade:	3
Clock Start/From:	1
Clock To:	
1st Value:	4.000
2nd Value:	
Value Percent:	
Continuous Index:	
Within 8" of Joint:	YES
Remarks:	SOIL VISIBLE AT THE FIRST JOINT BACK

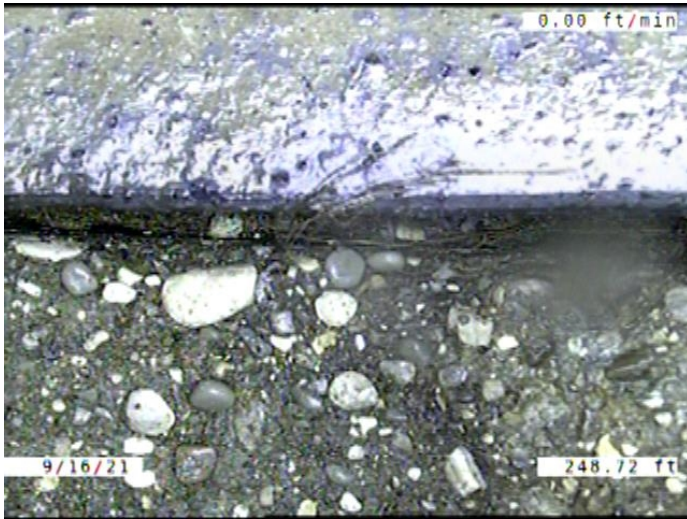
Code:	MMC
Description:	Miscellaneous Material Change
Distance (ft):	248.7
Structural Grade:	0
O&M Grade:	0
Clock Start/From:	
Clock To:	
1st Value:	
2nd Value:	
Value Percent:	
Continuous Index:	
Within 8" of Joint:	NO
Remarks:	VCP TO CONCRETE

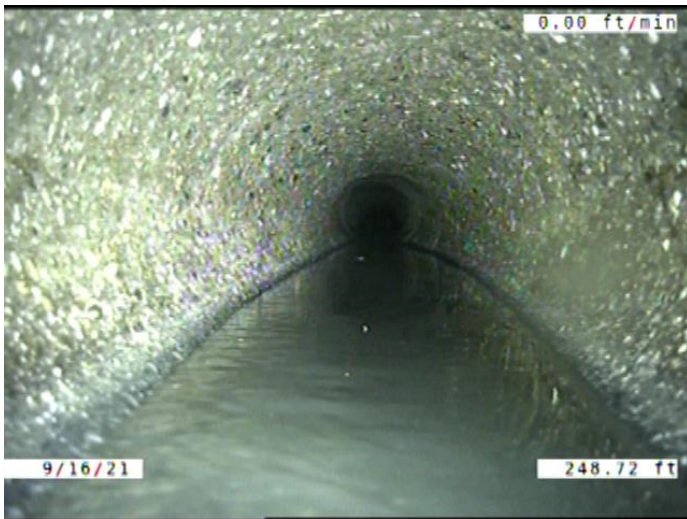
Code: **RFJ**
 Description: **Roots Fine Joint**

Distance (ft): **248.7**
 Structural Grade: **0**
 O&M Grade: **1**
 Clock Start/From: **2**
 Clock To: **3**
 1st Value:
 2nd Value:
 Value Percent:
 Continuous Index:
 Within 8" of Joint: **YES**
 Remarks:

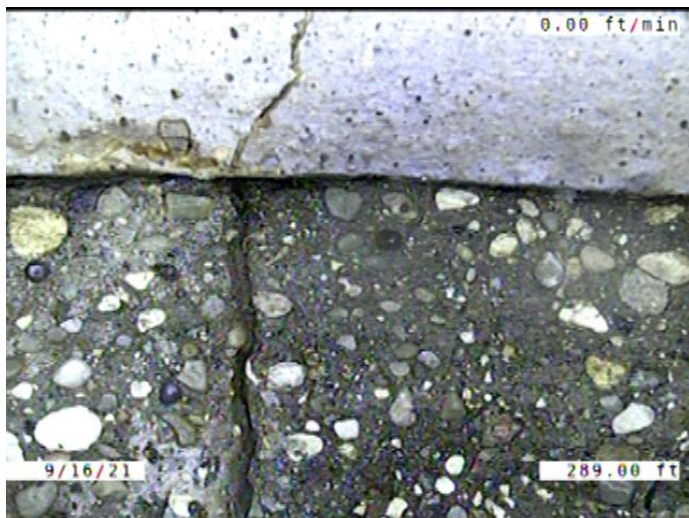
Code: **TFD**
Description: **Tap Factory Defective**

Distance (ft): **288.0**
Structural Grade: **0**
O&M Grade: **3**
Clock Start/From: **1**
Clock To:
1st Value: **4.000**
2nd Value:
Value Percent:
Continuous Index:
Within 8" of Joint: **YES**
Remarks: **Defective**

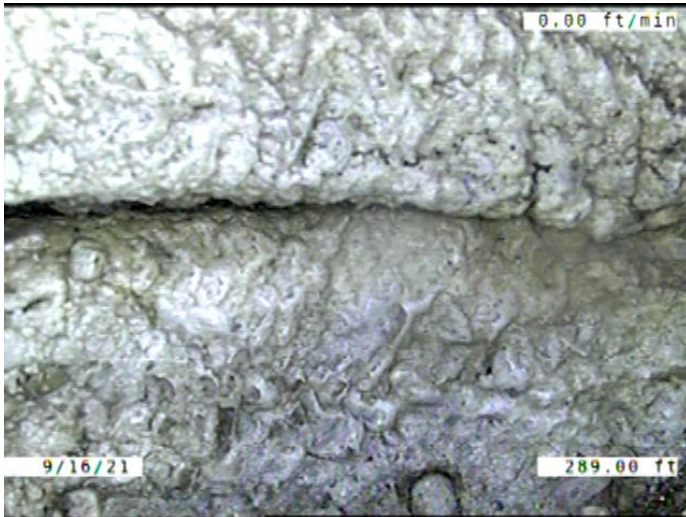
Code: **MMC**
Description: **Miscellaneous Material Change**

Distance (ft): **289.0**
Structural Grade: **0**
O&M Grade: **0**
Clock Start/From:
Clock To:
1st Value:
2nd Value:
Value Percent:
Continuous Index:
Within 8" of Joint: **NO**
Remarks: **VCP TO CONCRETE**

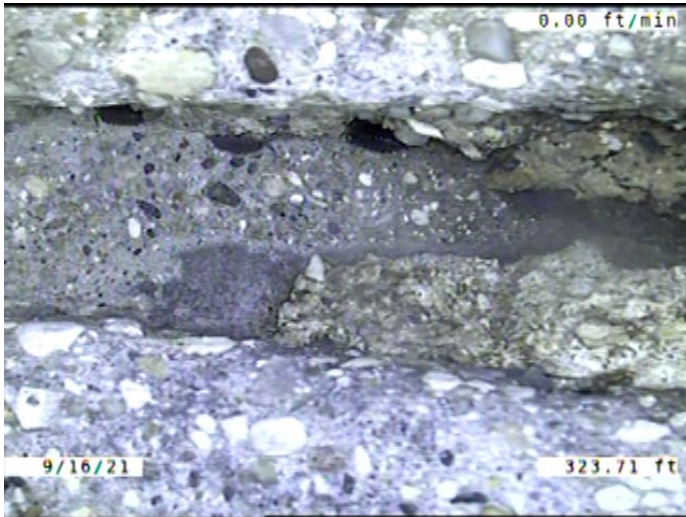
Code: **MWLS**
 Description: **Miscellaneous Water Level Sag**

Distance (ft): **322.9**
 Structural Grade: **2**
 O&M Grade: **0**
 Clock Start/From:
 Clock To:
 1st Value:
 2nd Value:
 Value Percent: **10.000**
 Continuous Index: **F13**
 Within 8" of Joint: **NO**
 Remarks:

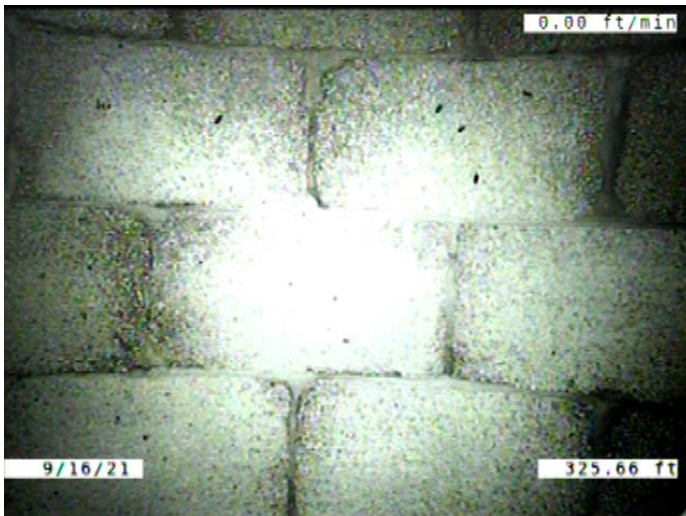
Code: **JAM**
 Description: **Joint Angular Medium**

Distance (ft): **323.7**
 Structural Grade: **3**
 O&M Grade: **0**
 Clock Start/From:
 Clock To:
 1st Value:
 2nd Value:
 Value Percent:
 Continuous Index:
 Within 8" of Joint: **NO**
 Remarks:

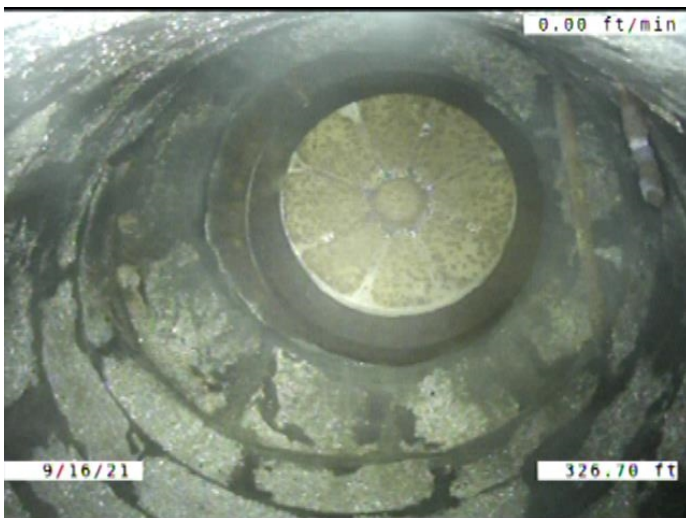
Code: **FM**
 Description: **Fracture Multiple**

Distance (ft): **325.7**
 Structural Grade: **4**
 O&M Grade: **0**
 Clock Start/From: **8**
 Clock To: **4**
 1st Value:
 2nd Value:
 Value Percent:
 Continuous Index: **F02**
 Within 8" of Joint: **YES**
 Remarks:
