RedZone
ROBOTICS

Street:	North Guyer Street		Flow Control:	Not Controlled	
City:	Hobart, IN		Year Renewed:		
Location:	Alley		Tape/Media #:		
Purpose:	Routine Assessment		Dia/Height:	12"	
Use:	Sanitary Sewage Pipe		Material:	CP	
Drain Area:			Lining:	None	
Category:	NA				
Comment:					
Location Details:			Direction of Survey: Downstream		
US MH:	M-504-027	DS MH:	M-504-052	Total Length Surveyed (ft):	326.7

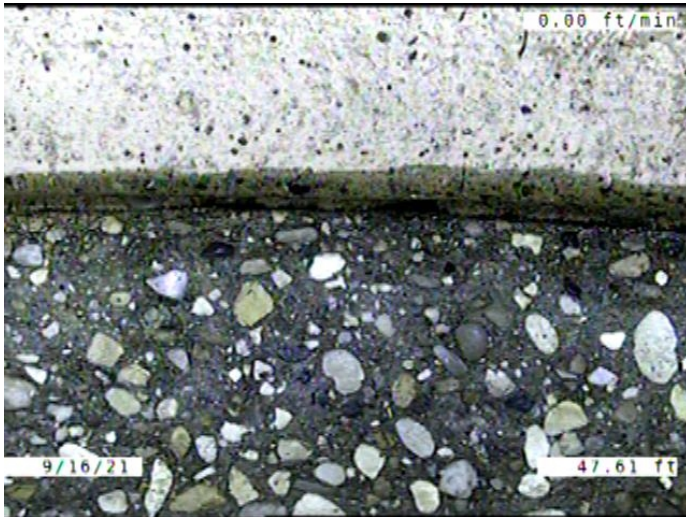
Code: **TFD**
 Description: **Tap Factory Defective**

Distance (ft): **46.7**
 Structural Grade: **0**
 O&M Grade: **3**
 Clock Start/From: **12**
 Clock To:
 1st Value: **4.000**
 2nd Value:
 Value Percent:
 Continuous Index:
 Within 8" of Joint: **YES**
 Remarks: **Defective**

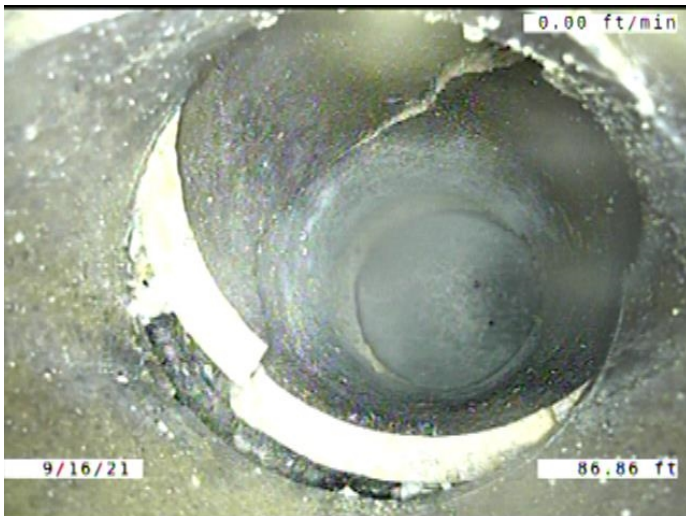
Code: **TFD**
 Description: **Tap Factory Defective**

Distance (ft): **84.8**
 Structural Grade: **0**
 O&M Grade: **3**
 Clock Start/From: **12**
 Clock To:
 1st Value: **4.000**
 2nd Value:
 Value Percent:
 Continuous Index:
 Within 8" of Joint: **YES**
 Remarks: **CAPPED**

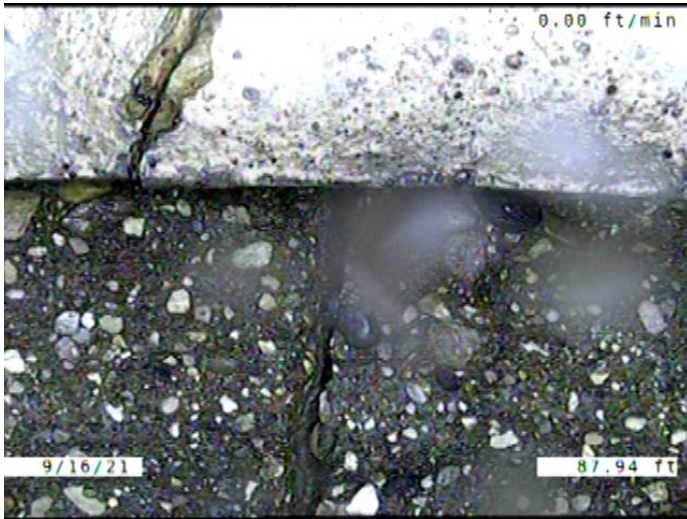
Code: **TFD**
 Description: **Tap Factory Defective**

Distance (ft): **86.9**
 Structural Grade: **0**
 O&M Grade: **3**
 Clock Start/From: **12**
 Clock To:
 1st Value: **4.000**
 2nd Value:
 Value Percent:
 Continuous Index:
 Within 8" of Joint: **YES**
 Remarks: **Defective**

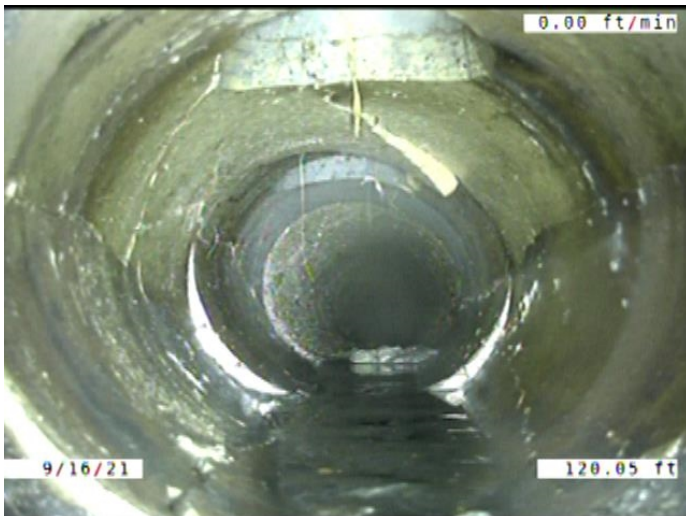
Code: **B**
Description: **Broken**

Distance (ft): **118.9**
Structural Grade: **4**
O&M Grade: **0**
Clock Start/From: **6**
Clock To: **3**
1st Value:
2nd Value:
Value Percent:
Continuous Index:
Within 8" of Joint: **NO**
Remarks:

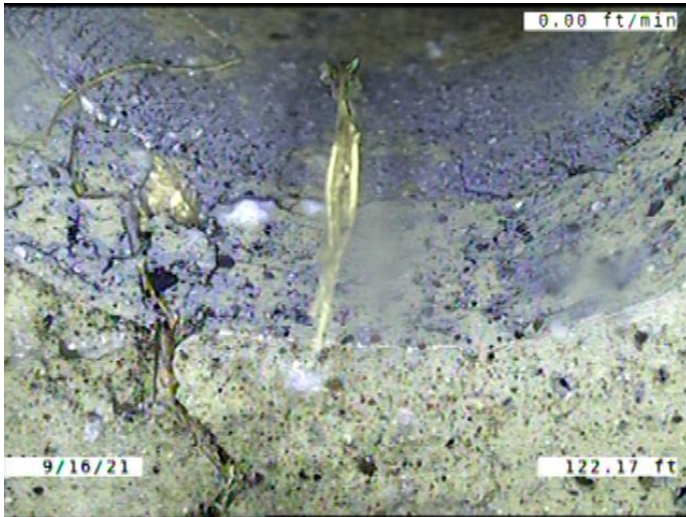
Code: **TFD**
 Description: **Tap Factory Defective**

Distance (ft): **122.2**
 Structural Grade: **0**
 O&M Grade: **3**
 Clock Start/From: **12**
 Clock To:
 1st Value: **4.000**
 2nd Value:
 Value Percent:
 Continuous Index:
 Within 8" of Joint: **YES**
 Remarks: **Defective**

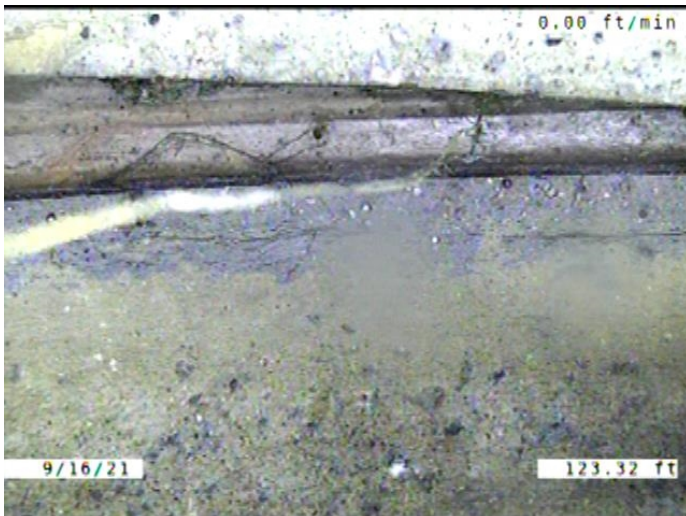
Code: **RFL**
 Description: **Roots Fine Lateral**

Distance (ft): **122.2**
 Structural Grade: **0**
 O&M Grade: **1**
 Clock Start/From: **12**
 Clock To:
 1st Value:
 2nd Value:
 Value Percent:
 Continuous Index:
 Within 8" of Joint: **NO**
 Remarks:

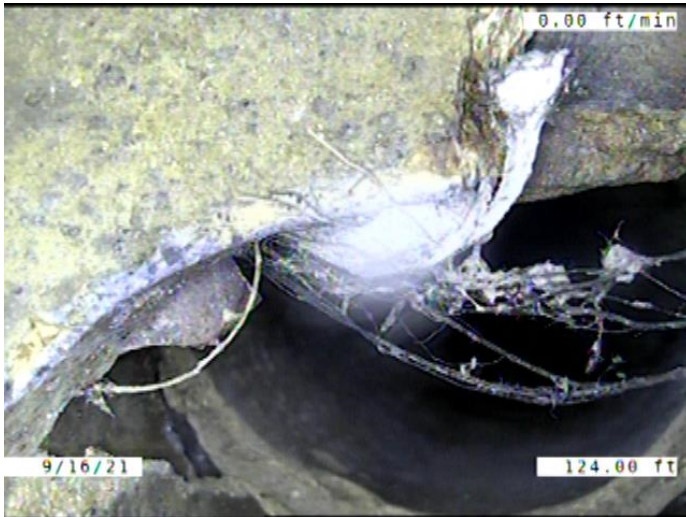
Code: **RFJ**
 Description: **Roots Fine Joint**

Distance (ft): **123.3**
 Structural Grade: **0**
 O&M Grade: **1**
 Clock Start/From: **9**
 Clock To: **3**
 1st Value:
 2nd Value:
 Value Percent:
 Continuous Index:
 Within 8" of Joint: **YES**
 Remarks:

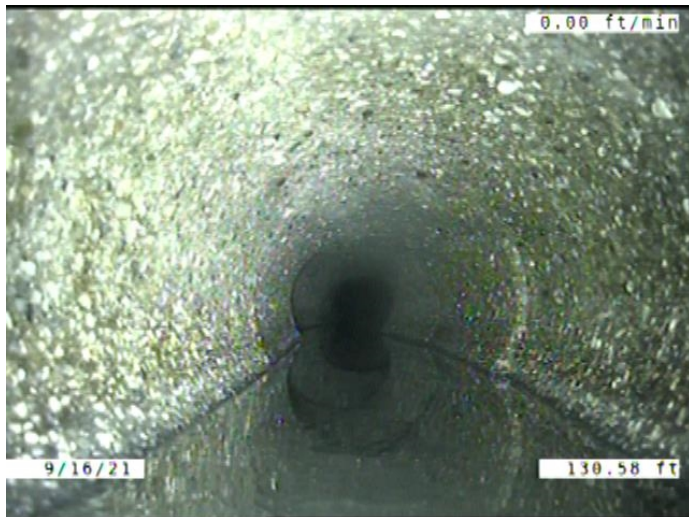
Code: **DAE**
 Description: **Deposits Attached Encrustation**

Distance (ft): **127.1**
 Structural Grade: **0**
 O&M Grade: **2**
 Clock Start/From: **8**
 Clock To: **9**
 1st Value:
 2nd Value:
 Value Percent: **5.000**
 Continuous Index: **S08**
 Within 8" of Joint: **YES**
 Remarks:

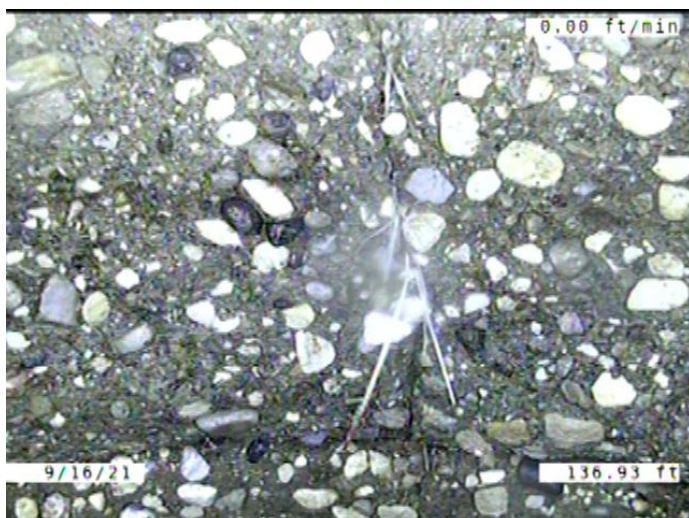
Code: **DAE**
 Description: **Deposits Attached Encrustation**

Distance (ft): **130.6**
 Structural Grade: **0**
 O&M Grade: **2**
 Clock Start/From: **8**
 Clock To: **9**
 1st Value:
 2nd Value:
 Value Percent: **5.000**
 Continuous Index: **F08**
 Within 8" of Joint: **YES**
 Remarks:

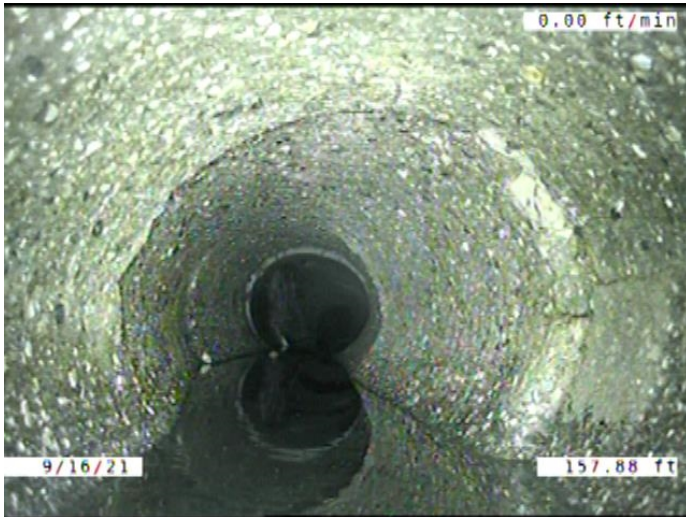
Code: **DAE**
 Description: **Deposits Attached Encrustation**

Distance (ft): **153.4**
 Structural Grade: **0**
 O&M Grade: **2**
 Clock Start/From: **8**
 Clock To: **4**
 1st Value:
 2nd Value:
 Value Percent: **5.000**
 Continuous Index: **S09**
 Within 8" of Joint: **YES**
 Remarks:

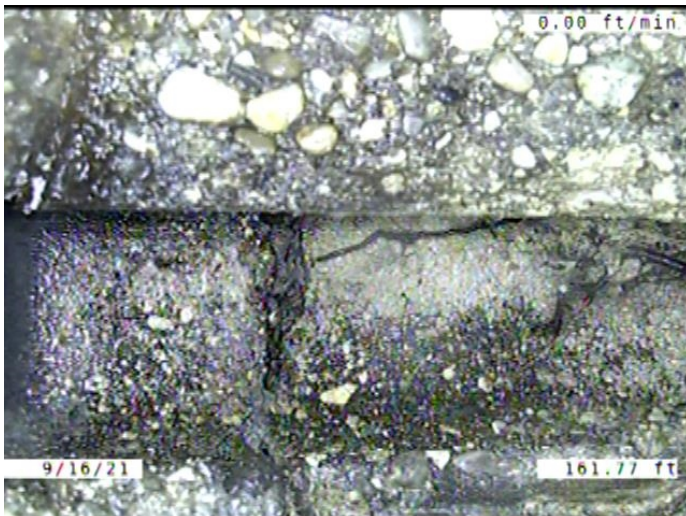
Code: **BSV**
 Description: **Broken Soil Visible**

Distance (ft): **158.9**
 Structural Grade: **5**
 O&M Grade: **0**
 Clock Start/From: **11**
 Clock To: **12**
 1st Value:
 2nd Value:
 Value Percent:
 Continuous Index:
 Within 8" of Joint: **YES**
 Remarks:

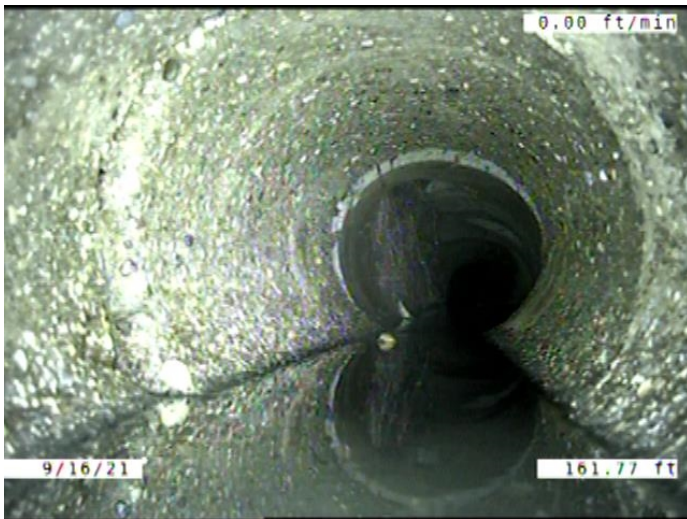
Code: **RFJ**
 Description: **Roots Fine Joint**

Distance (ft): **161.8**
 Structural Grade: **0**
 O&M Grade: **1**
 Clock Start/From: **9**
 Clock To: **11**
 1st Value:
 2nd Value:
 Value Percent:
 Continuous Index:
 Within 8" of Joint: **YES**
 Remarks:

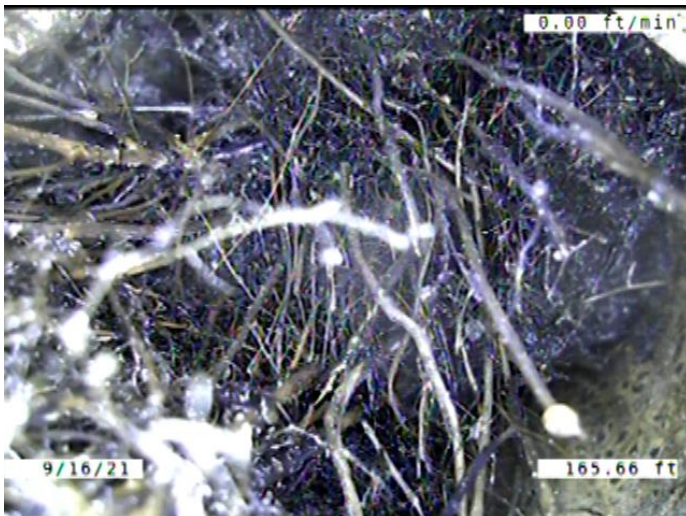
Code: **RFB**
 Description: **Roots Fine Barrel**

Distance (ft): **164.7**
 Structural Grade: **0**
 O&M Grade: **2**
 Clock Start/From: **9**
 Clock To: **1**
 1st Value:
 2nd Value:
 Value Percent:
 Continuous Index:
 Within 8" of Joint: **NO**
 Remarks:

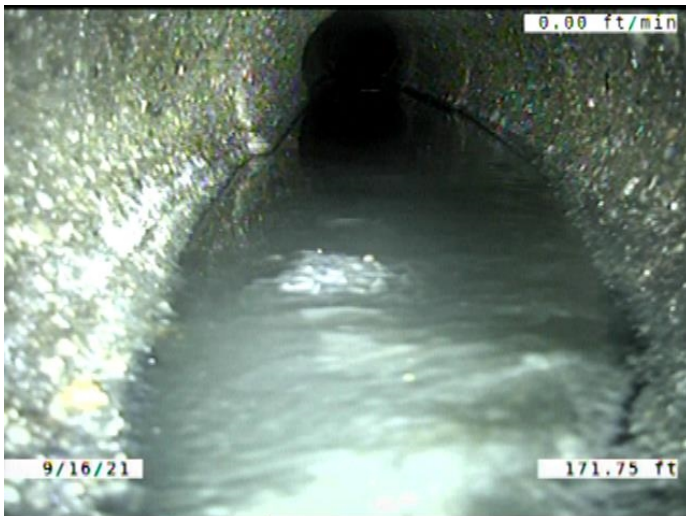
Code: **MMC**
 Description: **Miscellaneous Material Change**

Distance (ft): **168.9**
 Structural Grade: **0**
 O&M Grade: **0**
 Clock Start/From:
 Clock To:
 1st Value:
 2nd Value:
 Value Percent:
 Continuous Index:
 Within 8" of Joint: **NO**
 Remarks: **VCP TO CONCRETE**

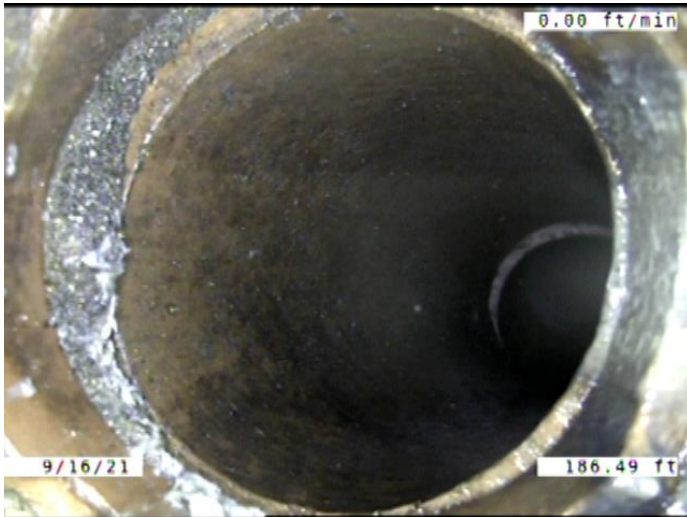
Code: **RFL**
 Description: **Roots Fine Lateral**

Distance (ft): **186.1**
 Structural Grade: **0**
 O&M Grade: **1**
 Clock Start/From: **12**
 Clock To: **2**
 1st Value:
 2nd Value:
 Value Percent:
 Continuous Index:
 Within 8" of Joint: **NO**
 Remarks:

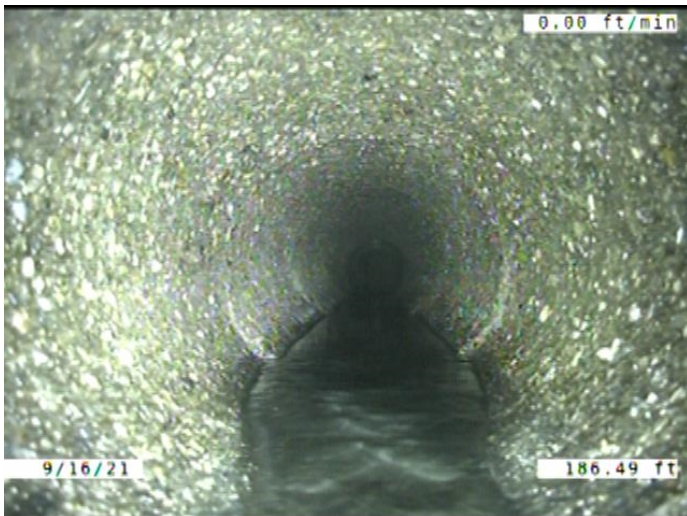
Code: **TB**
Description: **Tap Break-in/Hammer**

Distance (ft): **186.5**
Structural Grade: **0**
O&M Grade: **0**
Clock Start/From: **1**
Clock To:
1st Value: **4.000**
2nd Value:
Value Percent:
Continuous Index:
Within 8" of Joint: **YES**
Remarks:

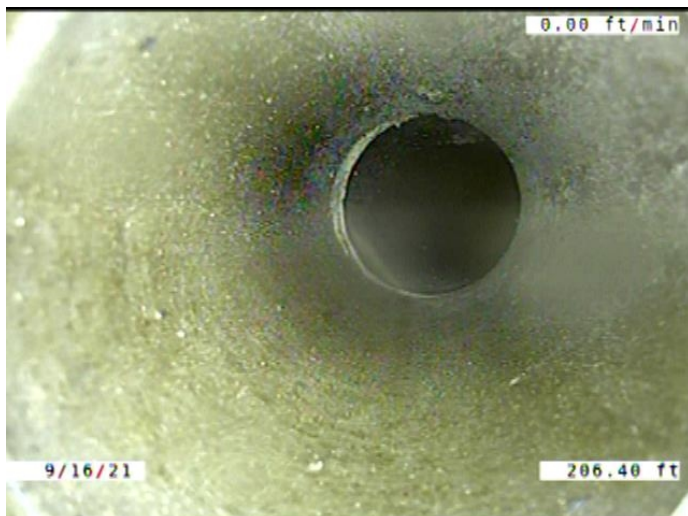
Code: **TB**
 Description: **Tap Break-in/Hammer**

Distance (ft): **203.8**
 Structural Grade: **0**
 O&M Grade: **0**
 Clock Start/From: **12**
 Clock To:
 1st Value: **4.000**
 2nd Value:
 Value Percent:
 Continuous Index:
 Within 8" of Joint: **YES**
 Remarks: **CONSTANTLY RUNNING WATER**

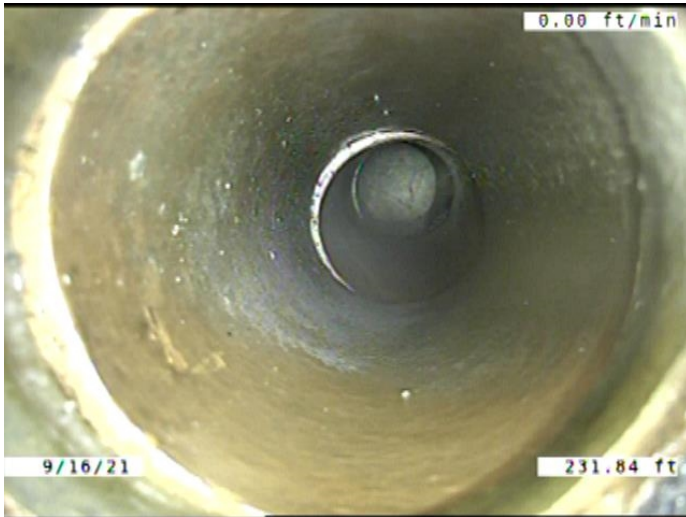
Code: **MWLS**
 Description: **Miscellaneous Water Level Sag**

Distance (ft): **221.8**
 Structural Grade: **2**
 O&M Grade: **0**
 Clock Start/From:
 Clock To:
 1st Value:
 2nd Value:
 Value Percent: **10.000**
 Continuous Index: **S11**
 Within 8" of Joint: **NO**
 Remarks:

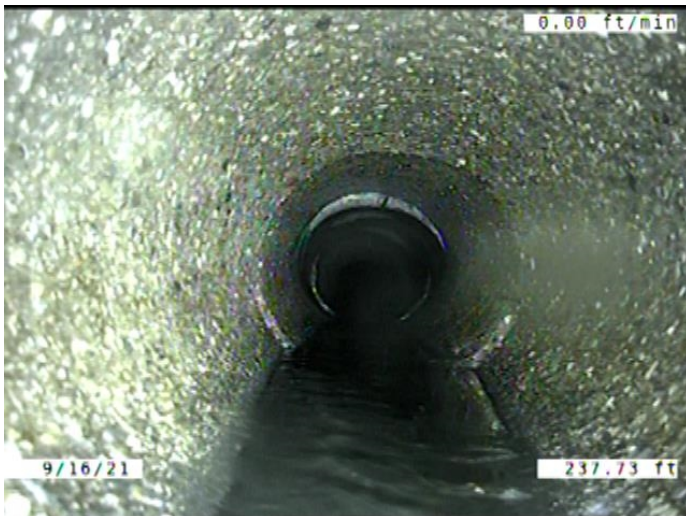
Code: **TBI**
 Description: **Tap Break-in Intruding**

Distance (ft): **231.8**
 Structural Grade: **0**
 O&M Grade: **2**
 Clock Start/From: **12**
 Clock To:
 1st Value: **4.000**
 2nd Value: **1.000**
 Value Percent:
 Continuous Index:
 Within 8" of Joint: **YES**
 Remarks:

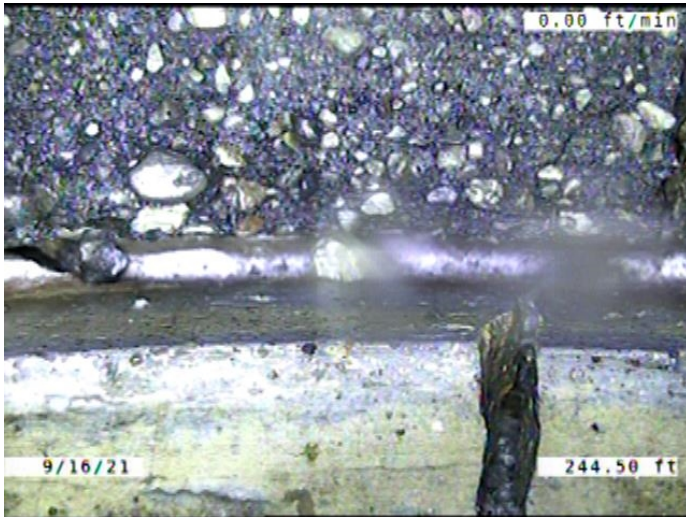
Code: **MWLS**
 Description: **Miscellaneous Water Level Sag**

Distance (ft): **237.7**
 Structural Grade: **2**
 O&M Grade: **0**
 Clock Start/From:
 Clock To:
 1st Value:
 2nd Value:
 Value Percent: **10.000**
 Continuous Index: **F11**
 Within 8" of Joint: **NO**
 Remarks:

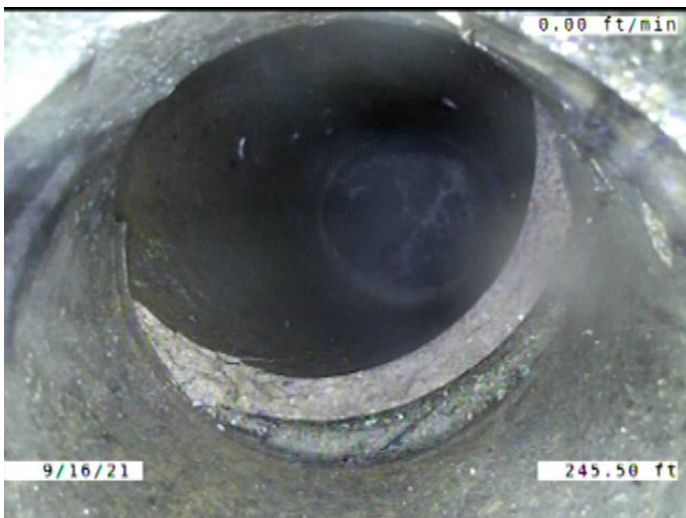
Code: **MMC**
 Description: **Miscellaneous Material Change**

Distance (ft): **244.5**
 Structural Grade: **0**
 O&M Grade: **0**
 Clock Start/From:
 Clock To:
 1st Value:
 2nd Value:
 Value Percent:
 Continuous Index:
 Within 8" of Joint: **NO**
 Remarks: **CONCRETE TO VCP**

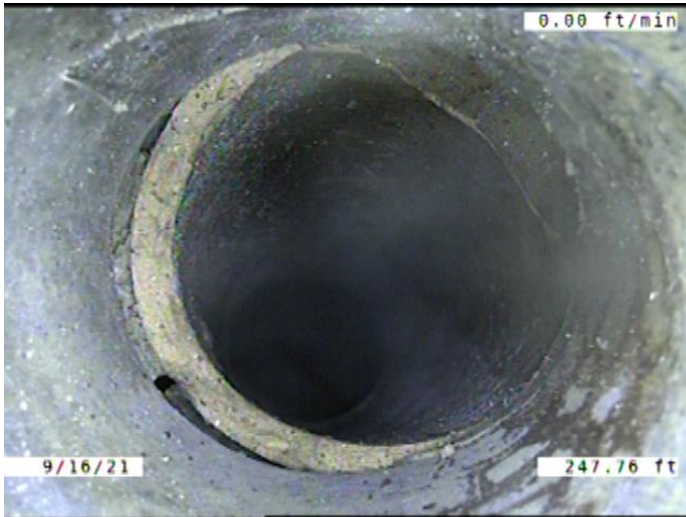
Code: **TFD**
 Description: **Tap Factory Defective**

Distance (ft): **245.5**
 Structural Grade: **0**
 O&M Grade: **3**
 Clock Start/From: **11**
 Clock To:
 1st Value: **4.000**
 2nd Value:
 Value Percent:
 Continuous Index:
 Within 8" of Joint: **YES**
 Remarks: **Defective**

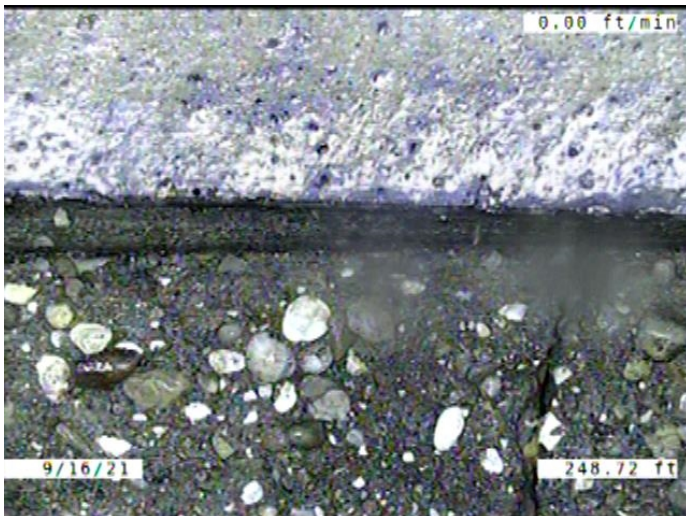
Code: **TFD**
 Description: **Tap Factory Defective**

Distance (ft): **247.8**
 Structural Grade: **0**
 O&M Grade: **3**
 Clock Start/From: **1**
 Clock To:
 1st Value: **4.000**
 2nd Value:
 Value Percent:
 Continuous Index:
 Within 8" of Joint: **YES**
 Remarks: **SOIL VISIBLE AT THE FIRST JOINT BACK**

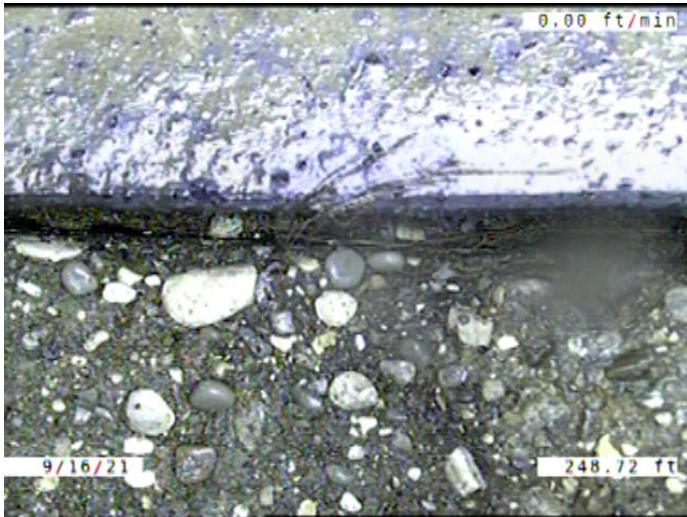
Code: **MMC**
 Description: **Miscellaneous Material Change**

Distance (ft): **248.7**
 Structural Grade: **0**
 O&M Grade: **0**
 Clock Start/From:
 Clock To:
 1st Value:
 2nd Value:
 Value Percent:
 Continuous Index:
 Within 8" of Joint: **NO**
 Remarks: **VCP TO CONCRETE**

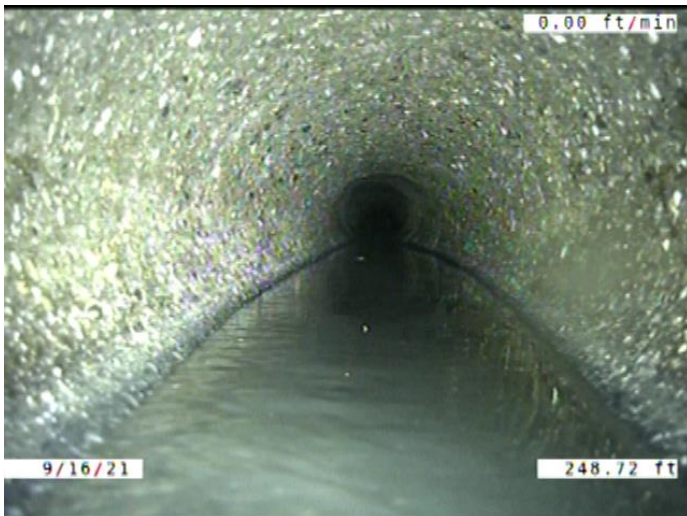
Code: **RFJ**
 Description: **Roots Fine Joint**

Distance (ft): **248.7**
 Structural Grade: **0**
 O&M Grade: **1**
 Clock Start/From: **2**
 Clock To: **3**
 1st Value:
 2nd Value:
 Value Percent:
 Continuous Index:
 Within 8" of Joint: **YES**
 Remarks:

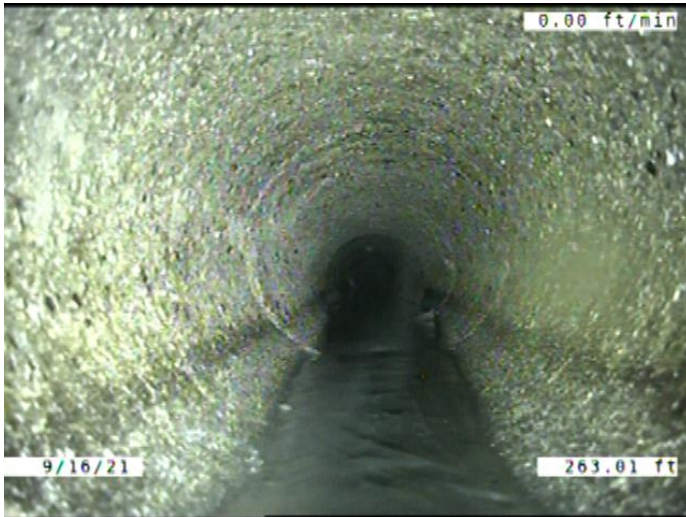
Code: **MWLS**
 Description: **Miscellaneous Water Level Sag**

Distance (ft): **248.7**
 Structural Grade: **2**
 O&M Grade: **0**
 Clock Start/From:
 Clock To:
 1st Value:
 2nd Value:
 Value Percent: **10.000**
 Continuous Index: **S12**
 Within 8" of Joint: **NO**
 Remarks:

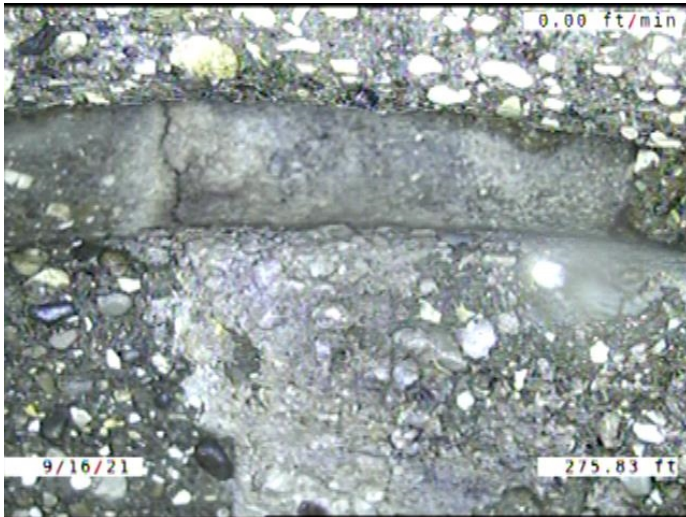
Code: **DAE**
 Description: **Deposits Attached Encrustation**

Distance (ft): **269.5**
 Structural Grade: **0**
 O&M Grade: **2**
 Clock Start/From: **4**
 Clock To: **5**
 1st Value:
 2nd Value:
 Value Percent: **5.000**
 Continuous Index:
 Within 8" of Joint: **YES**
 Remarks:

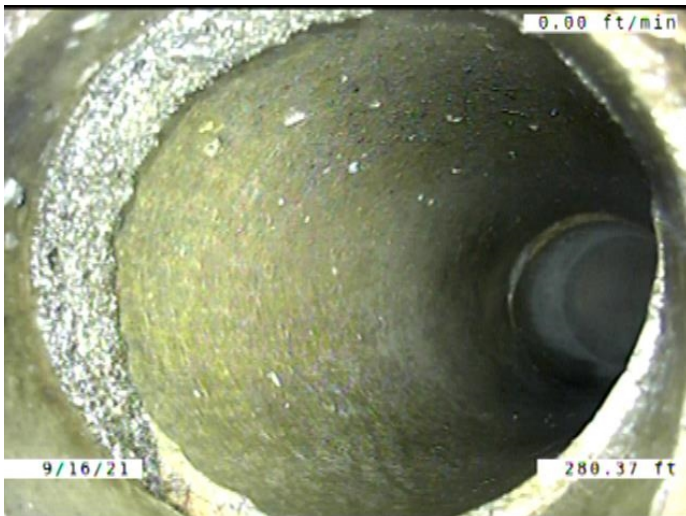
Code: **DAE**
 Description: **Deposits Attached Encrustation**

Distance (ft): **275.8**
 Structural Grade: **0**
 O&M Grade: **2**
 Clock Start/From: **2**
 Clock To: **3**
 1st Value:
 2nd Value:
 Value Percent: **5.000**
 Continuous Index:
 Within 8" of Joint: **YES**
 Remarks:

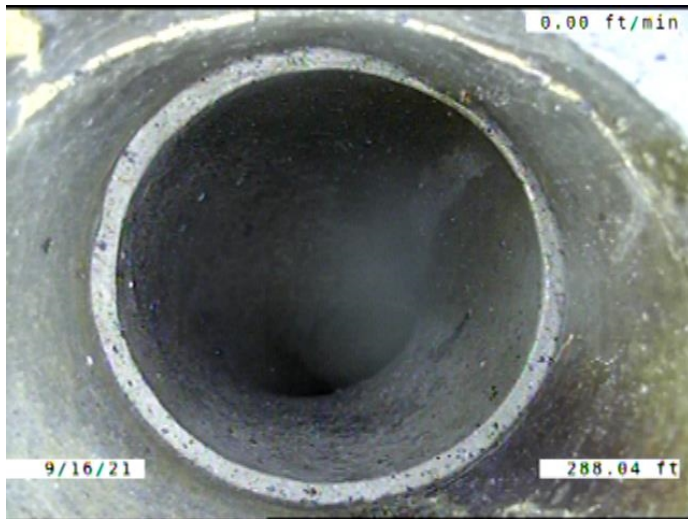
Code: **TFD**
 Description: **Tap Factory Defective**

Distance (ft): **286.0**
 Structural Grade: **0**
 O&M Grade: **3**
 Clock Start/From: **11**
 Clock To:
 1st Value: **4.000**
 2nd Value:
 Value Percent:
 Continuous Index:
 Within 8" of Joint: **YES**
 Remarks: **Defective**

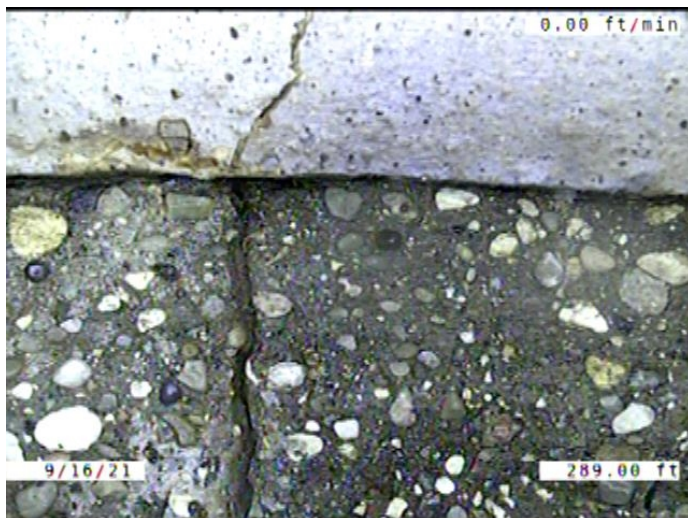
Code: **TFD**
 Description: **Tap Factory Defective**

Distance (ft): **288.0**
 Structural Grade: **0**
 O&M Grade: **3**
 Clock Start/From: **1**
 Clock To:
 1st Value: **4.000**
 2nd Value:
 Value Percent:
 Continuous Index:
 Within 8" of Joint: **YES**
 Remarks: **Defective**

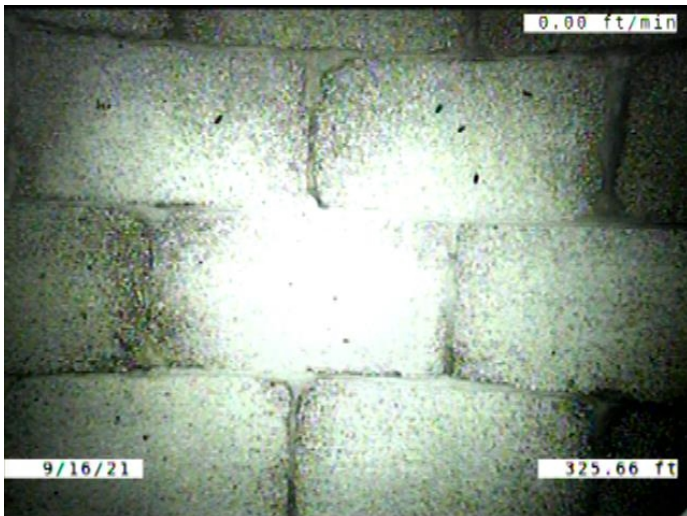
Code: **JAM**
 Description: **Joint Angular Medium**

Distance (ft): **323.7**
 Structural Grade: **3**
 O&M Grade: **0**
 Clock Start/From:
 Clock To:
 1st Value:
 2nd Value:
 Value Percent:
 Continuous Index:
 Within 8" of Joint: **NO**
 Remarks:

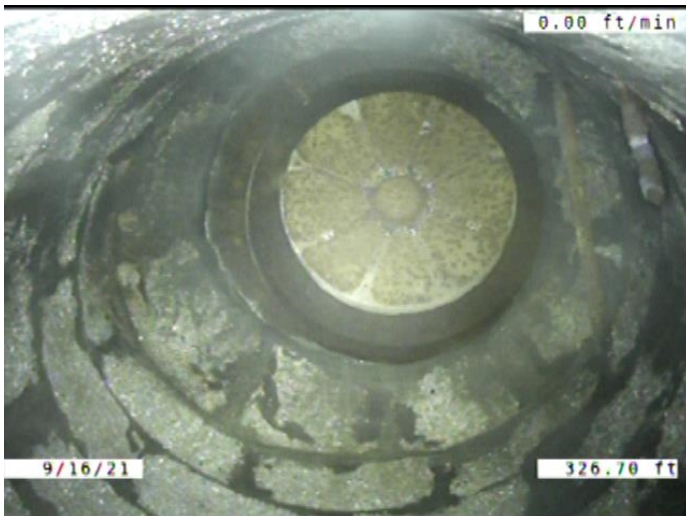
Code: **FM**
 Description: **Fracture Multiple**

Distance (ft): **325.7**
 Structural Grade: **4**
 O&M Grade: **0**
 Clock Start/From: **8**
 Clock To: **4**
 1st Value:
 2nd Value:
 Value Percent:
 Continuous Index: **F02**
 Within 8" of Joint: **YES**
 Remarks:
