Profile/Photo Observation Report

Date:	11/05/2021	Weather:		Coding:	PACP 7.0
Pipe Length (ft):	331.0	Owner:	City of Hobart	Pre Clean:	Heavy Cleaning
P.O.#:	YES502259	Surveyor:	S. Bucklin	PSR:	P-504-056-028
Customer:	City of Hobart	Clean Date:	11/05/2021	Shape:	C

Street:	North Wilson Street	Flow Control:	Not Controlled
City:	Hobart, IN	Year Renewed:	
Location:	Alley	Tape/Media #:	
Purpose:	Routine Assessment	Dia/Height:	12"
Use:	Sanitary Sewage Pipe	Material:	VCP
Drain Area:		Lining:	None
Category:	NA		
Comment:			
Location Details:		Direction of Survey:	Upstream
US MH:	M-504-028	DS MH:	M-504-056
		Total Length Surveyed (ft):	240.8

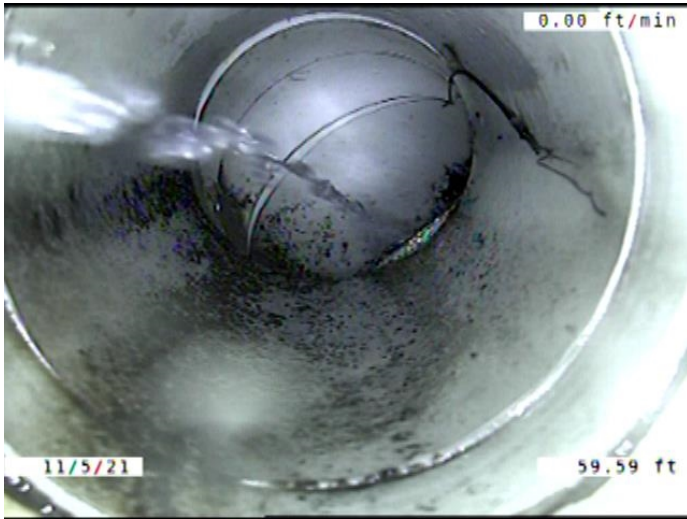
Code: **JOSD**
Description: **Joint Offset Small Defective**

Distance (ft): **55.4**
Structural Grade: **0**
O&M Grade: **0**
Clock Start/From:
Clock To:
1st Value:
2nd Value:
Value Percent:
Continuous Index: **F02**
Within 8" of Joint: **NO**
Remarks:

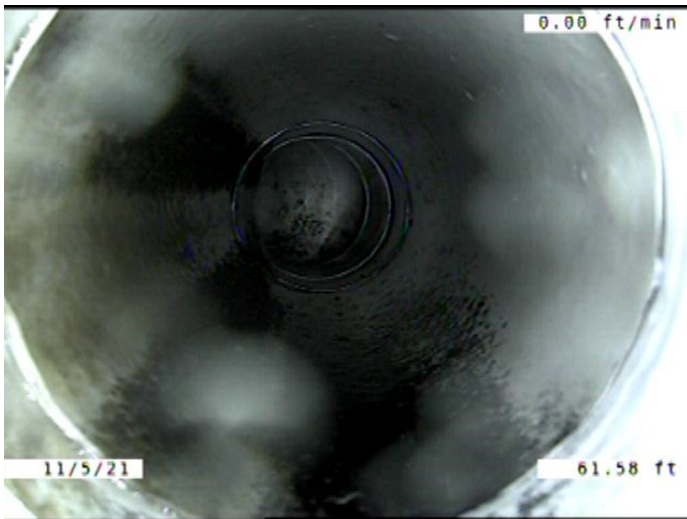
Code: **TFA**
 Description: **Tap Factory Activity**

Distance (ft): **59.6**
 Structural Grade: **0**
 O&M Grade: **0**
 Clock Start/From: **12**
 Clock To:
 1st Value: **4.000**
 2nd Value:
 Value Percent:
 Continuous Index:
 Within 8" of Joint: **YES**
 Remarks:

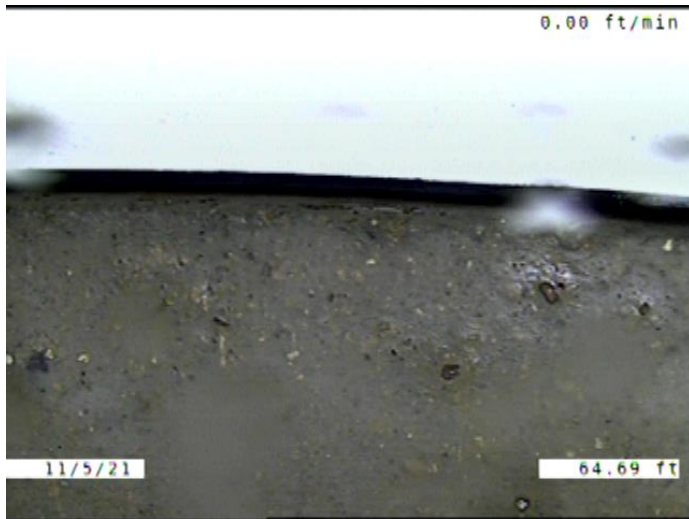
Code: **TF**
 Description: **Tap Factory**

Distance (ft): **61.6**
 Structural Grade: **0**
 O&M Grade: **0**
 Clock Start/From: **12**
 Clock To:
 1st Value: **4.000**
 2nd Value:
 Value Percent:
 Continuous Index:
 Within 8" of Joint: **YES**
 Remarks:

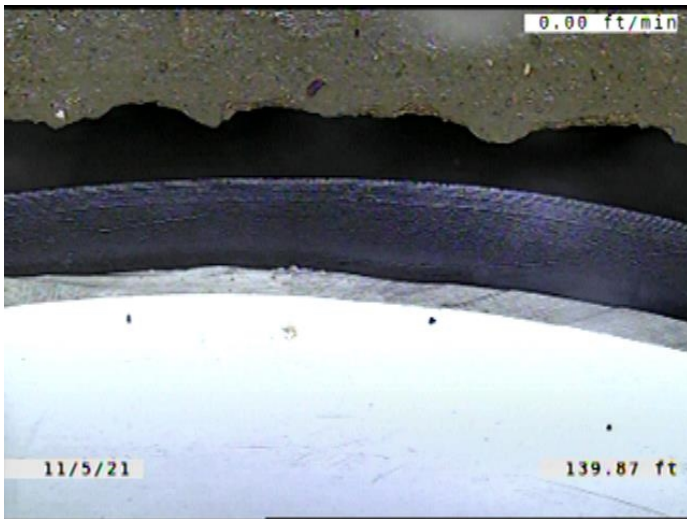
Code: **SSS**
Description: **Surface Damage Surface Spalling**

Distance (ft): **126.7**
Structural Grade: **2**
O&M Grade: **0**
Clock Start/From: **8**
Clock To: **9**
1st Value:
2nd Value:
Value Percent:
Continuous Index:
Within 8" of Joint: **NO**
Remarks:

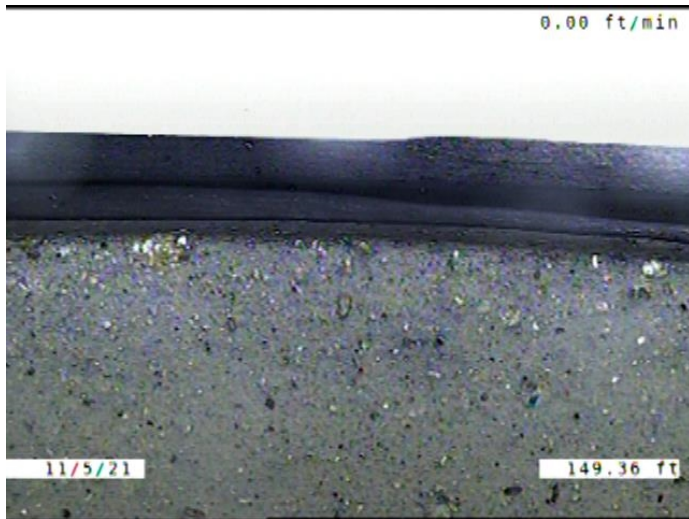
Code: **TF**
Description: **Tap Factory**

Distance (ft): **146.3**
Structural Grade: **0**
O&M Grade: **0**
Clock Start/From: **1**
Clock To:
1st Value: **4.000**
2nd Value:
Value Percent:
Continuous Index:
Within 8" of Joint: **YES**
Remarks: **CONSTANTLY RUNNING WATER.**
