# Profile/Photo Observation Report

Date:	<b>11/01/2021</b>	Weather:		Coding:	<b>PACP 7.0</b>
Pipe Length (ft):	<b>155.8</b>	Owner:	<b>City of Hobart</b>	Pre Clean:	<b>Heavy Cleaning</b>
P.O.#:	<b>YES502259</b>	Surveyor:	<b>S. Bucklin</b>	PSR:	<b>P-504-031-030</b>
Customer:	<b>City of Hobart</b>	Clean Date:	<b>10/28/2021</b>	Shape:	<b>C</b>

Street:	<b>North Colorado Street</b>	Flow Control:	<b>Not Controlled</b>
City:	<b>Hobart, IN</b>	Year Renewed:	
Location:	<b>Alley</b>	Tape/Media #:	
Purpose:	<b>Routine Assessment</b>	Dia/Height:	<b>12"</b>
Use:	<b>Sanitary Sewage Pipe</b>	Material:	<b>VCP</b>
Drain Area:		Lining:	<b>None</b>
Category:	<b>NA</b>		
Comment:			
Location Details:		Direction of Survey:	<b>Upstream</b>
US MH:	<b>M-504-030</b>	DS MH:	<b>M-504-031</b>
		Total Length Surveyed (ft):	<b>155.8</b>

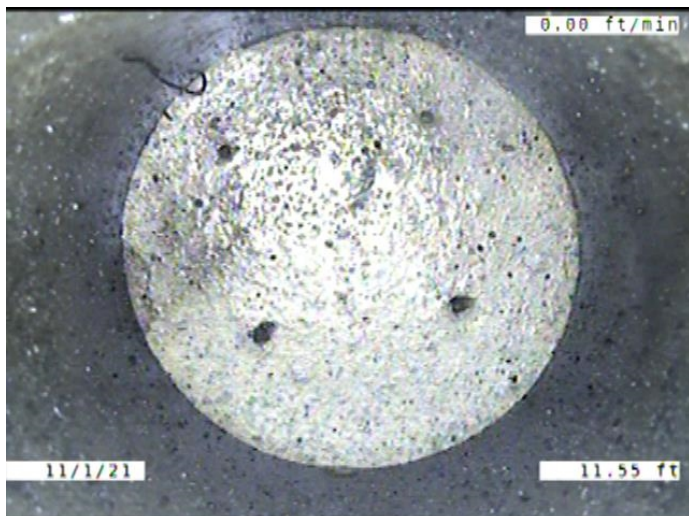
Code: **TFC**  
Description: **Tap Factory Capped**

Distance (ft): **11.6**  
Structural Grade: **0**  
O&M Grade: **0**  
Clock Start/From: **11**  
Clock To:  
1st Value: **4.000**  
2nd Value:  
Value Percent:  
Continuous Index:  
Within 8" of Joint: **YES**  
Remarks:

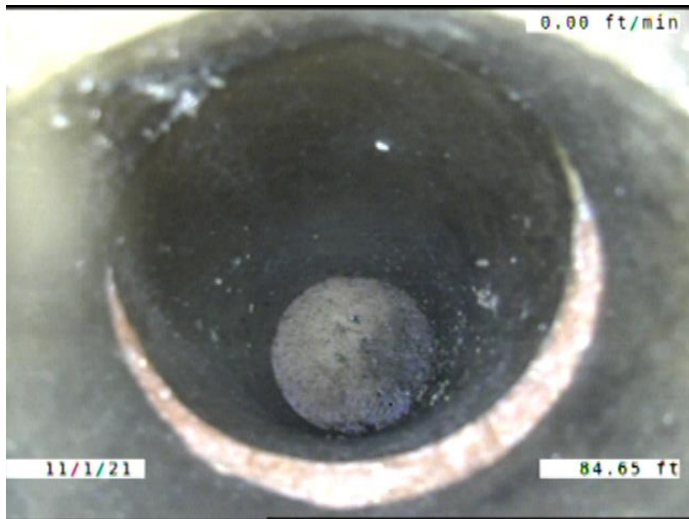
Code: **TFC**  
 Description: **Tap Factory Capped**

Distance (ft): **84.7**  
 Structural Grade: **0**  
 O&M Grade: **0**  
 Clock Start/From: **11**  
 Clock To:  
 1st Value: **4.000**  
 2nd Value:  
 Value Percent:  
 Continuous Index:  
 Within 8" of Joint: **YES**  
 Remarks:
