Profile/Photo Observation Report

Date:	11/01/2021	Weather:		Coding:	PACP 7.0
Pipe Length (ft):	155.8	Owner:	City of Hobart	Pre Clean:	Heavy Cleaning
P.O.#:	YES502259	Surveyor:	S. Bucklin	PSR:	P-504-031-030
Customer:	City of Hobart	Clean Date:	10/28/2021	Shape:	C

Street:	North Colorado Street	Flow Control:	Not Controlled
City:	Hobart, IN	Year Renewed:	
Location:	Alley	Tape/Media #:	
Purpose:	Routine Assessment	Dia/Height:	12"
Use:	Sanitary Sewage Pipe	Material:	VCP
Drain Area:		Lining:	None
Category:	NA		
Comment:			
Location Details:		Direction of Survey:	Upstream
US MH:	M-504-030	DS MH:	M-504-031
		Total Length Surveyed (ft):	155.8

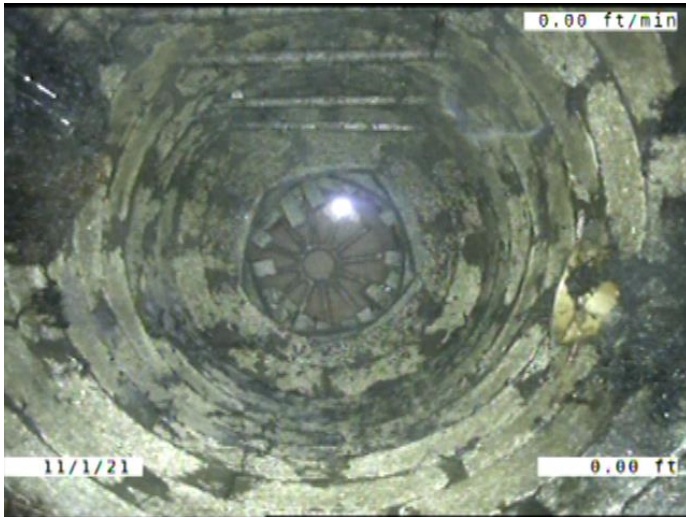
Code: **AMH**
Description: **Manhole**

Distance (ft): **.0**
Structural Grade: **0**
O&M Grade: **0**
Clock Start/From:
Clock To:
1st Value:
2nd Value:
Value Percent:
Continuous Index:
Within 8" of Joint: **NO**
Remarks: **M-504-031**

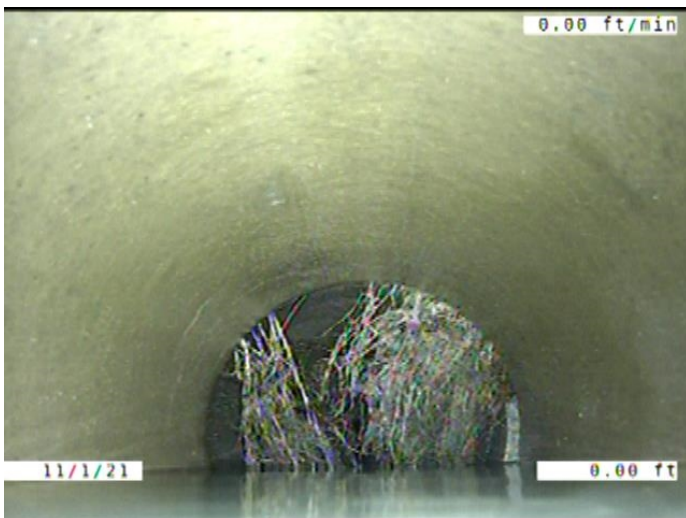
Code: **MWL**
Description: **Miscellaneous Water Level**

Distance (ft): **.0**
Structural Grade: **0**
O&M Grade: **0**
Clock Start/From:
Clock To:
1st Value:
2nd Value:
Value Percent: **15.000**
Continuous Index:
Within 8" of Joint: **NO**
Remarks:

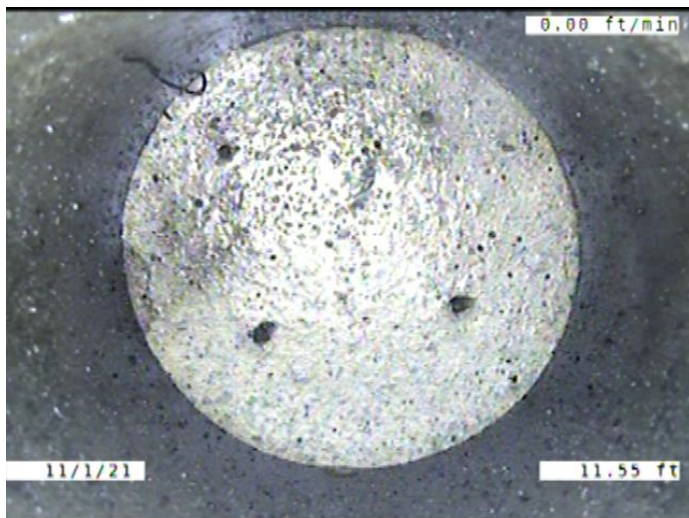
Code: **TFC**
 Description: **Tap Factory Capped**

Distance (ft): **11.6**
 Structural Grade: **0**
 O&M Grade: **0**
 Clock Start/From: **11**
 Clock To:
 1st Value: **4.000**
 2nd Value:
 Value Percent:
 Continuous Index:
 Within 8" of Joint: **YES**
 Remarks:

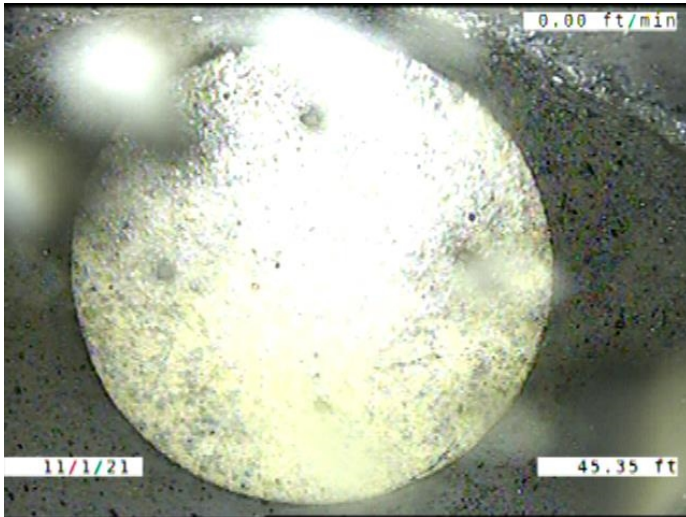
Code: **TFC**
Description: **Tap Factory Capped**

Distance (ft): **45.3**
Structural Grade: **0**
O&M Grade: **0**
Clock Start/From: **11**
Clock To:
1st Value: **4.000**
2nd Value:
Value Percent:
Continuous Index:
Within 8" of Joint: **YES**
Remarks:

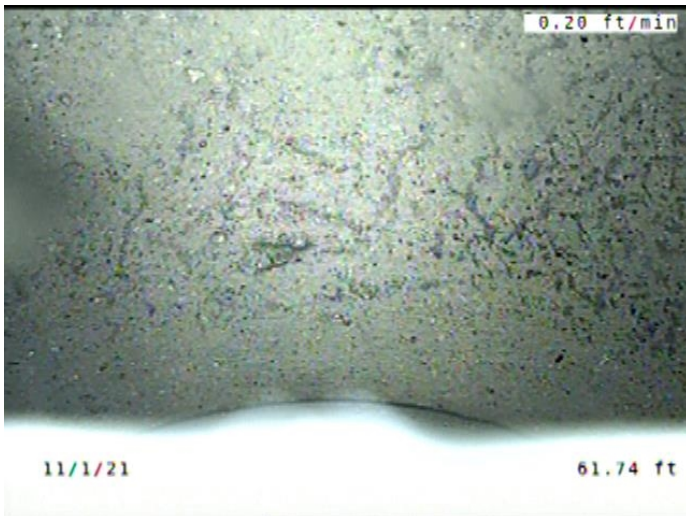
Code: **MWL**
 Description: **Miscellaneous Water Level**

Distance (ft): **61.7**
 Structural Grade: **0**
 O&M Grade: **0**
 Clock Start/From:
 Clock To:
 1st Value:
 2nd Value:
 Value Percent: **25.000**
 Continuous Index:
 Within 8" of Joint: **NO**
 Remarks:

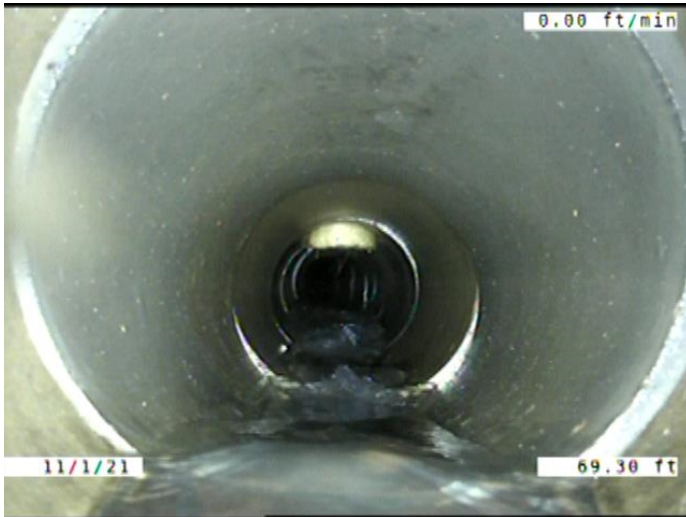
Code: **MWL**
Description: **Miscellaneous Water Level**

Distance (ft): **69.3**
Structural Grade: **0**
O&M Grade: **0**
Clock Start/From:
Clock To:
1st Value:
2nd Value:
Value Percent: **10.000**
Continuous Index:
Within 8" of Joint: **NO**
Remarks:

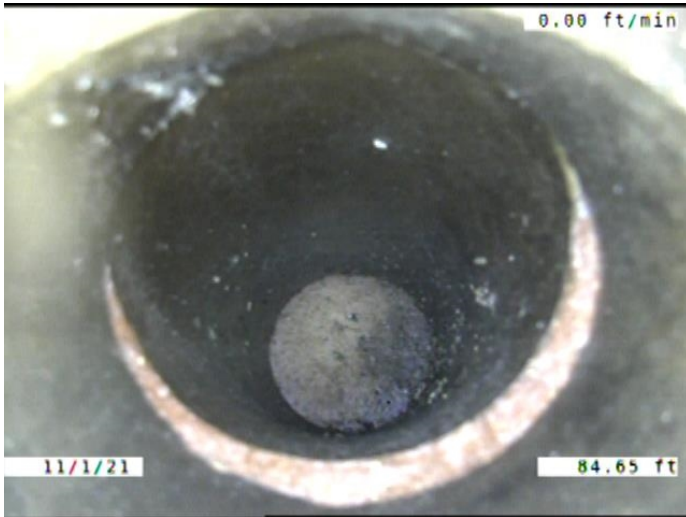
Code: **TFC**
 Description: **Tap Factory Capped**

Distance (ft): **84.7**
 Structural Grade: **0**
 O&M Grade: **0**
 Clock Start/From: **11**
 Clock To:
 1st Value: **4.000**
 2nd Value:
 Value Percent:
 Continuous Index:
 Within 8" of Joint: **YES**
 Remarks:

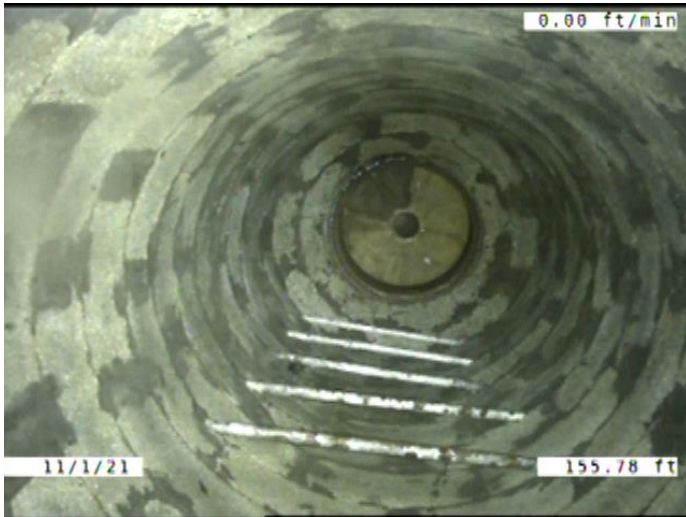
Code:	AMH
Description:	Manhole
Distance (ft):	155.8
Structural Grade:	0
O&M Grade:	0
Clock Start/From:	
Clock To:	
1st Value:	
2nd Value:	
Value Percent:	
Continuous Index:	
Within 8" of Joint:	NO
Remarks:	M-504-030
