Profile/Photo Observation Report

Date:	11/01/2021	Weather:		Coding:	PACP 7.0
Pipe Length (ft):	160.3	Owner:	City of Hobart	Pre Clean:	Heavy Cleaning
P.O.#:	YES502259	Surveyor:	S. Bucklin	PSR:	P-504-032-031
Customer:	City of Hobart	Clean Date:	10/27/2021	Shape:	C

Street:	North Colorado Street	Flow Control:	Not Controlled
City:	Hobart, IN	Year Renewed:	
Location:	Alley	Tape/Media #:	
Purpose:	Routine Assessment	Dia/Height:	12"
Use:	Sanitary Sewage Pipe	Material:	VCP
Drain Area:		Lining:	None
Category:	NA		
Comment:			
Location Details:		Direction of Survey:	Downstream
US MH:	M-504-031	DS MH:	M-504-032
		Total Length Surveyed (ft):	160.3

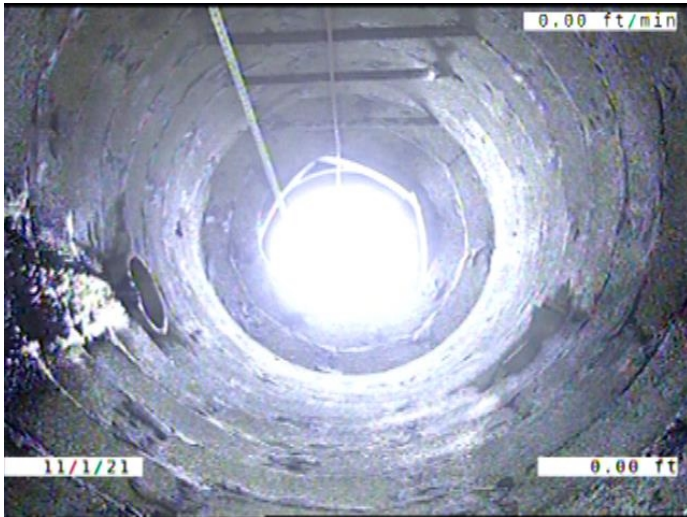
Code: **AMH**
 Description: **Manhole**

Distance (ft): **.0**
 Structural Grade: **0**
 O&M Grade: **0**
 Clock Start/From:
 Clock To:
 1st Value:
 2nd Value:
 Value Percent:
 Continuous Index:
 Within 8" of Joint: **NO**
 Remarks: **M-504-031**

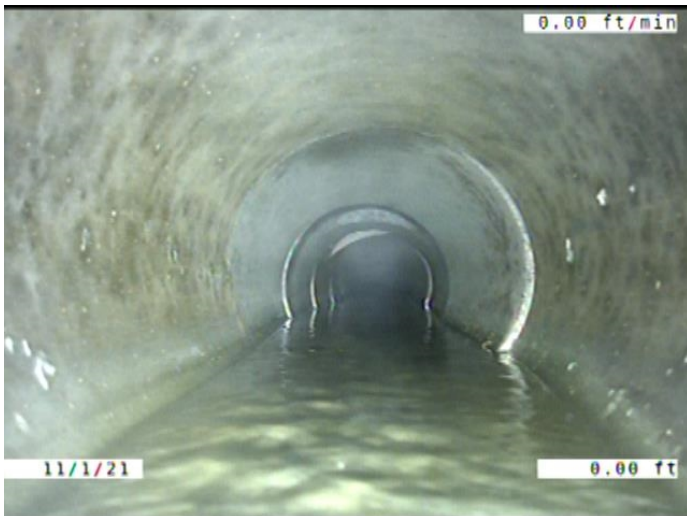
Code: **MWL**
 Description: **Miscellaneous Water Level**

Distance (ft): **.0**
 Structural Grade: **0**
 O&M Grade: **0**
 Clock Start/From:
 Clock To:
 1st Value:
 2nd Value:
 Value Percent: **10.000**
 Continuous Index:
 Within 8" of Joint: **NO**
 Remarks:

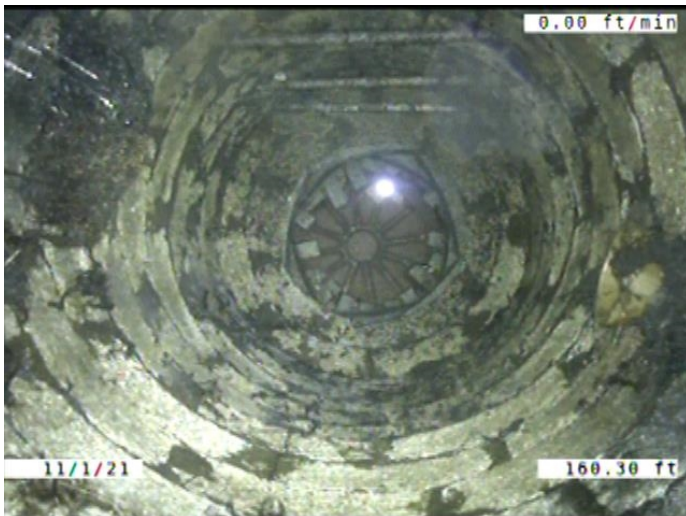
Code: **AMH**
 Description: **Manhole**

Distance (ft): **160.3**
 Structural Grade: **0**
 O&M Grade: **0**
 Clock Start/From:
 Clock To:
 1st Value:
 2nd Value:
 Value Percent:
 Continuous Index:
 Within 8" of Joint: **NO**
 Remarks: **M-504-032**
