Profile/Photo Observation Report

| Pipe Length (ft): | 160.3 | Owner: | City of Hobart | Pre Clean: | Heavy Cleaning |

| Street: | North Colorado Street | Flow Control: | Not Controlled |
| US MH: | M-504-031 | DS MH: | M-504-032 |

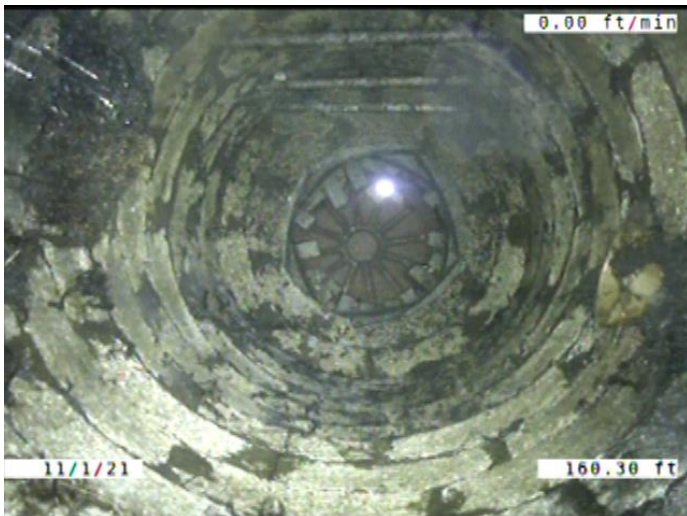
Code: **AMH**
 Description: **Manhole**

Distance (ft): **160.3**
 Structural Grade: **0**
 O&M Grade: **0**
 Clock Start/From:
 Clock To:
 1st Value:
 2nd Value:
 Value Percent:
 Continuous Index:
 Within 8" of Joint: **NO**
 Remarks: **M-504-032**
