Profile/Photo Observation Report

Date:	04/24/2018	Weather:		Coding:	PACP 6.0
Pipe Length (ft):	156.1	Owner:	NA	Pre Clean:	No Pre-Cleaning
P.O.#:		Surveyor:	Jen Costello	PSR:	P-504-033-032
Customer:		Clean Date:	01/01/1900	Shape:	C

Street:	FOXCROFT STREET	Flow Control:	Not Controlled
City:	Hobart, IN	Year Renewed:	
Location:	Light Highway	Tape/Media #:	
Purpose:	Routine Assessment	Dia/Height:	12"
Use:	Sanitary	Material:	VCP
Drain Area:	NA	Lining:	
Category:	NA		
Comment:	Flow direction wrong

Location Details:		Direction of Survey:	Upstream
US MH:	M-504-032	DS MH:	M-504-033
		Total Length Surveyed (ft):	162.9

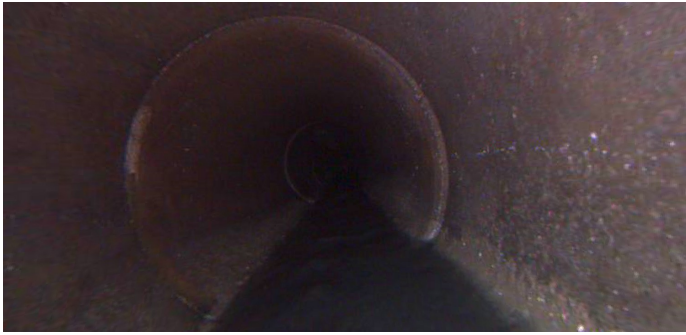
Code: **AMH**
Description: **Manhole**

Distance (ft): **.0**
Structural Grade: **0**
O&M Grade: **0**
Clock Start/From:
Clock To:
1st Value:
2nd Value:
Value Percent:
Continuous Index:
Within 8" of Joint: **NO**
Remarks: **M-504-033**

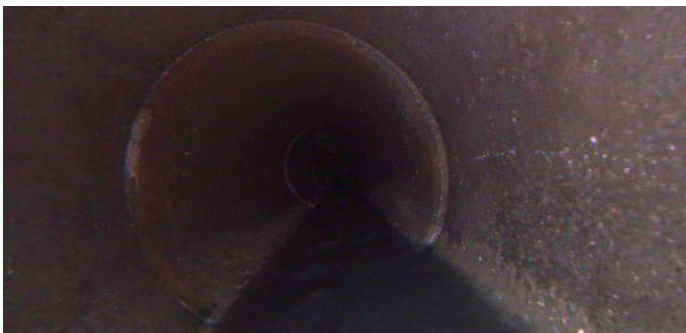
Code: **MWL**
Description: **Water Level**

Distance (ft): **.0**
Structural Grade: **0**
O&M Grade: **0**
Clock Start/From:
Clock To:
1st Value:
2nd Value:
Value Percent: **10.000**
Continuous Index:
Within 8" of Joint: **NO**
Remarks:

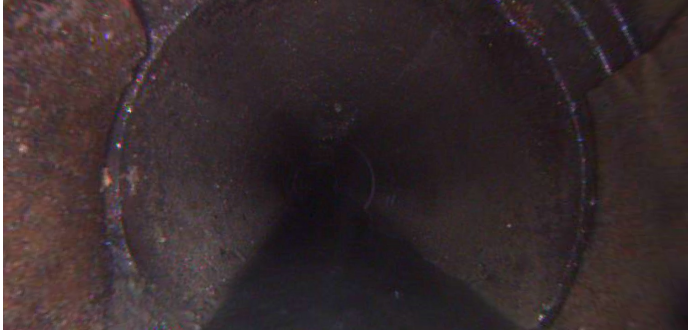
Code:	AMH
Description:	Manhole
Distance (ft):	162.9
Structural Grade:	0
O&M Grade:	0
Clock Start/From:	
Clock To:	
1st Value:	
2nd Value:	
Value Percent:	
Continuous Index:	
Within 8" of Joint:	NO
Remarks:	M-504-032
