## Profile/Photo Observation Report

Date:	<b>04/24/2018</b>	Weather:		Coding:	<b>PACP 6.0</b>
Pipe Length (ft):	<b>187.7</b>	Owner:	<b>NA</b>	Pre Clean:	<b>No Pre-Cleaning</b>
P.O.#:		Surveyor:	<b>Jen Costello</b>	PSR:	<b>P-504-045-033</b>
Customer:		Clean Date:	<b>01/01/1900</b>	Shape:	<b>C</b>

Street:	<b>W HOME AVE</b>	Flow Control:	<b>Not Controlled</b>
City:	<b>Hobart, IN</b>	Year Renewed:	
Location:	<b>Light Highway</b>	Tape/Media #:	
Purpose:	<b>Routine Assessment</b>	Dia/Height:	<b>12"</b>
Use:	<b>Sanitary</b>	Material:	<b>VCP</b>
Drain Area:	<b>NA</b>	Lining:	
Category:	<b>NA</b>		
Comment:	<b>P_C at 125 nothing visible . Flow direction wrong</b>		
Location Details:		Direction of Survey:	<b>Upstream</b>
US MH:	<b>M-504-033</b>	DS MH:	<b>M-504-045</b>
		Total Length Surveyed (ft):	<b>126.6</b>

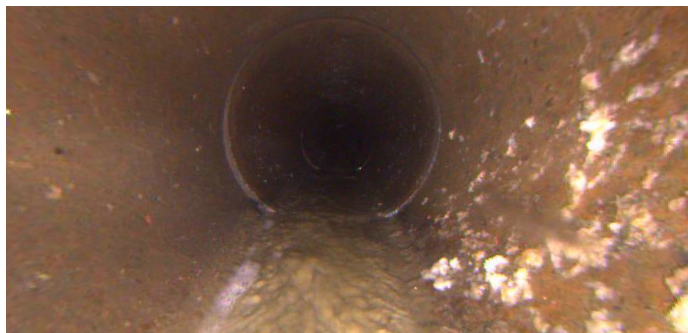
Code: **AMH**  
 Description: **Manhole**  
 Distance (ft): **.0**  
 Structural Grade: **0**  
 O&M Grade: **0**  
 Clock Start/From:  
 Clock To:  
 1st Value:  
 2nd Value:  
 Value Percent:  
 Continuous Index:  
 Within 8" of Joint: **NO**  
 Remarks: **M-504-045**

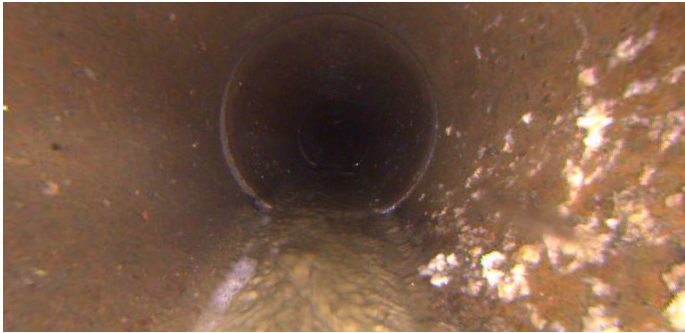
Code:	<b>MWL</b>
Description:	<b>Water Level</b>

Distance (ft):	<b>.0</b>
Structural Grade:	<b>0</b>
O&M Grade:	<b>0</b>
Clock Start/From:	
Clock To:	
1st Value:	
2nd Value:	
Value Percent:	<b>5.000</b>
Continuous Index:	
Within 8" of Joint:	<b>NO</b>
Remarks:

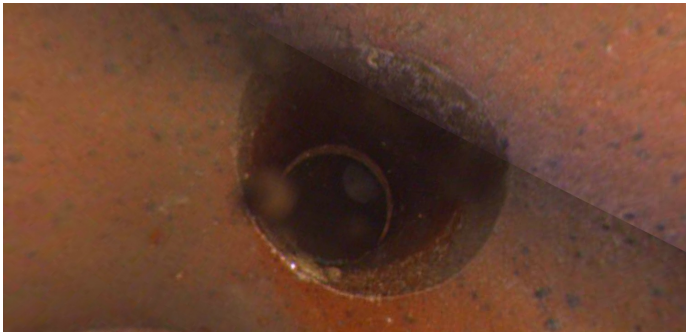
Code: **TF**  
Description: **Tap Factory**

Distance (ft): **25.8**  
Structural Grade: **0**  
O&M Grade: **0**  
Clock Start/From: **12**  
Clock To:  
1st Value: **4.000**  
2nd Value:  
Value Percent:  
Continuous Index:  
Within 8" of Joint:  
Remarks:

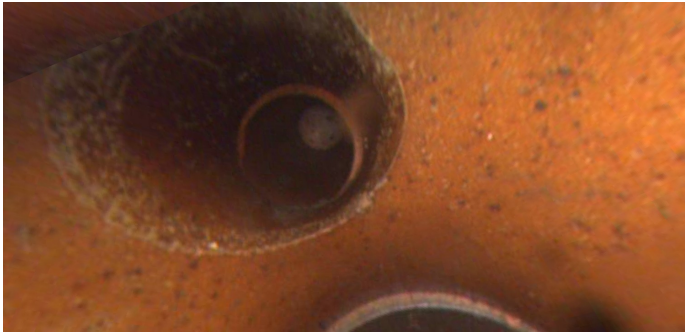
Code: **TF**  
Description: **Tap Factory**

Distance (ft): **40.7**  
Structural Grade: **0**  
O&M Grade: **0**  
Clock Start/From: **12**  
Clock To:  
1st Value: **4.000**  
2nd Value:  
Value Percent:  
Continuous Index:  
Within 8" of Joint:  
Remarks:

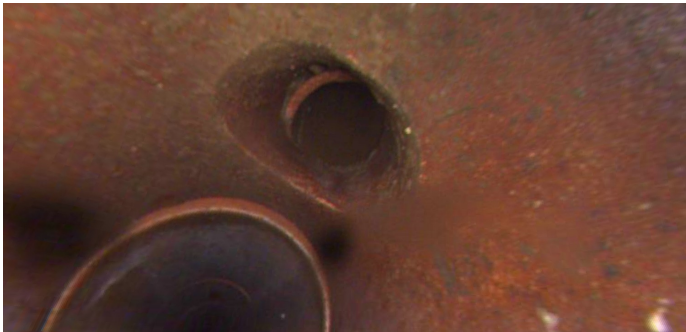
Code: **TF**  
Description: **Tap Factory**

Distance (ft): **119.0**  
Structural Grade: **0**  
O&M Grade: **0**  
Clock Start/From: **11**  
Clock To:  
1st Value: **4.000**  
2nd Value:  
Value Percent:  
Continuous Index:  
Within 8" of Joint:  
Remarks:

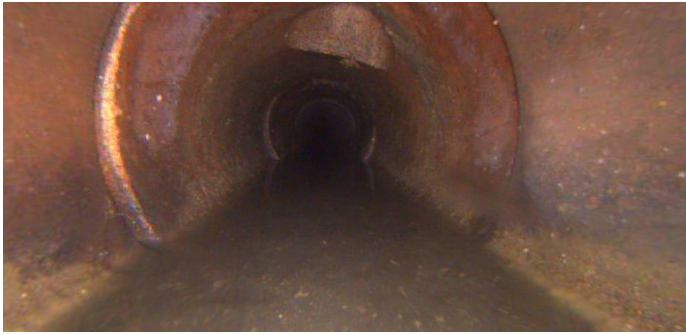
Code: **MSA**  
Description: **Abandoned Survey**

Distance (ft): **126.6**  
Structural Grade: **0**  
O&M Grade: **0**  
Clock Start/From:  
Clock To:  
1st Value:  
2nd Value:  
Value Percent:  
Continuous Index:  
Within 8" of Joint: **NO**  
Remarks: **unknown**
