Profile/Photo Observation Report

Date:	04/24/2018	Weather:		Coding:	PACP 6.0
Pipe Length (ft):	187.7	Owner:	NA	Pre Clean:	No Pre-Cleaning
P.O.#:		Surveyor:	Jen Costello	PSR:	P-504-045-033
Customer:		Clean Date:	01/01/1900	Shape:	C

Street:	FOXCROFT STREET	Flow Control:	Not Controlled
City:	Hobart, IN	Year Renewed:	
Location:	Light Highway	Tape/Media #:	
Purpose:	Routine Assessment	Dia/Height:	12"
Use:	Sanitary	Material:	VCP
Drain Area:	NA	Lining:	
Category:	NA		
Comment:	P_C at 125 nothing visible . Flow direction wrong		
Location Details:		Direction of Survey:	Upstream
US MH:	M-504-033	DS MH:	M-504-045
		Total Length Surveyed (ft):	126.6

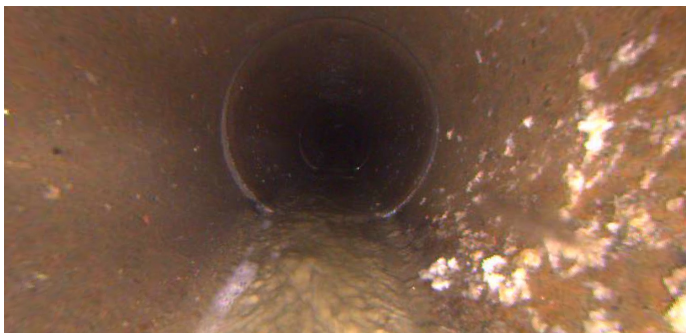
Code: **AMH**
Description: **Manhole**

Distance (ft): **.0**
Structural Grade: **0**
O&M Grade: **0**
Clock Start/From:
Clock To:
1st Value:
2nd Value:
Value Percent:
Continuous Index:
Within 8" of Joint: **NO**
Remarks: **M-504-045**

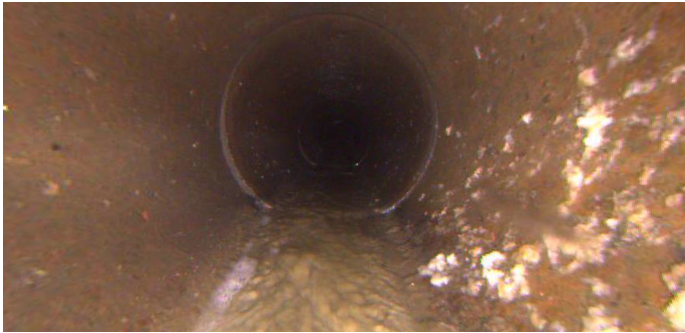
Code:	MWL
Description:	Water Level

Distance (ft):	.0
Structural Grade:	0
O&M Grade:	0
Clock Start/From:	
Clock To:	
1st Value:	
2nd Value:	
Value Percent:	5.000
Continuous Index:	
Within 8" of Joint:	NO
Remarks:

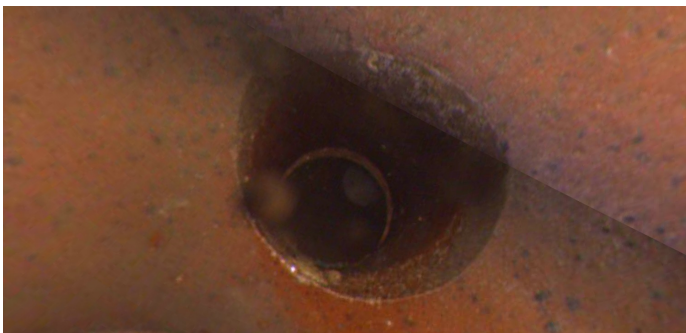
Code: **TF**
Description: **Tap Factory**

Distance (ft): **25.8**
Structural Grade: **0**
O&M Grade: **0**
Clock Start/From: **12**
Clock To:
1st Value: **4.000**
2nd Value:
Value Percent:
Continuous Index:
Within 8" of Joint:
Remarks:

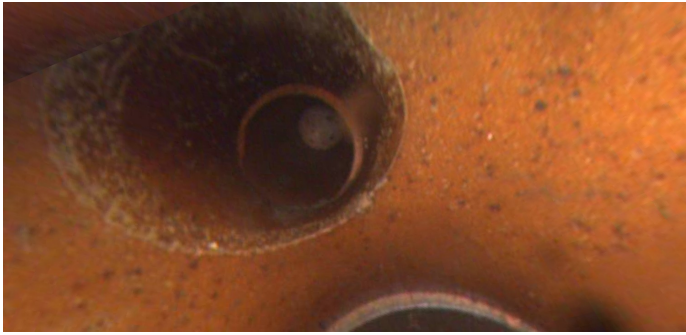
Code: **TF**
Description: **Tap Factory**

Distance (ft): **40.7**
Structural Grade: **0**
O&M Grade: **0**
Clock Start/From: **12**
Clock To:
1st Value: **4.000**
2nd Value:
Value Percent:
Continuous Index:
Within 8" of Joint:
Remarks:

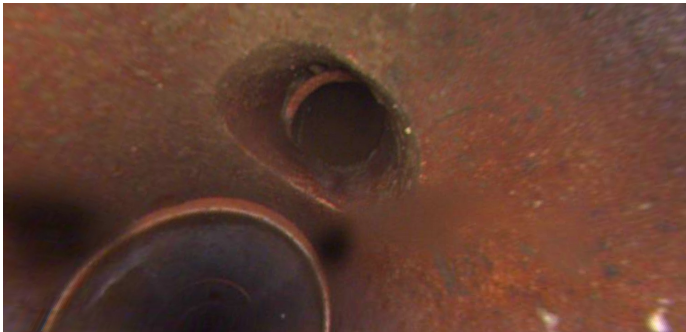
Code: **TF**
Description: **Tap Factory**

Distance (ft): **119.0**
Structural Grade: **0**
O&M Grade: **0**
Clock Start/From: **11**
Clock To:
1st Value: **4.000**
2nd Value:
Value Percent:
Continuous Index:
Within 8" of Joint:
Remarks:

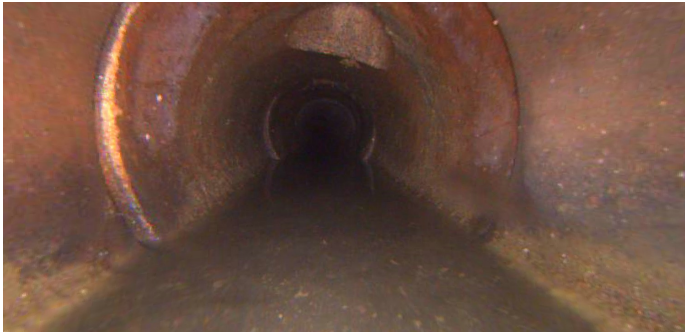
Code: **MSA**
Description: **Abandoned Survey**

Distance (ft): **126.6**
Structural Grade: **0**
O&M Grade: **0**
Clock Start/From:
Clock To:
1st Value:
2nd Value:
Value Percent:
Continuous Index:
Within 8" of Joint: **NO**
Remarks: **unknown**
