## Profile/Photo Observation Report

Date:	<b>10/30/2021</b>	Weather:		Coding:	<b>PACP 7.0</b>
Pipe Length (ft):	<b>177.7</b>	Owner:	<b>City of Hobart</b>	Pre Clean:	<b>Heavy Cleaning</b>
P.O.#:	<b>YES502259</b>	Surveyor:	<b>S. Bucklin</b>	PSR:	<b>P-504-045-033</b>
Customer:	<b>City of Hobart</b>	Clean Date:	<b>10/26/2021</b>	Shape:	<b>C</b>

Street:	<b>North Colorado Street</b>	Flow Control:	<b>Not Controlled</b>
City:	<b>Hobart, IN</b>	Year Renewed:	
Location:	<b>Alley</b>	Tape/Media #:	
Purpose:	<b>Routine Assessment</b>	Dia/Height:	<b>12"</b>
Use:	<b>Sanitary Sewage Pipe</b>	Material:	<b>VCP</b>
Drain Area:		Lining:	<b>None</b>
Category:	<b>NA</b>		
Comment:

Location Details:		Direction of Survey:	<b>Downstream</b>
US MH:	<b>M-504-033</b>	DS MH:	<b>M-504-045</b>
		Total Length Surveyed (ft):	<b>177.7</b>

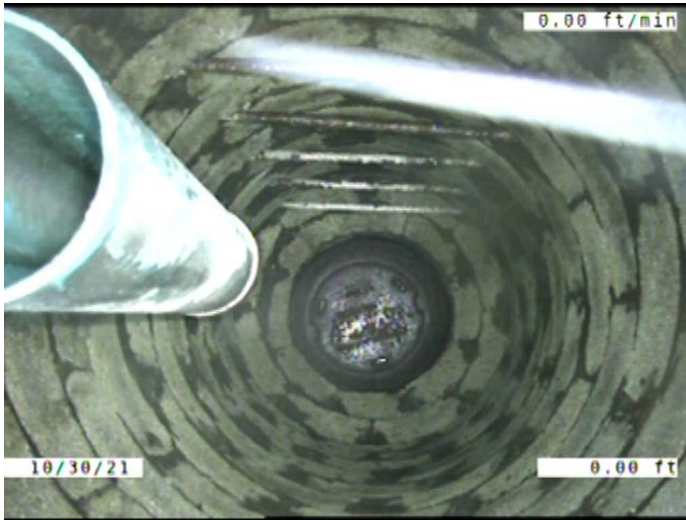
Code: **AMH**  
 Description: **Manhole**

Distance (ft): **.0**  
 Structural Grade: **0**  
 O&M Grade: **0**  
 Clock Start/From:  
 Clock To:  
 1st Value:  
 2nd Value:  
 Value Percent:  
 Continuous Index:  
 Within 8" of Joint: **NO**  
 Remarks: **M-504-033**

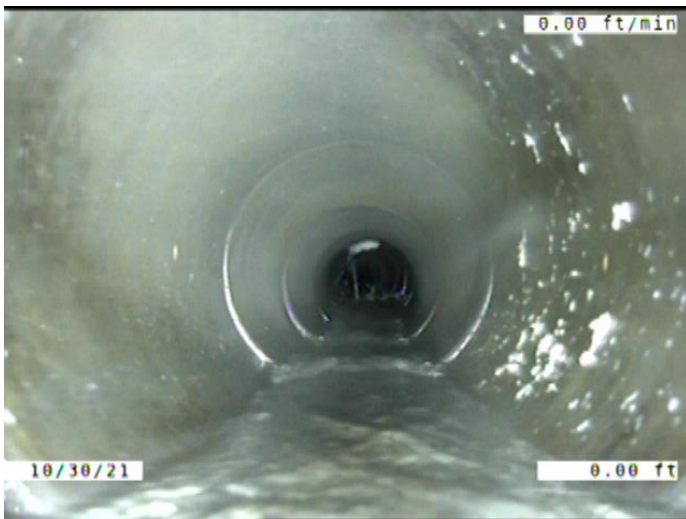
Code: **MWL**  
 Description: **Miscellaneous Water Level**

Distance (ft): **.0**  
 Structural Grade: **0**  
 O&M Grade: **0**  
 Clock Start/From:  
 Clock To:  
 1st Value:  
 2nd Value:  
 Value Percent: **5.000**  
 Continuous Index:  
 Within 8" of Joint: **NO**  
 Remarks:
