# Profile/Photo Observation Report

Date:	<b>10/31/2021</b>	Weather:		Coding:	<b>PACP 7.0</b>
Pipe Length (ft):	<b>163.8</b>	Owner:	<b>City of Hobart</b>	Pre Clean:	<b>Heavy Cleaning</b>
P.O.#:	<b>YES502259</b>	Surveyor:	<b>S. Bucklin</b>	PSR:	<b>P-504-035-034</b>
Customer:	<b>City of Hobart</b>	Clean Date:	<b>10/27/2021</b>	Shape:	<b>C</b>

Street:	<b>North Colorado Street</b>	Flow Control:	<b>Not Controlled</b>
City:	<b>Hobart, IN</b>	Year Renewed:	
Location:	<b>Local rural streets with light traffic, t</b>	Tape/Media #:	
Purpose:	<b>Routine Assessment</b>	Dia/Height:	<b>10"</b>
Use:	<b>Sanitary Sewage Pipe</b>	Material:	<b>VCP</b>
Drain Area:		Lining:	<b>None</b>
Category:	<b>NA</b>		
Comment:			
Location Details:		Direction of Survey:	<b>Upstream</b>
US MH:	<b>M-504-034</b>	DS MH:	<b>M-504-035</b>
		Total Length Surveyed (ft):	<b>163.8</b>

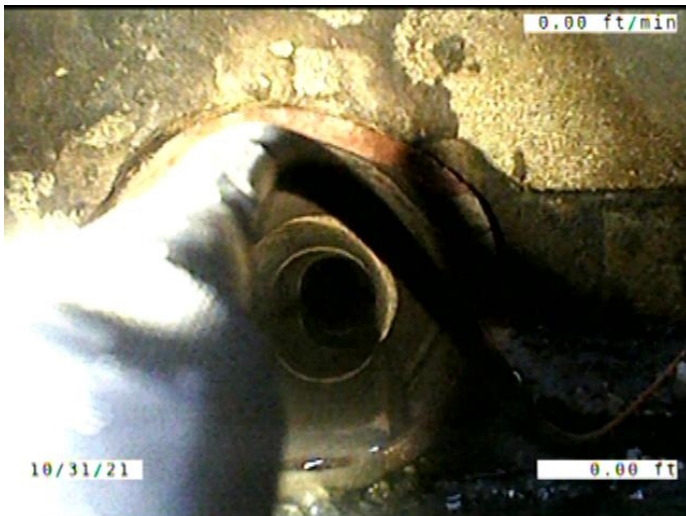
Code: **AMH**  
Description: **Manhole**

Distance (ft): **.0**  
Structural Grade: **0**  
O&M Grade: **0**  
Clock Start/From:  
Clock To:  
1st Value:  
2nd Value:  
Value Percent:  
Continuous Index:  
Within 8" of Joint: **NO**  
Remarks: **M-504-035**

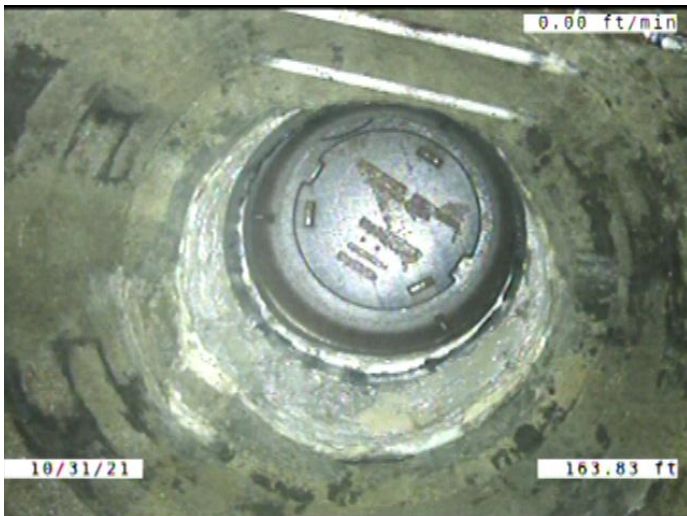
Code: **AMH**  
 Description: **Manhole**

Distance (ft): **163.8**  
 Structural Grade: **0**  
 O&M Grade: **0**  
 Clock Start/From:  
 Clock To:  
 1st Value:  
 2nd Value:  
 Value Percent:  
 Continuous Index:  
 Within 8" of Joint: **NO**  
 Remarks: **M-504-034**
