# Profile/Photo Observation Report

Date:	10/31/2021	Weather:		Coding:	PACP 7.0
Pipe Length (ft):	163.8	Owner:	City of Hobart	Pre Clean:	Heavy Cleaning
P.O.#:	YES502259	Surveyor:	S. Bucklin	PSR:	P-504-035-034
Customer:	City of Hobart	Clean Date:	10/27/2021	Shape:	C

Street:	North Colorado Street	Flow Control:	Not Controlled
City:	Hobart, IN	Year Renewed:	
Location:	Local rural streets with light traffic, t	Tape/Media #:	
Purpose:	Routine Assessment	Dia/Height:	10"
Use:	Sanitary Sewage Pipe	Material:	VCP
Drain Area:		Lining:	None
Category:	NA		
Comment:			
Location Details:		Direction of Survey:	Upstream
US MH:	M-504-034	DS MH:	M-504-035
		Total Length Surveyed (ft):	163.8

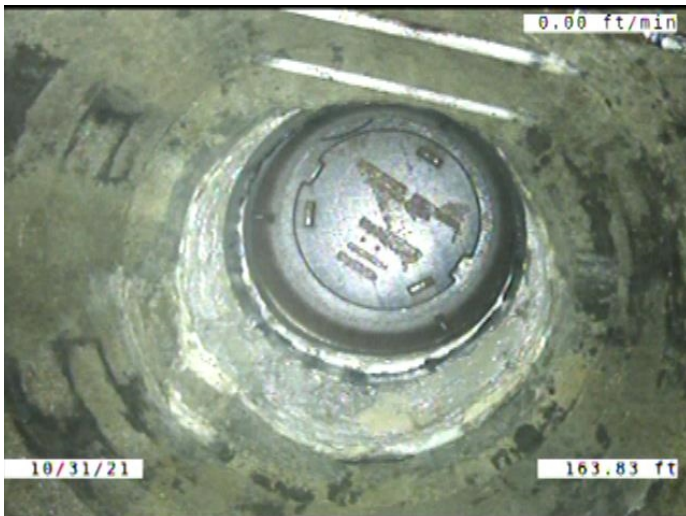
Code: **AMH**  
 Description: **Manhole**

Distance (ft): **163.8**  
 Structural Grade: **0**  
 O&M Grade: **0**  
 Clock Start/From:  
 Clock To:  
 1st Value:  
 2nd Value:  
 Value Percent:  
 Continuous Index:  
 Within 8" of Joint: **NO**  
 Remarks: **M-504-034**
