RedZone[®]
ROBOTICS

Street:	North Colorado Street		Flow Control:	Not Controlled	
City:	Hobart, IN		Year Renewed:		
Location:	Local rural streets with light traffic, t		Tape/Media #:		
Purpose:	Routine Assessment		Dia/Height:	10"	
Use:	Sanitary Sewage Pipe		Material:	VCP	
Drain Area:			Lining:	None	
Category:	NA				
Comment:					
Location Details:			Direction of Survey:	Upstream	
US MH:	M-504-034	DS MH:	M-504-041	Total Length Surveyed (ft):	161.8

Tuesday, April 25, 2023

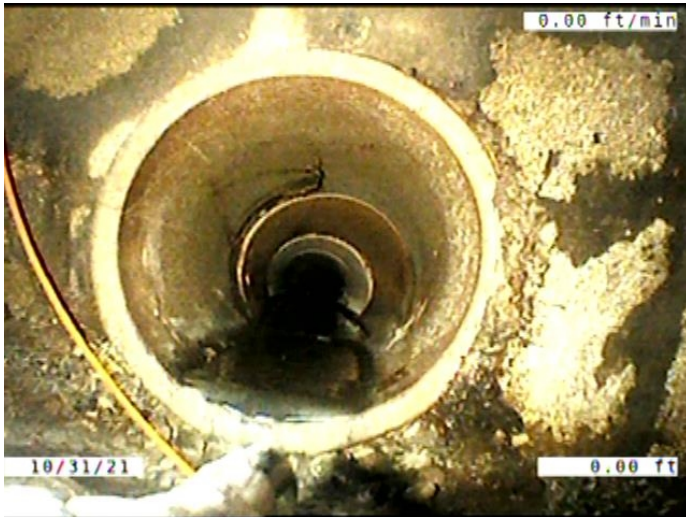
Code: **AMH**
Description: **Manhole**

Distance (ft): **.0**
Structural Grade: **0**
O&M Grade: **0**
Clock Start/From:
Clock To:
1st Value:
2nd Value:
Value Percent:
Continuous Index:
Within 8" of Joint: **NO**
Remarks: **M-504-041**

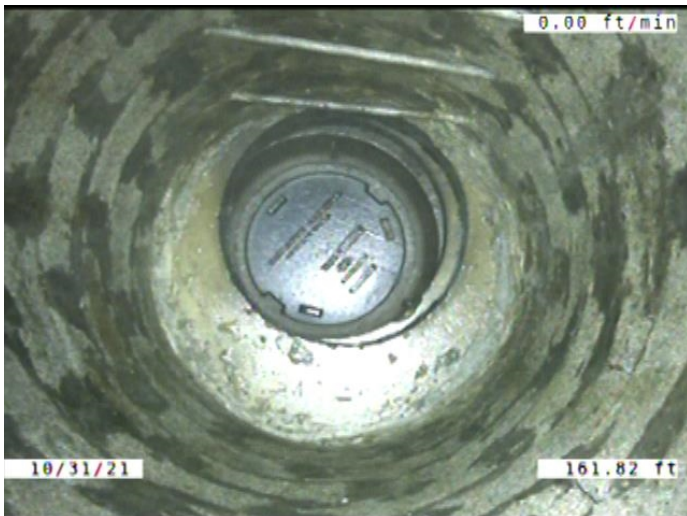
Code: **AMH**
 Description: **Manhole**

Distance (ft): **161.8**
 Structural Grade: **0**
 O&M Grade: **0**
 Clock Start/From:
 Clock To:
 1st Value:
 2nd Value:
 Value Percent:
 Continuous Index:
 Within 8" of Joint: **NO**
 Remarks: **M-504-034**
