Profile/Photo Observation Report

Date:	10/31/2021	Weather:		Coding:	PACP 7.0
Pipe Length (ft):	210.2	Owner:	City of Hobart	Pre Clean:	Heavy Cleaning
P.O.#:	YES502259	Surveyor:	S. Bucklin	PSR:	P-504-036-035
Customer:	City of Hobart	Clean Date:	10/27/2021	Shape:	C

Street:	North Colorado Street	Flow Control:	Not Controlled
City:	Hobart, IN	Year Renewed:	
Location:	Alley	Tape/Media #:	
Purpose:	Routine Assessment	Dia/Height:	10"
Use:	Sanitary Sewage Pipe	Material:	VCP
Drain Area:		Lining:	None
Category:	NA		
Comment:			
Location Details:		Direction of Survey:	Downstream
US MH:	M-504-035	DS MH:	M-504-036
		Total Length Surveyed (ft):	210.2

O&M Index:	1.73	O&M Quick:	362B	O&M Rating:	64.00
Structural Index:	2.67	Structural Quick:	5546	Structural Rating:	112.00
Overall Index:	2.23	Overall Quick:	5546	Overall Rating:	176.00

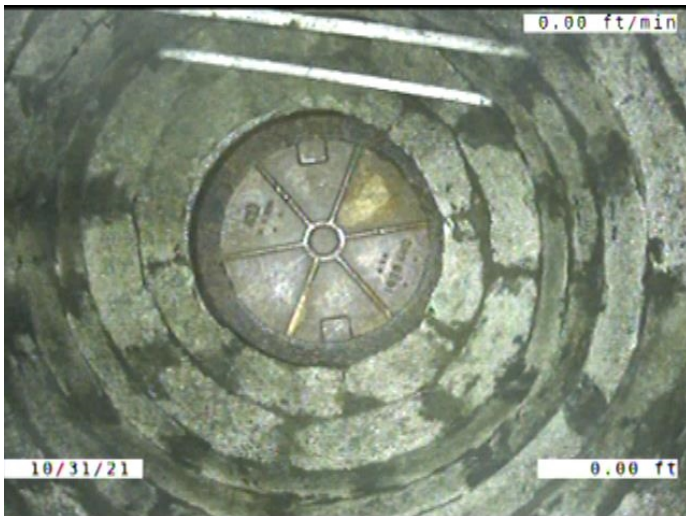
M-504-036

Code: **AMH**
 Description: **Manhole**

Distance (ft): **.0**
 Structural Grade: **0**
 O&M Grade: **0**
 Clock Start/From:
 Clock To:
 1st Value:
 2nd Value:
 Value Percent:
 Continuous Index:
 Within 8" of Joint: **NO**
 Remarks: **M-504-035**

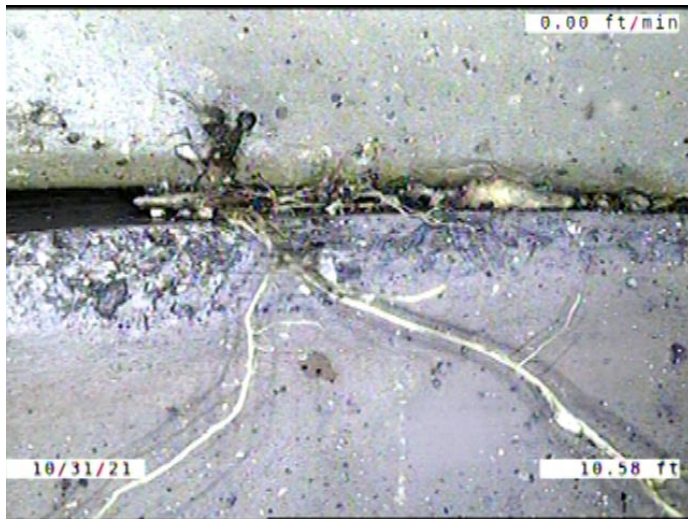
Code: **RFJ**
 Description: **Roots Fine Joint**

Distance (ft): **10.6**
 Structural Grade: **0**
 O&M Grade: **1**
 Clock Start/From: **10**
 Clock To:
 1st Value:
 2nd Value:
 Value Percent:
 Continuous Index:
 Within 8" of Joint: **YES**
 Remarks:

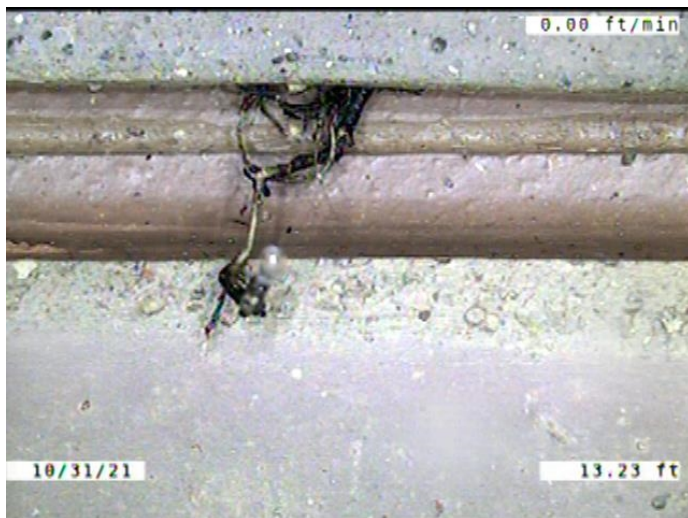
Code: **RFJ**
 Description: **Roots Fine Joint**

Distance (ft): **13.2**
 Structural Grade: **0**
 O&M Grade: **1**
 Clock Start/From: **9**
 Clock To: **1**
 1st Value:
 2nd Value:
 Value Percent:
 Continuous Index:
 Within 8" of Joint: **YES**
 Remarks:

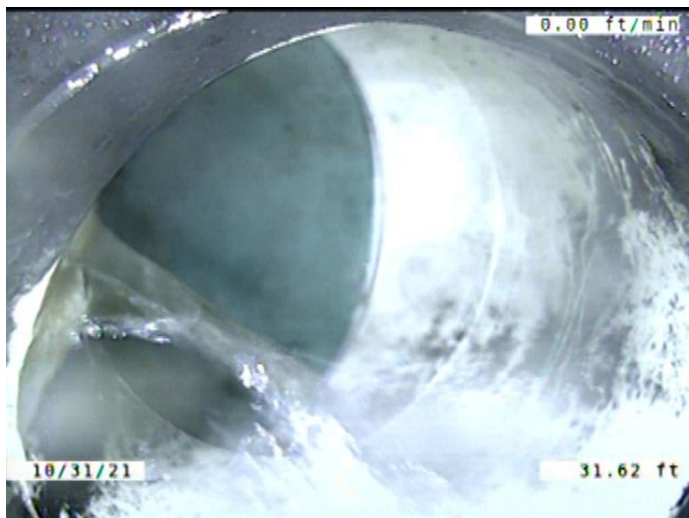
Code: **TBA**
 Description: **Tap Break-in Activity**

Distance (ft): **31.6**
 Structural Grade: **0**
 O&M Grade: **0**
 Clock Start/From: **11**
 Clock To:
 1st Value: **4.000**
 2nd Value:
 Value Percent:
 Continuous Index:
 Within 8" of Joint: **YES**
 Remarks:

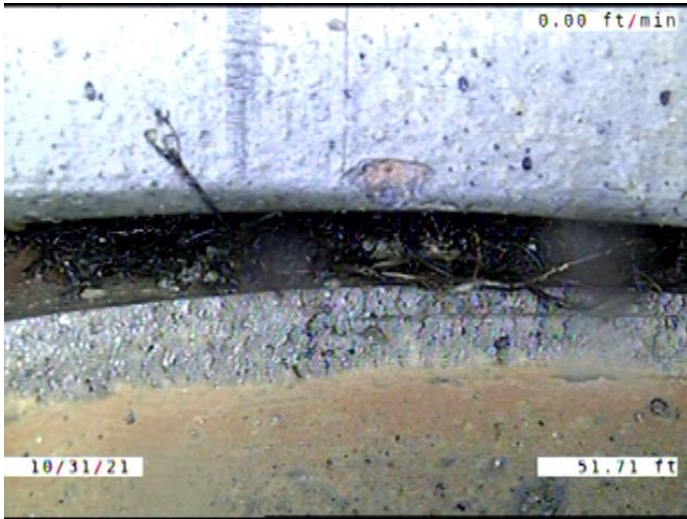
Code: **RFJ**
Description: **Roots Fine Joint**

Distance (ft): **51.7**
Structural Grade: **0**
O&M Grade: **1**
Clock Start/From: **10**
Clock To: **2**
1st Value:
2nd Value:
Value Percent:
Continuous Index:
Within 8" of Joint: **YES**
Remarks:

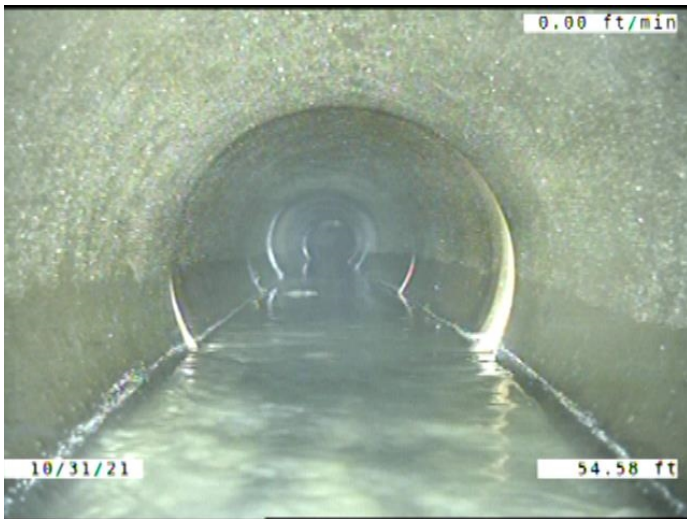
Code: **MWLS**
Description: **Miscellaneous Water Level Sag**

Distance (ft): **54.6**
Structural Grade: **2**
O&M Grade: **0**
Clock Start/From:
Clock To:
1st Value:
2nd Value:
Value Percent: **10.000**
Continuous Index: **S02**
Within 8" of Joint: **NO**
Remarks:

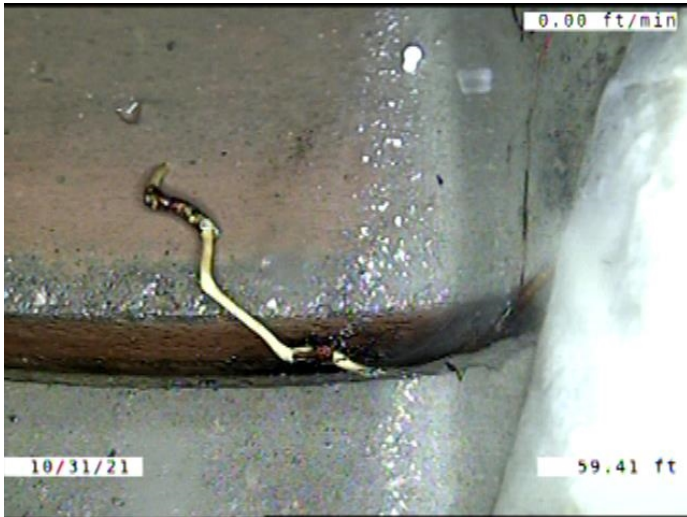
Code: **RFJ**
 Description: **Roots Fine Joint**

Distance (ft): **59.4**
 Structural Grade: **0**
 O&M Grade: **1**
 Clock Start/From: **8**
 Clock To:
 1st Value:
 2nd Value:
 Value Percent:
 Continuous Index:
 Within 8" of Joint: **YES**
 Remarks:

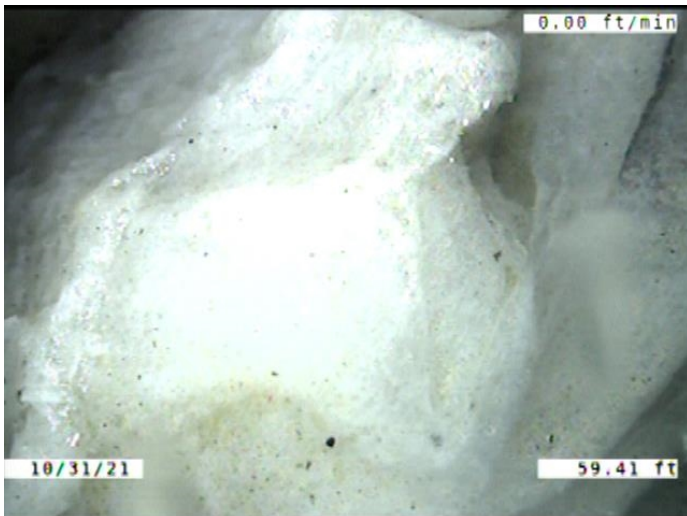
Code: **DAR**
 Description: **Deposits Attached Ragging**

Distance (ft): **59.4**
 Structural Grade: **0**
 O&M Grade: **2**
 Clock Start/From: **7**
 Clock To:
 1st Value:
 2nd Value:
 Value Percent: **5.000**
 Continuous Index:
 Within 8" of Joint: **YES**
 Remarks:

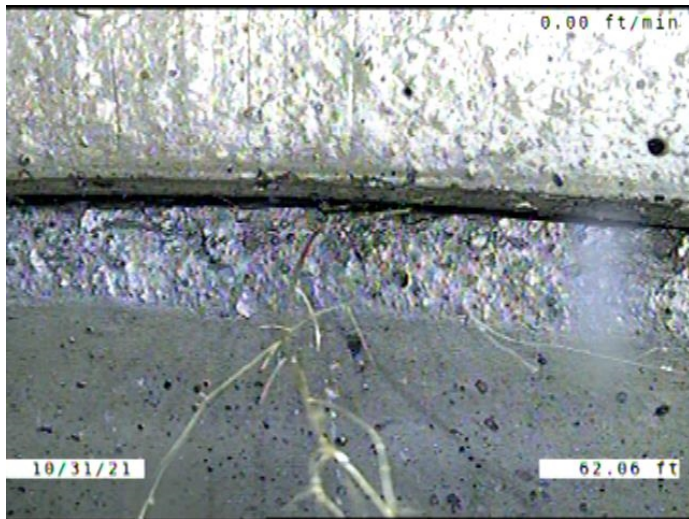
Code: **RFJ**
 Description: **Roots Fine Joint**

Distance (ft): **62.1**
 Structural Grade: **0**
 O&M Grade: **1**
 Clock Start/From: **2**
 Clock To:
 1st Value:
 2nd Value:
 Value Percent:
 Continuous Index:
 Within 8" of Joint: **YES**
 Remarks:

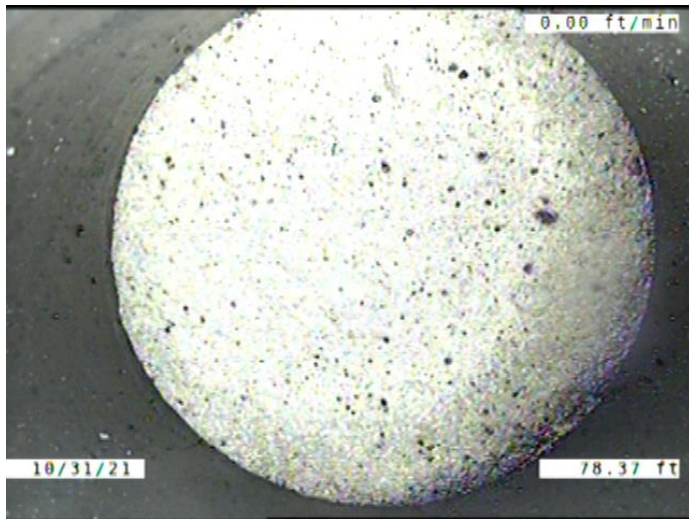
Code: **TFC**
 Description: **Tap Factory Capped**

Distance (ft): **78.4**
 Structural Grade: **0**
 O&M Grade: **0**
 Clock Start/From: **11**
 Clock To:
 1st Value: **4.000**
 2nd Value:
 Value Percent:
 Continuous Index:
 Within 8" of Joint: **YES**
 Remarks:

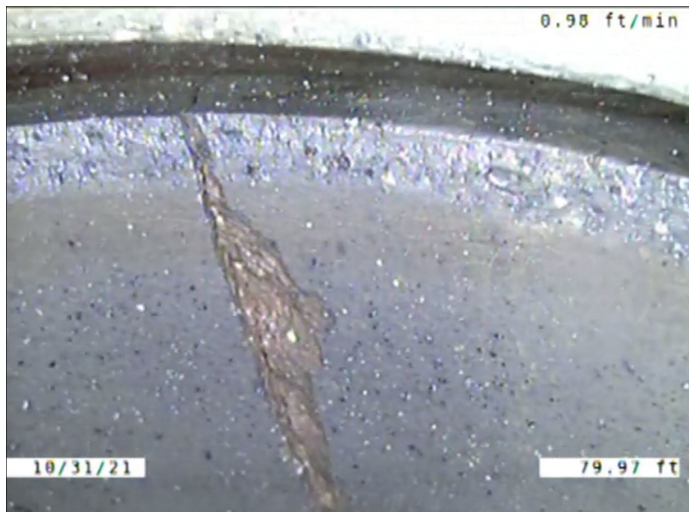
Code: **SSS**
 Description: **Surface Damage Surface Spalling**

Distance (ft): **80.0**
 Structural Grade: **2**
 O&M Grade: **0**
 Clock Start/From: **3**
 Clock To:
 1st Value:
 2nd Value:
 Value Percent:
 Continuous Index:
 Within 8" of Joint: **YES**
 Remarks:

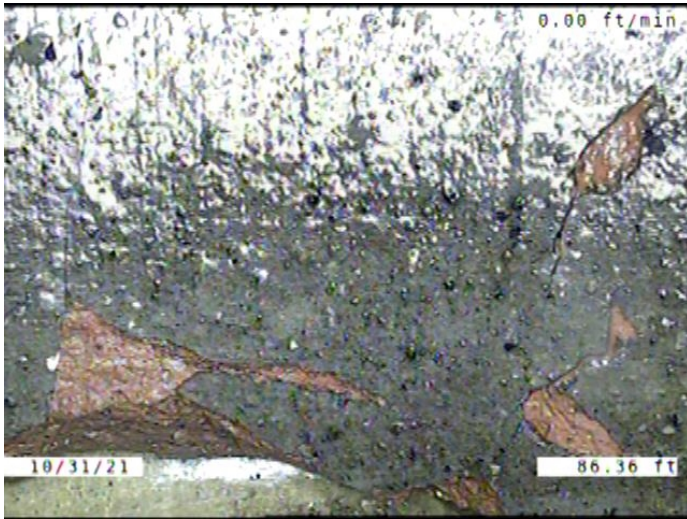
Code: **SSS**
Description: **Surface Damage Surface Spalling**

Distance (ft): **86.3**
Structural Grade: **2**
O&M Grade: **0**
Clock Start/From: **1**
Clock To: **3**
1st Value:
2nd Value:
Value Percent:
Continuous Index:
Within 8" of Joint: **YES**
Remarks:

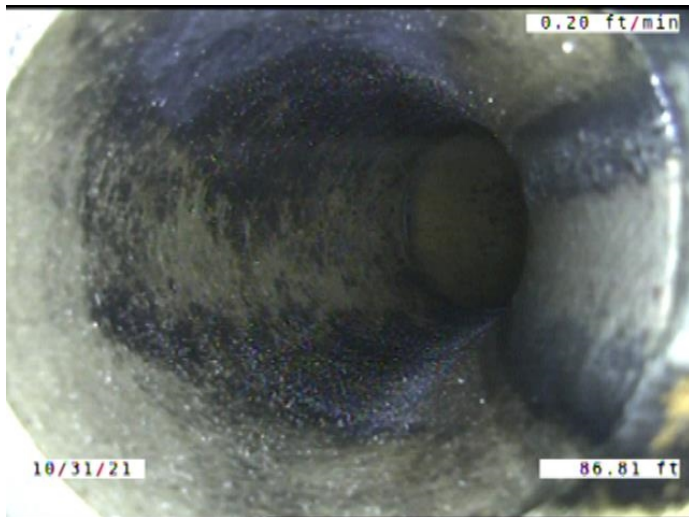
Code: **TBI**
 Description: **Tap Break-in Intruding**

Distance (ft): **86.8**
 Structural Grade: **0**
 O&M Grade: **2**
 Clock Start/From: **1**
 Clock To:
 1st Value: **4.000**
 2nd Value: **1.000**
 Value Percent:
 Continuous Index:
 Within 8" of Joint: **YES**
 Remarks:

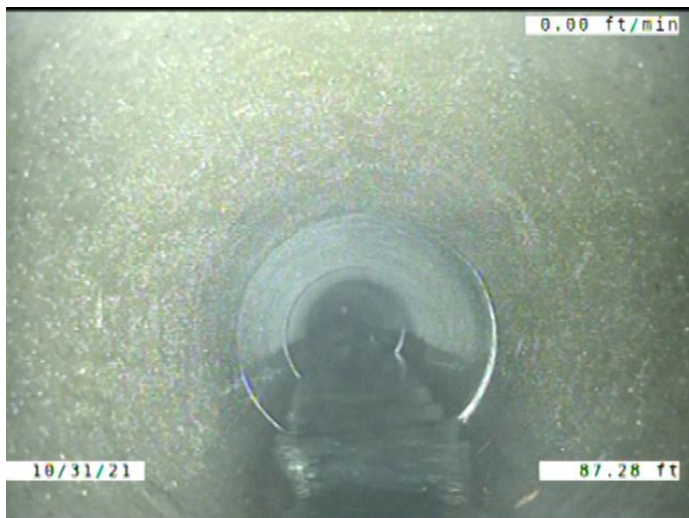
Code: **MWLS**
 Description: **Miscellaneous Water Level Sag**

Distance (ft): **87.3**
 Structural Grade: **2**
 O&M Grade: **0**
 Clock Start/From:
 Clock To:
 1st Value:
 2nd Value:
 Value Percent: **10.000**
 Continuous Index: **F02**
 Within 8" of Joint: **NO**
 Remarks:

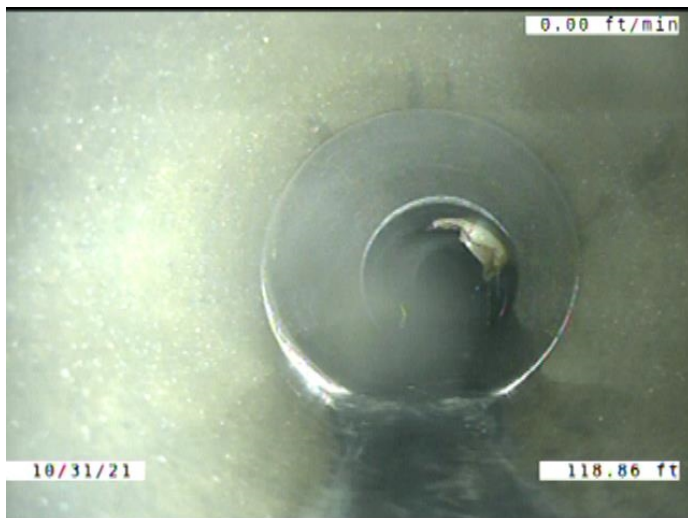
Code: **MWLS**
 Description: **Miscellaneous Water Level Sag**

Distance (ft): **118.9**
 Structural Grade: **2**
 O&M Grade: **0**
 Clock Start/From:
 Clock To:
 1st Value:
 2nd Value:
 Value Percent: **10.000**
 Continuous Index: **F03**
 Within 8" of Joint: **NO**
 Remarks:

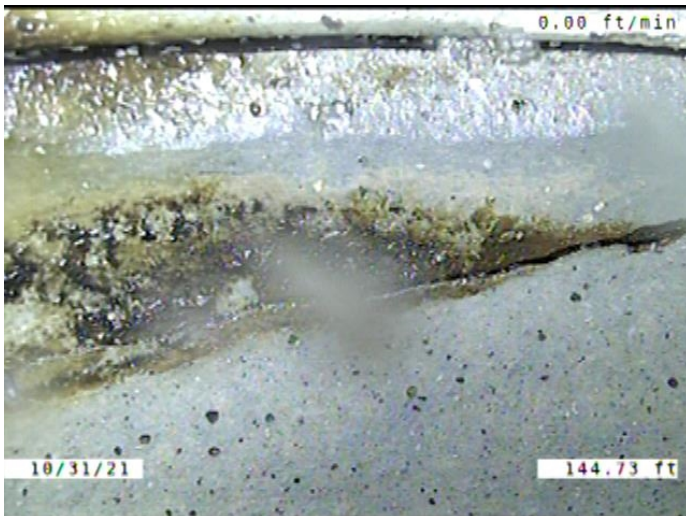
Code: **ISB**
Description: **Infiltration Stain Barrel**

Distance (ft): **144.7**
Structural Grade: **0**
O&M Grade: **1**
Clock Start/From: **8**
Clock To: **10**
1st Value:
2nd Value:
Value Percent:
Continuous Index:
Within 8" of Joint: **YES**
Remarks:

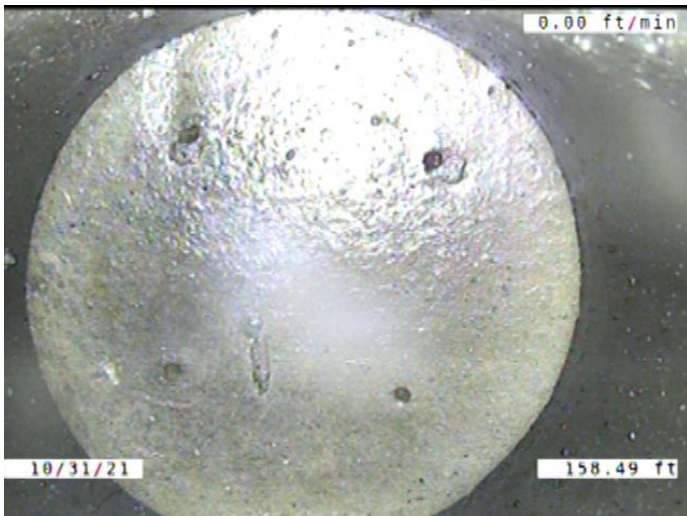
Code: **FM**
 Description: **Fracture Multiple**

Distance (ft): **157.6**
 Structural Grade: **4**
 O&M Grade: **0**
 Clock Start/From: **10**
 Clock To: **4**
 1st Value:
 2nd Value:
 Value Percent:
 Continuous Index:
 Within 8" of Joint: **YES**
 Remarks:

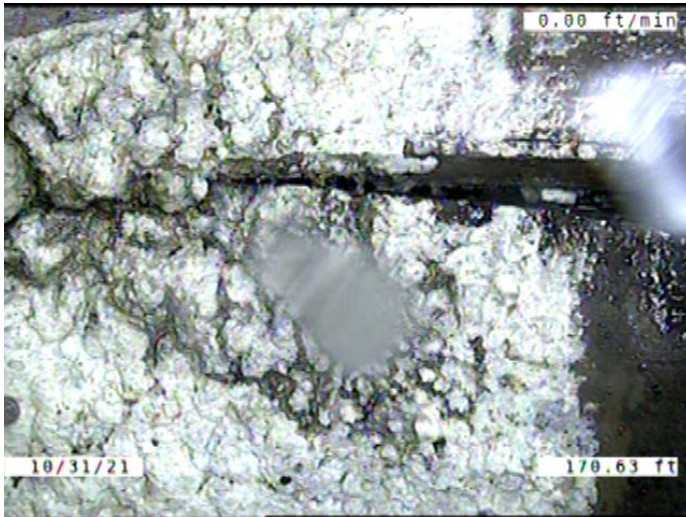
Code: **RFJ**
 Description: **Roots Fine Joint**

Distance (ft): **170.6**
 Structural Grade: **0**
 O&M Grade: **1**
 Clock Start/From: **6**
 Clock To: **7**
 1st Value:
 2nd Value:
 Value Percent:
 Continuous Index:
 Within 8" of Joint: **YES**
 Remarks:

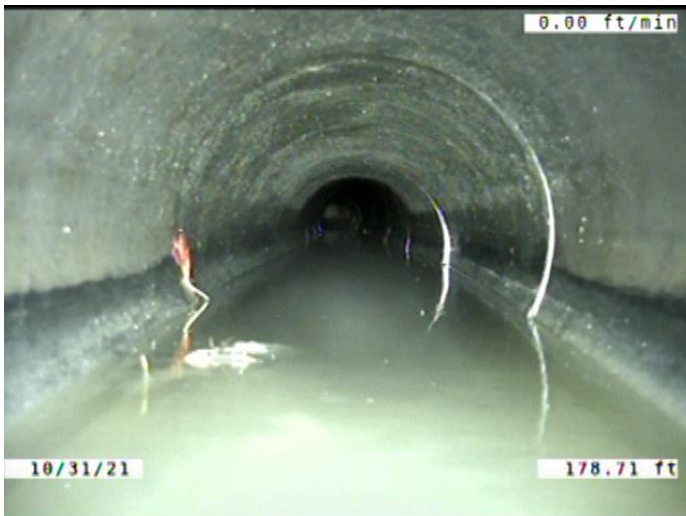
Code: **DAE**
 Description: **Deposits Attached Encrustation**

Distance (ft): **170.6**
 Structural Grade: **0**
 O&M Grade: **2**
 Clock Start/From: **1**
 Clock To: **3**
 1st Value:
 2nd Value:
 Value Percent: **5.000**
 Continuous Index:
 Within 8" of Joint: **YES**
 Remarks:
