# Profile/Photo Observation Report

Date:	10/31/2021	Weather:		Coding:	PACP 7.0
Pipe Length (ft):	210.2	Owner:	City of Hobart	Pre Clean:	Heavy Cleaning
P.O.#:	YES502259	Surveyor:	S. Bucklin	PSR:	P-504-036-035
Customer:	City of Hobart	Clean Date:	10/27/2021	Shape:	C

Street:	North Colorado Street	Flow Control:	Not Controlled
City:	Hobart, IN	Year Renewed:	
Location:	Alley	Tape/Media #:	
Purpose:	Routine Assessment	Dia/Height:	10"
Use:	Sanitary Sewage Pipe	Material:	VCP
Drain Area:		Lining:	None
Category:	NA		
Comment:			
Location Details:		Direction of Survey:	Downstream
US MH:	M-504-035	DS MH:	M-504-036
		Total Length Surveyed (ft):	210.2

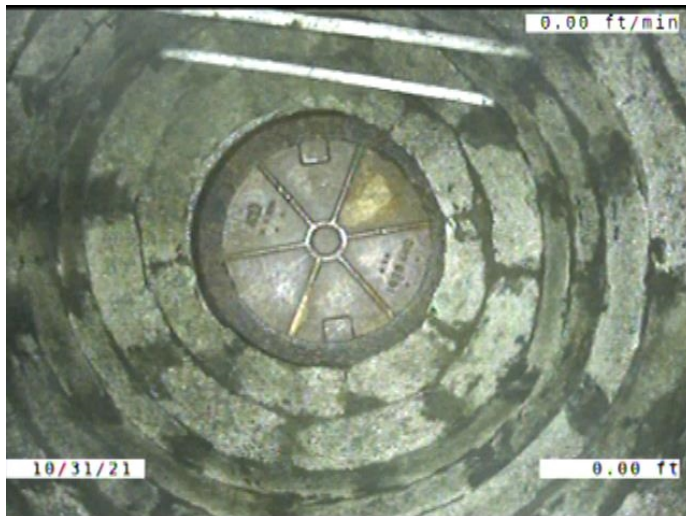
Code: **AMH**  
Description: **Manhole**

Distance (ft): **.0**  
Structural Grade: **0**  
O&M Grade: **0**  
Clock Start/From:  
Clock To:  
1st Value:  
2nd Value:  
Value Percent:  
Continuous Index:  
Within 8" of Joint: **NO**  
Remarks: **M-504-035**

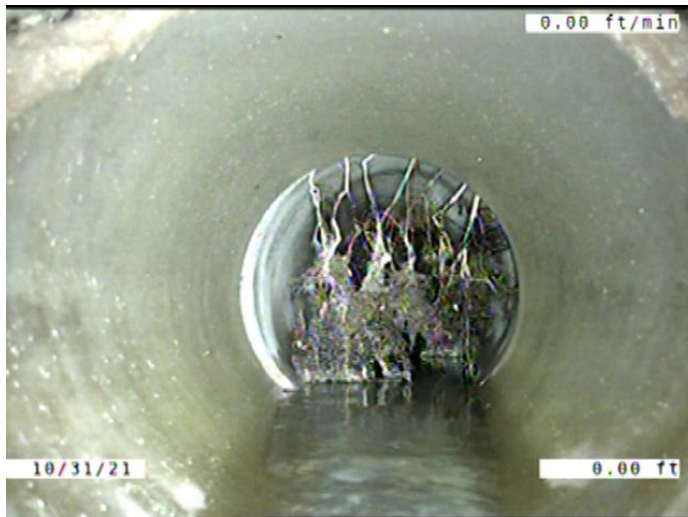
Code: **MWL**  
 Description: **Miscellaneous Water Level**

Distance (ft): **.0**  
 Structural Grade: **0**  
 O&M Grade: **0**  
 Clock Start/From:  
 Clock To:  
 1st Value:  
 2nd Value:  
 Value Percent: **5.000**  
 Continuous Index:  
 Within 8" of Joint: **NO**  
 Remarks:

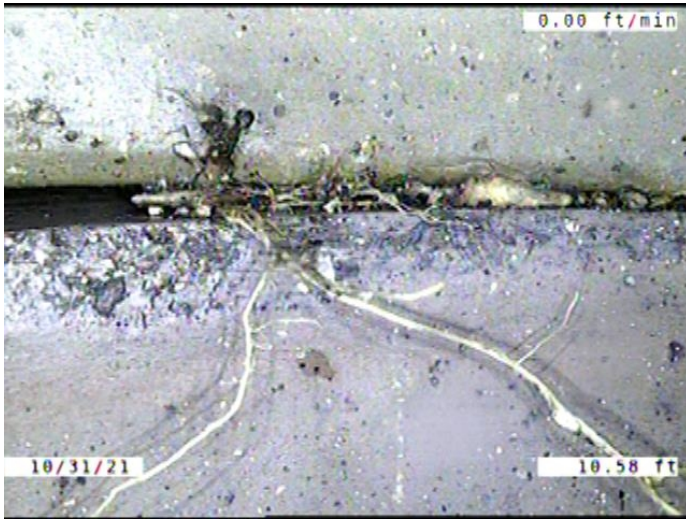
Code: **RFJ**  
 Description: **Roots Fine Joint**

Distance (ft): **10.6**  
 Structural Grade: **0**  
 O&M Grade: **1**  
 Clock Start/From: **10**  
 Clock To:  
 1st Value:  
 2nd Value:  
 Value Percent:  
 Continuous Index:  
 Within 8" of Joint: **YES**  
 Remarks:

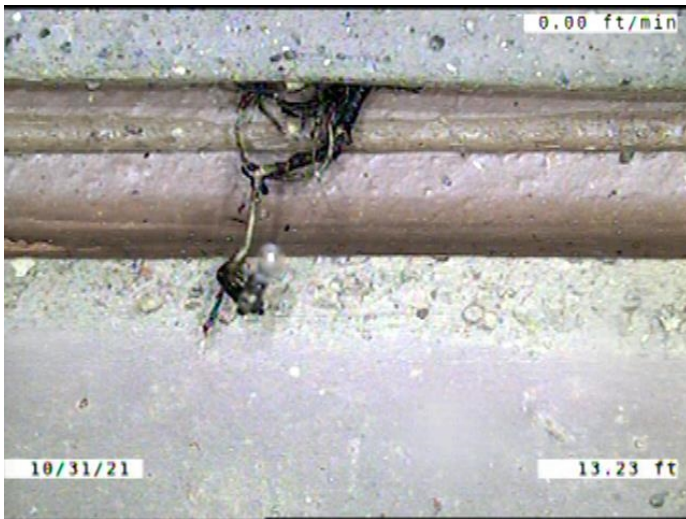
Code: **RFJ**  
 Description: **Roots Fine Joint**

Distance (ft): **13.2**  
 Structural Grade: **0**  
 O&M Grade: **1**  
 Clock Start/From: **9**  
 Clock To: **1**  
 1st Value:  
 2nd Value:  
 Value Percent:  
 Continuous Index:  
 Within 8" of Joint: **YES**  
 Remarks:

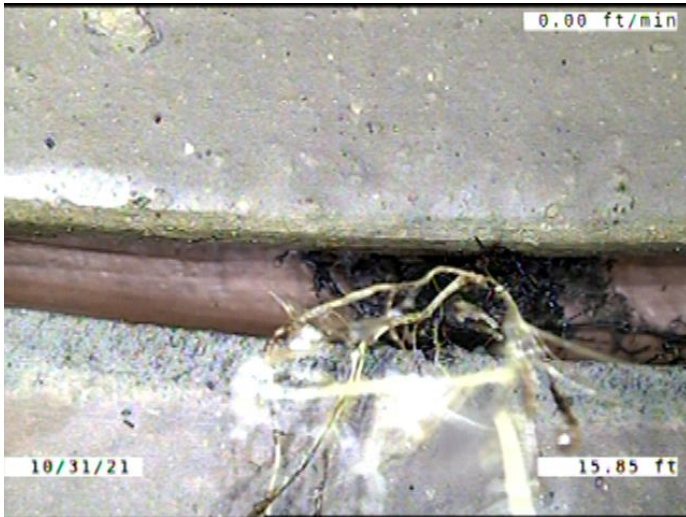
Code: **RFJ**  
 Description: **Roots Fine Joint**

Distance (ft): **15.8**  
 Structural Grade: **0**  
 O&M Grade: **1**  
 Clock Start/From: **10**  
 Clock To: **3**  
 1st Value:  
 2nd Value:  
 Value Percent:  
 Continuous Index:  
 Within 8" of Joint: **YES**  
 Remarks:

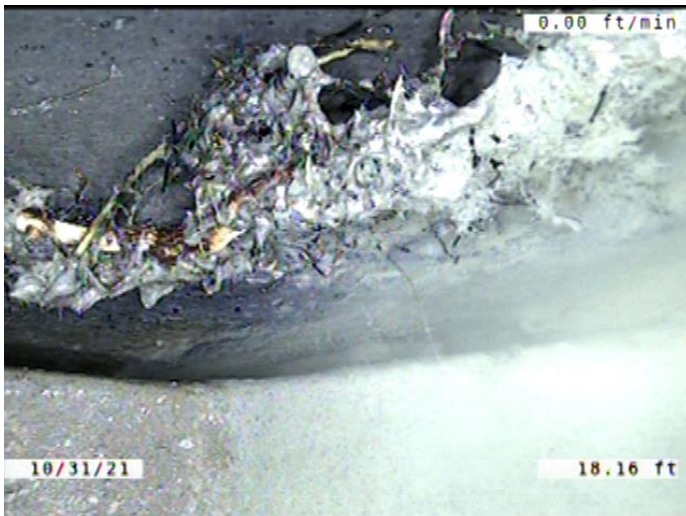
Code: **RFJ**  
 Description: **Roots Fine Joint**

Distance (ft): **18.2**  
 Structural Grade: **0**  
 O&M Grade: **1**  
 Clock Start/From: **4**  
 Clock To: **8**  
 1st Value:  
 2nd Value:  
 Value Percent:  
 Continuous Index:  
 Within 8" of Joint: **YES**  
 Remarks:

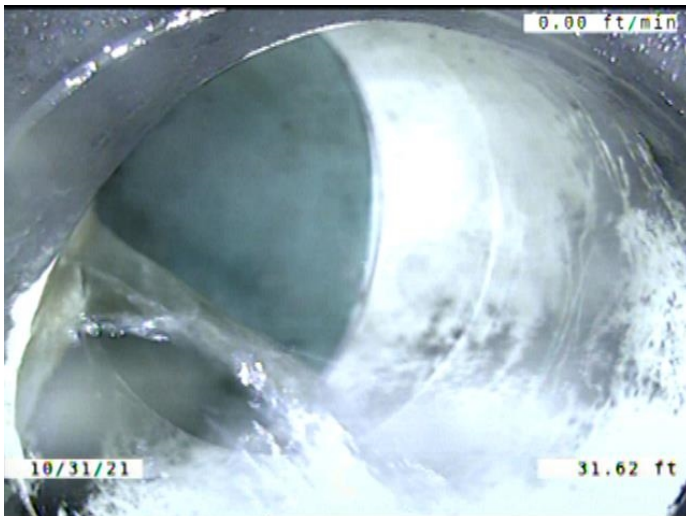
Code: **TBA**  
 Description: **Tap Break-in Activity**

Distance (ft): **31.6**  
 Structural Grade: **0**  
 O&M Grade: **0**  
 Clock Start/From: **11**  
 Clock To:  
 1st Value: **4.000**  
 2nd Value:  
 Value Percent:  
 Continuous Index:  
 Within 8" of Joint: **YES**  
 Remarks:

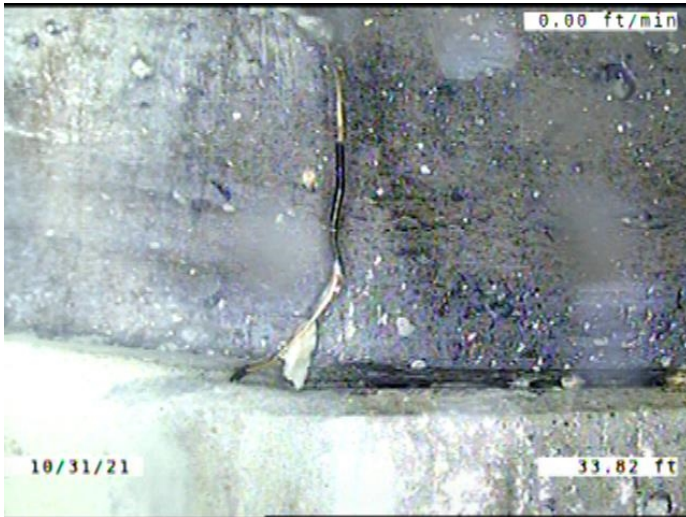
Code: **RFJ**  
 Description: **Roots Fine Joint**

Distance (ft): **33.8**  
 Structural Grade: **0**  
 O&M Grade: **1**  
 Clock Start/From: **4**  
 Clock To: **5**  
 1st Value:  
 2nd Value:  
 Value Percent:  
 Continuous Index:  
 Within 8" of Joint: **YES**  
 Remarks:

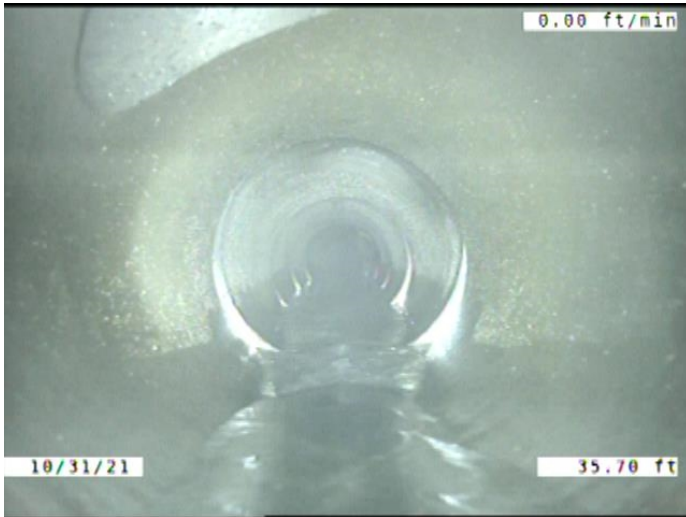
Code: **MWLS**  
 Description: **Miscellaneous Water Level Sag**

Distance (ft): **35.7**  
 Structural Grade: **2**  
 O&M Grade: **0**  
 Clock Start/From:  
 Clock To:  
 1st Value:  
 2nd Value:  
 Value Percent: **10.000**  
 Continuous Index: **F01**  
 Within 8" of Joint: **NO**  
 Remarks:

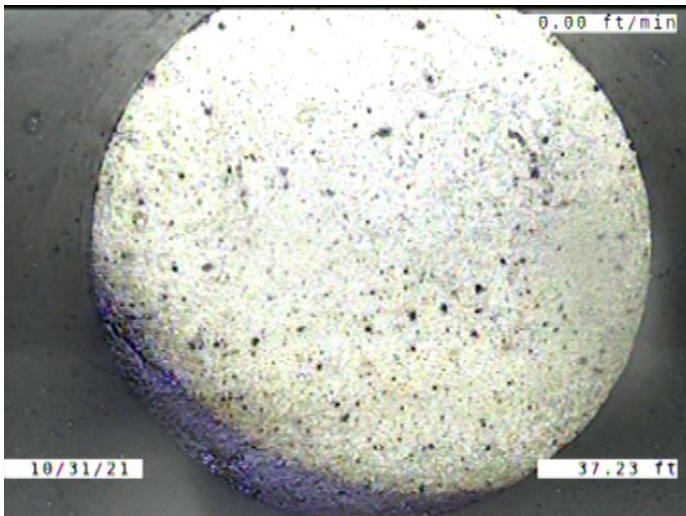
Code: **TFC**  
 Description: **Tap Factory Capped**

Distance (ft): **37.2**  
 Structural Grade: **0**  
 O&M Grade: **0**  
 Clock Start/From: **11**  
 Clock To:  
 1st Value: **4.000**  
 2nd Value:  
 Value Percent:  
 Continuous Index:  
 Within 8" of Joint: **YES**  
 Remarks:

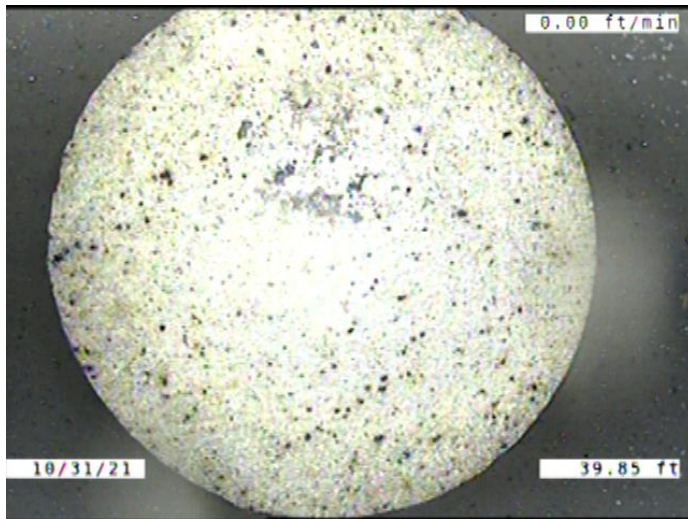
Code: **TFC**  
 Description: **Tap Factory Capped**

Distance (ft): **39.8**  
 Structural Grade: **0**  
 O&M Grade: **0**  
 Clock Start/From: **1**  
 Clock To:  
 1st Value: **4.000**  
 2nd Value:  
 Value Percent:  
 Continuous Index:  
 Within 8" of Joint: **YES**  
 Remarks:

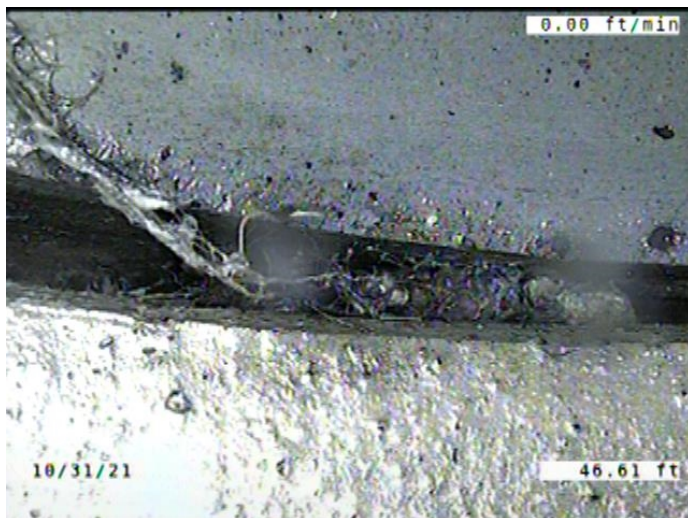
Code: **RFJ**  
 Description: **Roots Fine Joint**

Distance (ft): **46.6**  
 Structural Grade: **0**  
 O&M Grade: **1**  
 Clock Start/From: **2**  
 Clock To: **10**  
 1st Value:  
 2nd Value:  
 Value Percent:  
 Continuous Index:  
 Within 8" of Joint: **YES**  
 Remarks:

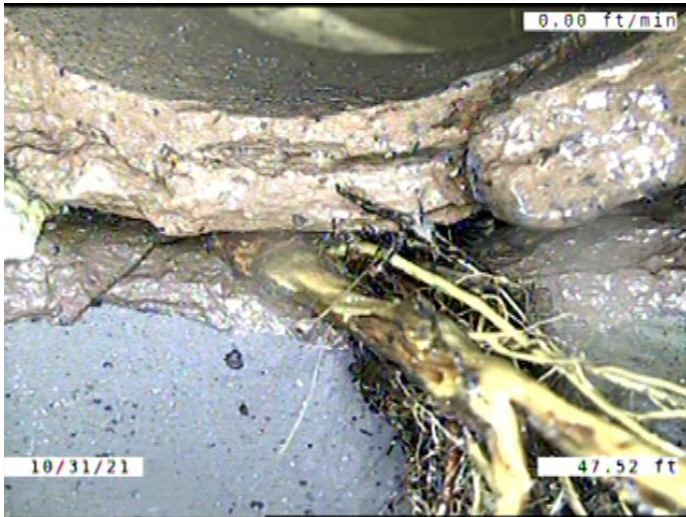
Code: **RFC**  
 Description: **Roots Fine Connection**

Distance (ft): **47.5**  
 Structural Grade: **0**  
 O&M Grade: **1**  
 Clock Start/From: **1**  
 Clock To: **2**  
 1st Value:  
 2nd Value:  
 Value Percent:  
 Continuous Index:  
 Within 8" of Joint: **NO**  
 Remarks:

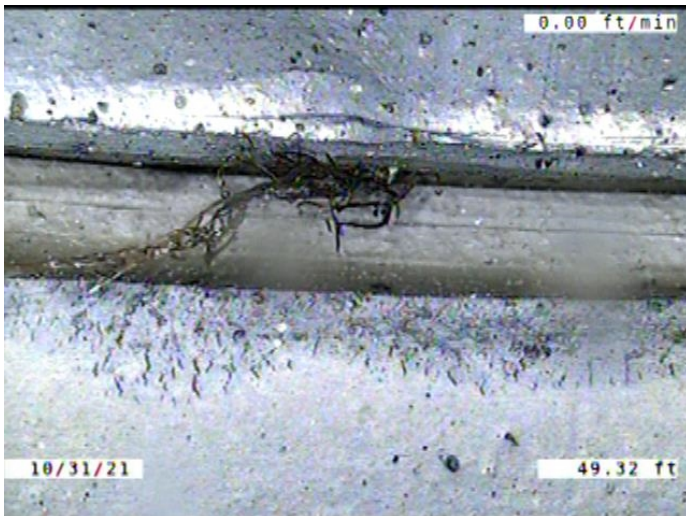
Code: **RFJ**  
 Description: **Roots Fine Joint**

Distance (ft): **49.3**  
 Structural Grade: **0**  
 O&M Grade: **1**  
 Clock Start/From: **11**  
 Clock To:  
 1st Value:  
 2nd Value:  
 Value Percent:  
 Continuous Index:  
 Within 8" of Joint: **YES**  
 Remarks:

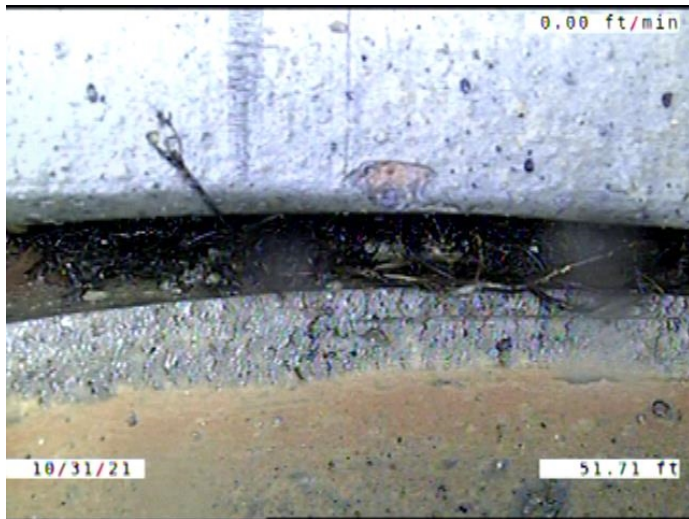
Code: **RFJ**  
 Description: **Roots Fine Joint**

Distance (ft): **51.7**  
 Structural Grade: **0**  
 O&M Grade: **1**  
 Clock Start/From: **10**  
 Clock To: **2**  
 1st Value:  
 2nd Value:  
 Value Percent:  
 Continuous Index:  
 Within 8" of Joint: **YES**  
 Remarks:

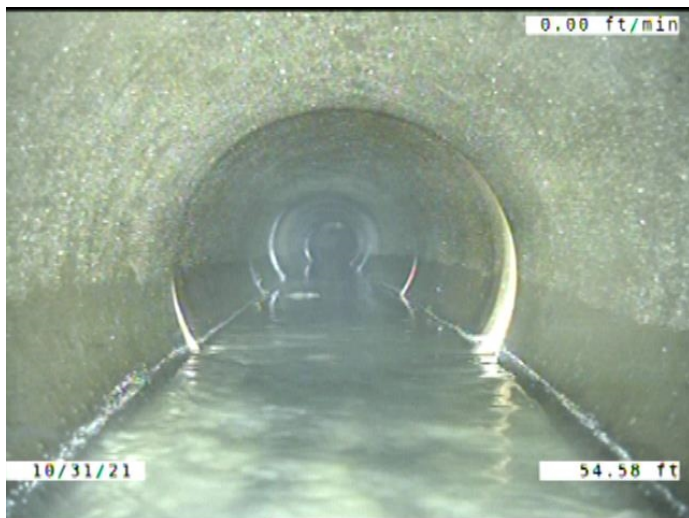
Code: **MWLS**  
 Description: **Miscellaneous Water Level Sag**

Distance (ft): **54.6**  
 Structural Grade: **2**  
 O&M Grade: **0**  
 Clock Start/From:  
 Clock To:  
 1st Value:  
 2nd Value:  
 Value Percent: **10.000**  
 Continuous Index: **S02**  
 Within 8" of Joint: **NO**  
 Remarks:

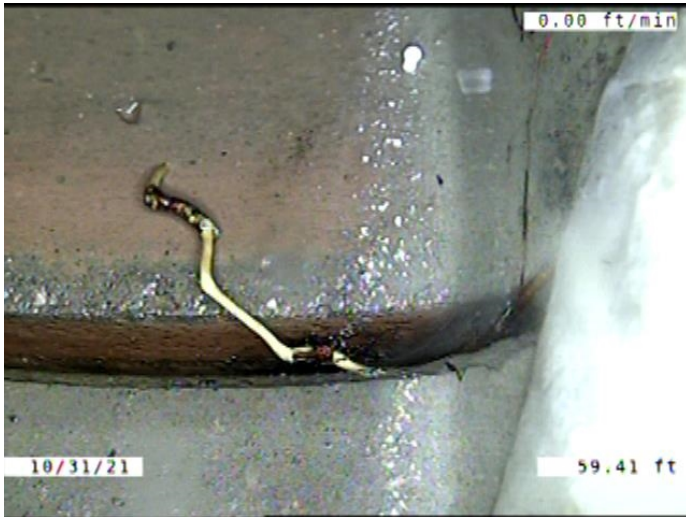
Code: **RFJ**  
 Description: **Roots Fine Joint**

Distance (ft): **59.4**  
 Structural Grade: **0**  
 O&M Grade: **1**  
 Clock Start/From: **8**  
 Clock To:  
 1st Value:  
 2nd Value:  
 Value Percent:  
 Continuous Index:  
 Within 8" of Joint: **YES**  
 Remarks:

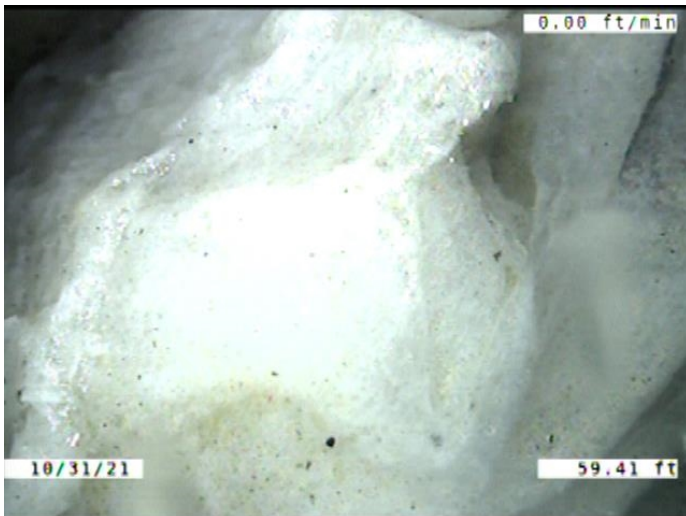
Code: **DAR**  
 Description: **Deposits Attached Ragging**

Distance (ft): **59.4**  
 Structural Grade: **0**  
 O&M Grade: **2**  
 Clock Start/From: **7**  
 Clock To:  
 1st Value:  
 2nd Value:  
 Value Percent: **5.000**  
 Continuous Index:  
 Within 8" of Joint: **YES**  
 Remarks:

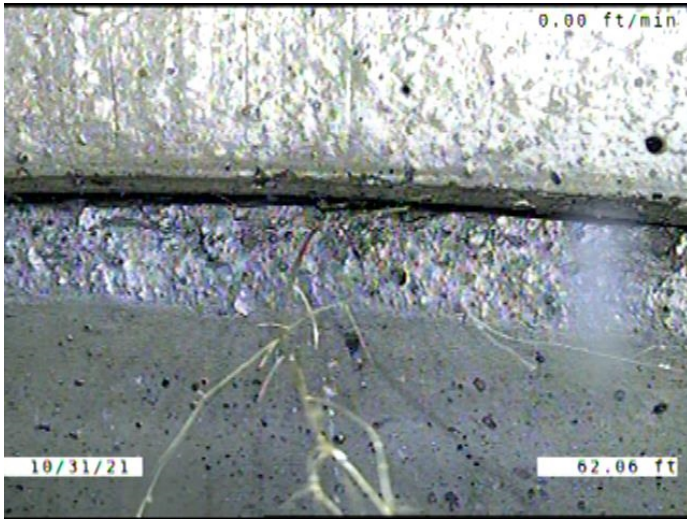
Code: **RFJ**  
Description: **Roots Fine Joint**

Distance (ft): **62.1**  
Structural Grade: **0**  
O&M Grade: **1**  
Clock Start/From: **2**  
Clock To:  
1st Value:  
2nd Value:  
Value Percent:  
Continuous Index:  
Within 8" of Joint: **YES**  
Remarks:

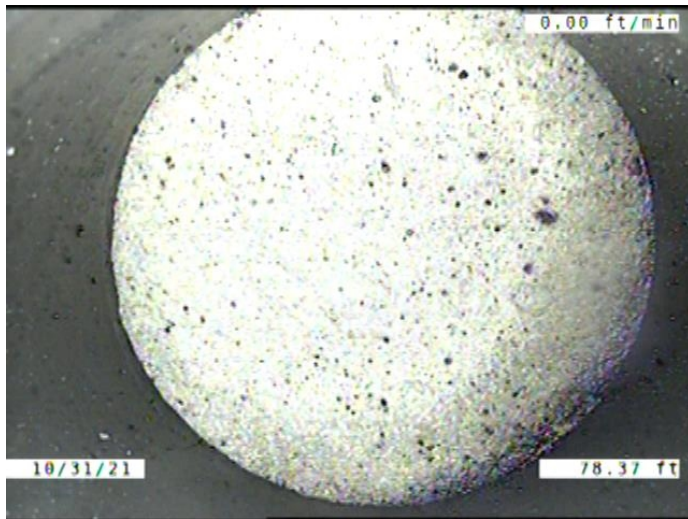
Code: **TFC**  
 Description: **Tap Factory Capped**

Distance (ft): **78.4**  
 Structural Grade: **0**  
 O&M Grade: **0**  
 Clock Start/From: **11**  
 Clock To:  
 1st Value: **4.000**  
 2nd Value:  
 Value Percent:  
 Continuous Index:  
 Within 8" of Joint: **YES**  
 Remarks:

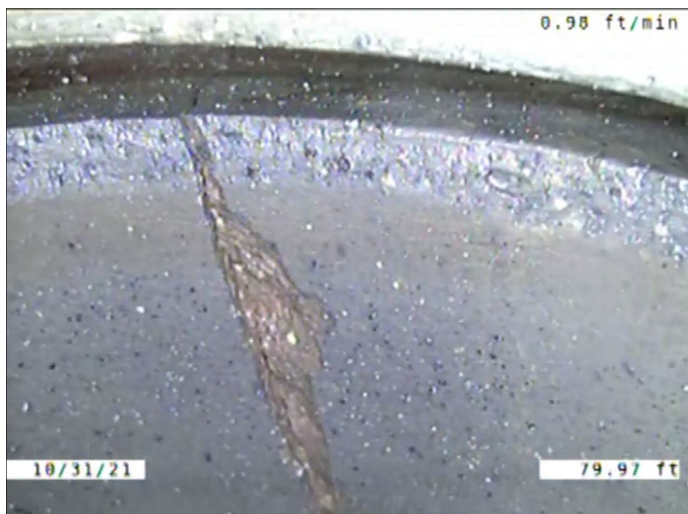
Code: **SSS**  
 Description: **Surface Damage Surface Spalling**

Distance (ft): **80.0**  
 Structural Grade: **2**  
 O&M Grade: **0**  
 Clock Start/From: **3**  
 Clock To:  
 1st Value:  
 2nd Value:  
 Value Percent:  
 Continuous Index:  
 Within 8" of Joint: **YES**  
 Remarks:

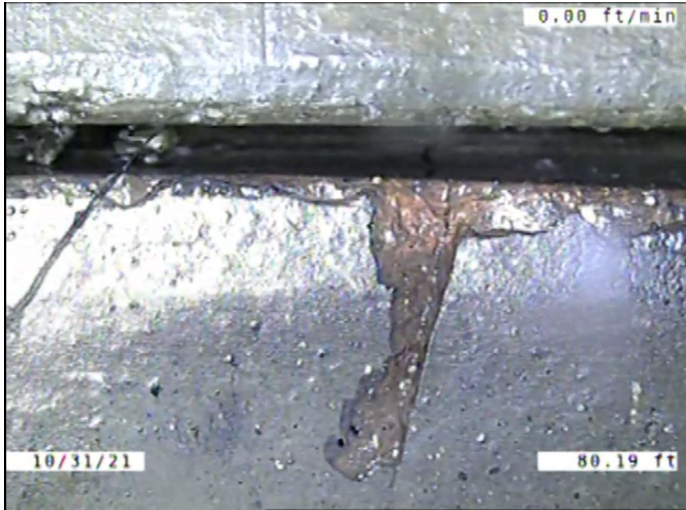
Code: **SSS**  
Description: **Surface Damage Surface Spalling**

Distance (ft): **80.2**  
Structural Grade: **2**  
O&M Grade: **0**  
Clock Start/From: **9**  
Clock To:  
1st Value:  
2nd Value:  
Value Percent:  
Continuous Index:  
Within 8" of Joint: **YES**  
Remarks:

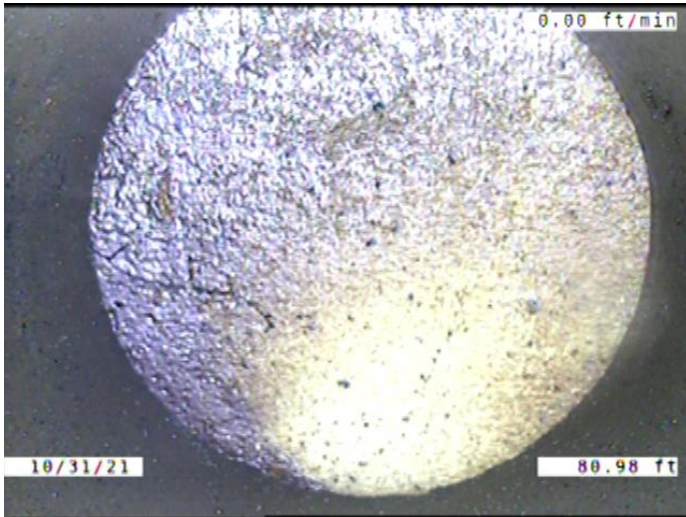
Code: **TFC**  
 Description: **Tap Factory Capped**

Distance (ft): **81.0**  
 Structural Grade: **0**  
 O&M Grade: **0**  
 Clock Start/From: **1**  
 Clock To:  
 1st Value: **4.000**  
 2nd Value:  
 Value Percent:  
 Continuous Index:  
 Within 8" of Joint: **YES**  
 Remarks:

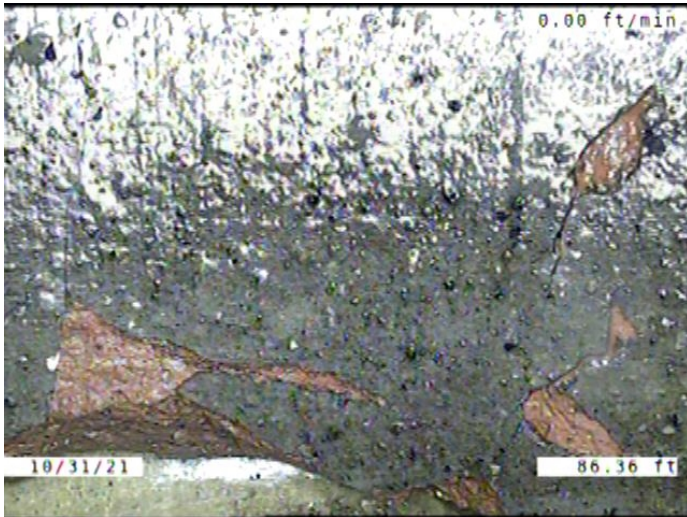
Code: **SSS**  
 Description: **Surface Damage Surface Spalling**

Distance (ft): **86.3**  
 Structural Grade: **2**  
 O&M Grade: **0**  
 Clock Start/From: **1**  
 Clock To: **3**  
 1st Value:  
 2nd Value:  
 Value Percent:  
 Continuous Index:  
 Within 8" of Joint: **YES**  
 Remarks:

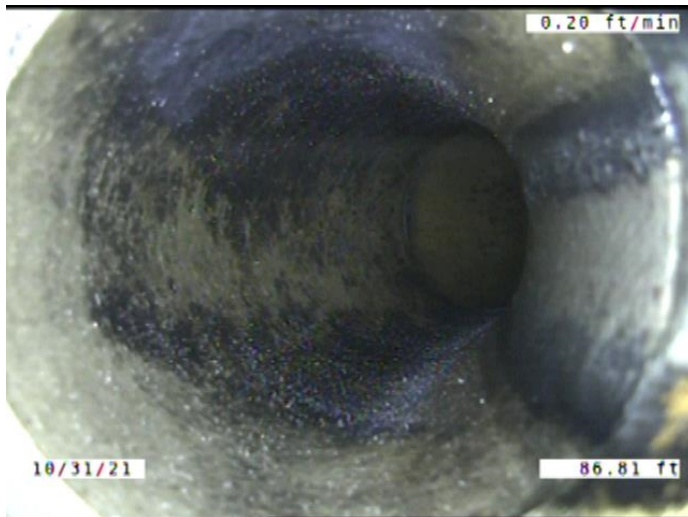
Code: **TBI**  
 Description: **Tap Break-in Intruding**

Distance (ft): **86.8**  
 Structural Grade: **0**  
 O&M Grade: **2**  
 Clock Start/From: **1**  
 Clock To:  
 1st Value: **4.000**  
 2nd Value: **1.000**  
 Value Percent:  
 Continuous Index:  
 Within 8" of Joint: **YES**  
 Remarks:

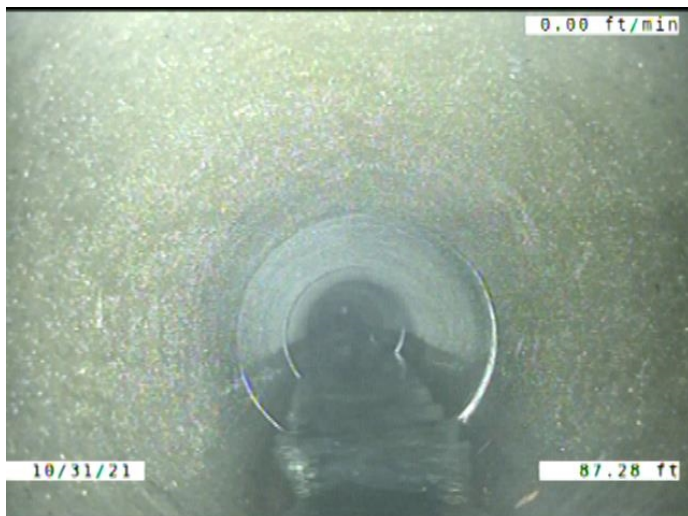
Code: **MWLS**  
 Description: **Miscellaneous Water Level Sag**

Distance (ft): **87.3**  
 Structural Grade: **2**  
 O&M Grade: **0**  
 Clock Start/From:  
 Clock To:  
 1st Value:  
 2nd Value:  
 Value Percent: **10.000**  
 Continuous Index: **F02**  
 Within 8" of Joint: **NO**  
 Remarks:

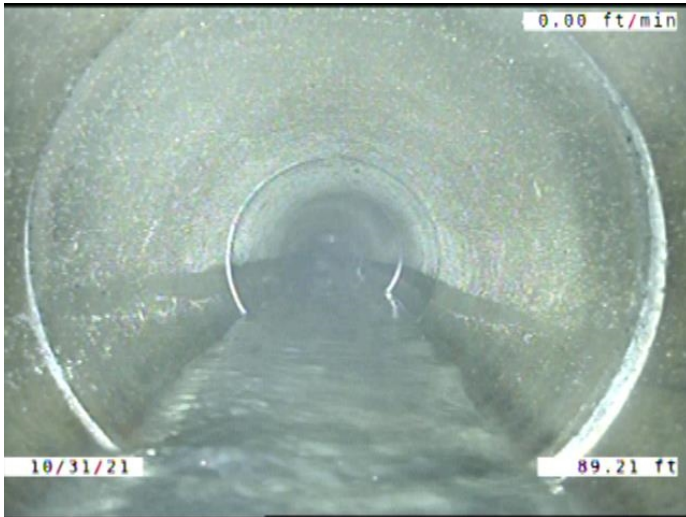
Code: **MWLS**  
 Description: **Miscellaneous Water Level Sag**

Distance (ft): **89.2**  
 Structural Grade: **2**  
 O&M Grade: **0**  
 Clock Start/From:  
 Clock To:  
 1st Value:  
 2nd Value:  
 Value Percent: **10.000**  
 Continuous Index: **S03**  
 Within 8" of Joint: **NO**  
 Remarks:

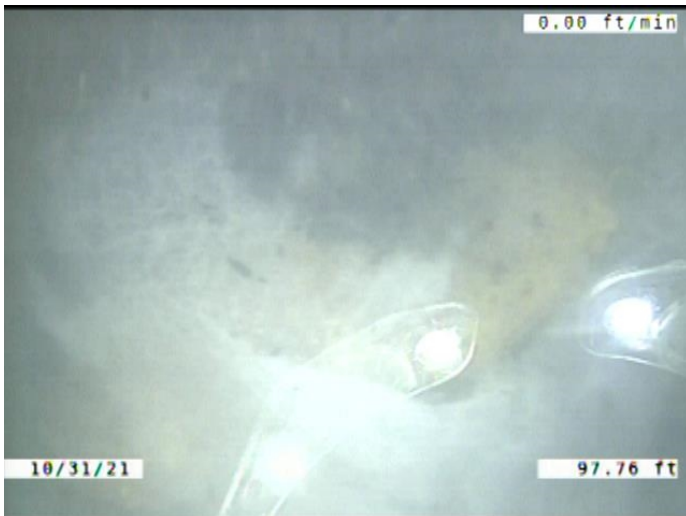
Code: **OBM**  
 Description: **Obstruction Pipe Material in Invert**

Distance (ft): **97.8**  
 Structural Grade: **0**  
 O&M Grade: **2**  
 Clock Start/From: **5**  
 Clock To: **7**  
 1st Value:  
 2nd Value:  
 Value Percent: **5.000**  
 Continuous Index:  
 Within 8" of Joint: **YES**  
 Remarks:

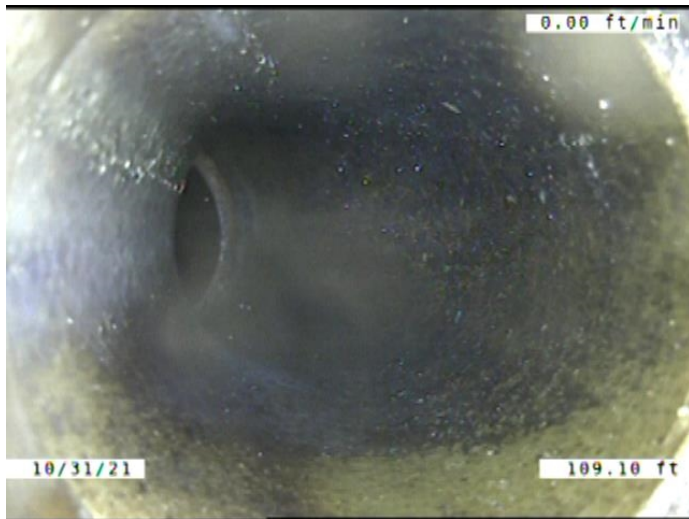
Code: **TBI**  
Description: **Tap Break-in Intruding**

Distance (ft): **109.1**  
Structural Grade: **0**  
O&M Grade: **2**  
Clock Start/From: **12**  
Clock To:  
1st Value: **4.000**  
2nd Value: **1.000**  
Value Percent:  
Continuous Index:  
Within 8" of Joint: **YES**  
Remarks:

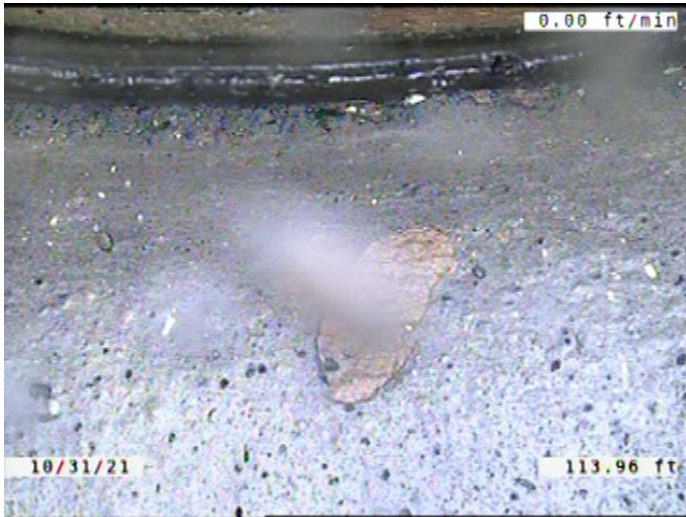
Code: **SSS**  
Description: **Surface Damage Surface Spalling**

Distance (ft): **114.0**  
Structural Grade: **2**  
O&M Grade: **0**  
Clock Start/From: **1**  
Clock To:  
1st Value:  
2nd Value:  
Value Percent:  
Continuous Index:  
Within 8" of Joint: **YES**  
Remarks:

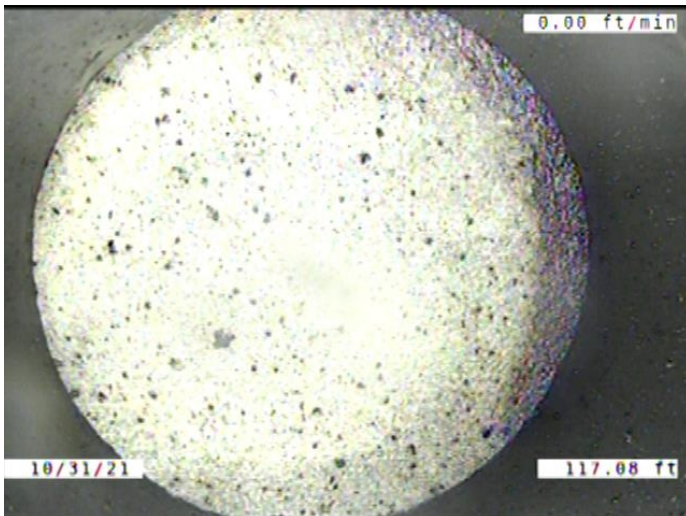
Code: **TFC**  
Description: **Tap Factory Capped**

Distance (ft): **117.1**  
Structural Grade: **0**  
O&M Grade: **0**  
Clock Start/From: **11**  
Clock To:  
1st Value: **4.000**  
2nd Value:  
Value Percent:  
Continuous Index:  
Within 8" of Joint: **YES**  
Remarks:

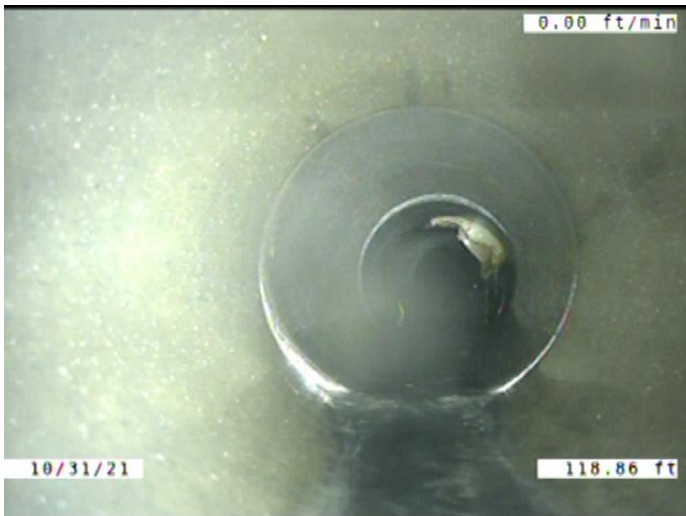
Code: **MWLS**  
 Description: **Miscellaneous Water Level Sag**

Distance (ft): **118.9**  
 Structural Grade: **2**  
 O&M Grade: **0**  
 Clock Start/From:  
 Clock To:  
 1st Value:  
 2nd Value:  
 Value Percent: **10.000**  
 Continuous Index: **F03**  
 Within 8" of Joint: **NO**  
 Remarks:

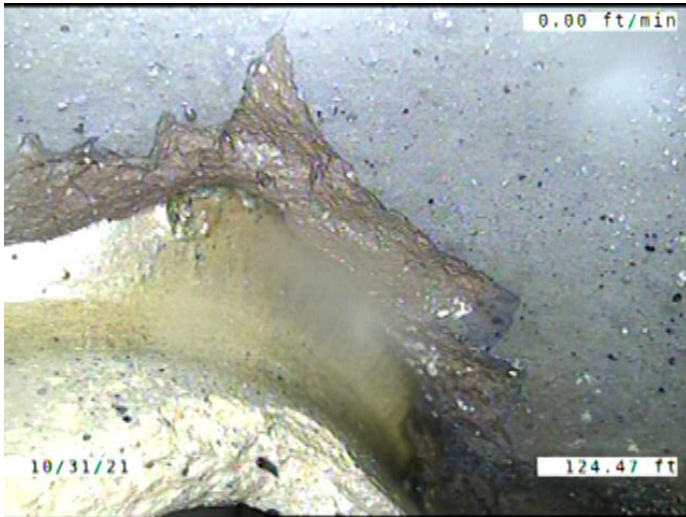
Code: **SSS**  
 Description: **Surface Damage Surface Spalling**

Distance (ft): **124.5**  
 Structural Grade: **2**  
 O&M Grade: **0**  
 Clock Start/From: **11**  
 Clock To: **2**  
 1st Value:  
 2nd Value:  
 Value Percent:  
 Continuous Index:  
 Within 8" of Joint: **YES**  
 Remarks:

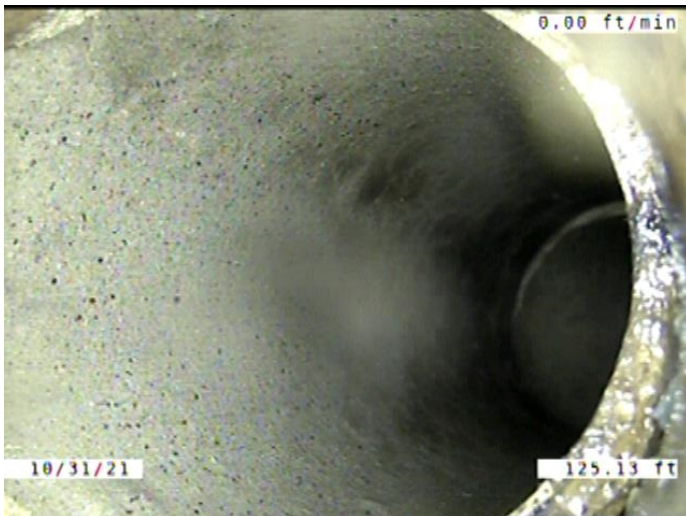
Code: **TBI**  
 Description: **Tap Break-in Intruding**

Distance (ft): **125.1**  
 Structural Grade: **0**  
 O&M Grade: **2**  
 Clock Start/From: **1**  
 Clock To:  
 1st Value: **4.000**  
 2nd Value: **3.000**  
 Value Percent:  
 Continuous Index:  
 Within 8" of Joint: **YES**  
 Remarks:

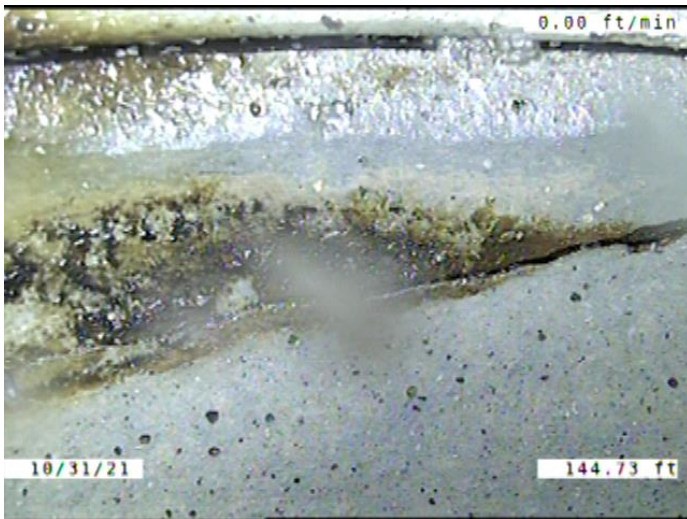
Code: **ISB**  
 Description: **Infiltration Stain Barrel**

Distance (ft): **144.7**  
 Structural Grade: **0**  
 O&M Grade: **1**  
 Clock Start/From: **8**  
 Clock To: **10**  
 1st Value:  
 2nd Value:  
 Value Percent:  
 Continuous Index:  
 Within 8" of Joint: **YES**  
 Remarks:

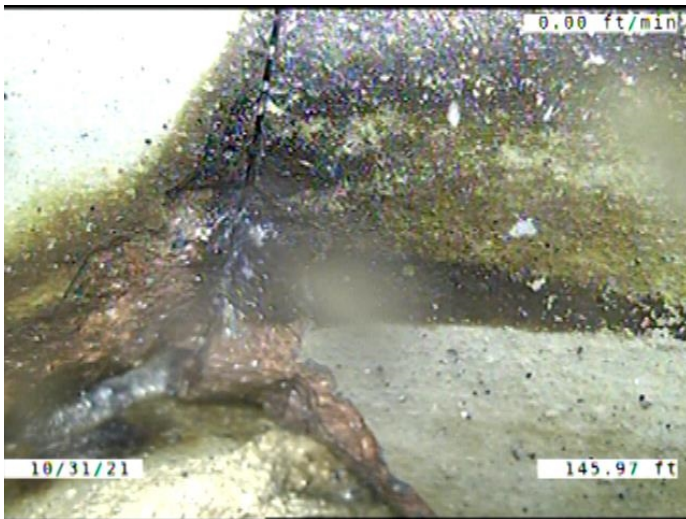
Code: **ISB**  
Description: **Infiltration Stain Barrel**

Distance (ft): **146.0**  
Structural Grade: **0**  
O&M Grade: **1**  
Clock Start/From: **8**  
Clock To: **4**  
1st Value:  
2nd Value:  
Value Percent:  
Continuous Index:  
Within 8" of Joint: **YES**  
Remarks:

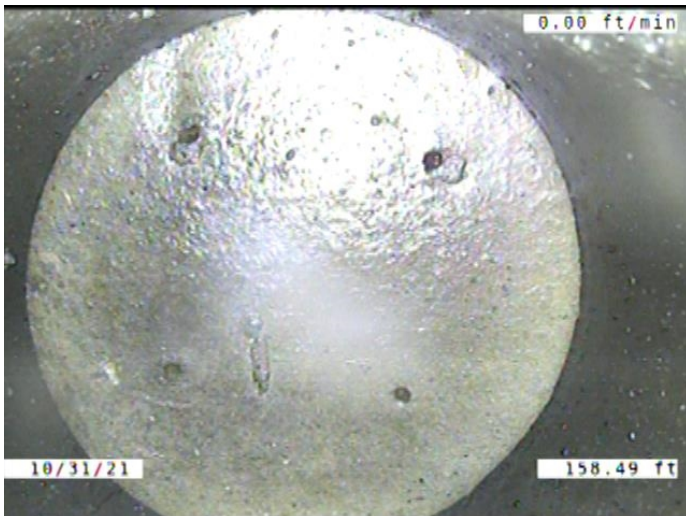
Code: **FM**  
Description: **Fracture Multiple**

Distance (ft): **157.6**  
Structural Grade: **4**  
O&M Grade: **0**  
Clock Start/From: **10**  
Clock To: **4**  
1st Value:  
2nd Value:  
Value Percent:  
Continuous Index:  
Within 8" of Joint: **YES**  
Remarks:

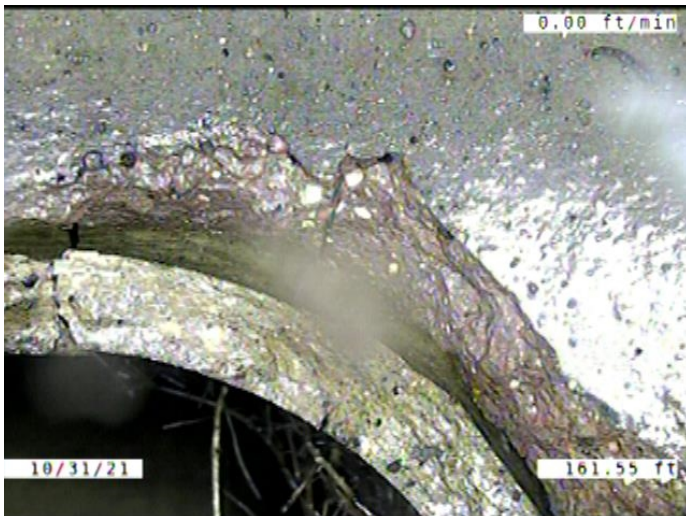
Code:	TFD
Description:	Tap Factory Defective
Distance (ft):	161.0
Structural Grade:	0
O&M Grade:	3
Clock Start/From:	11
Clock To:	
1st Value:	4.000
2nd Value:	
Value Percent:	
Continuous Index:	
Within 8" of Joint:	YES
Remarks:	A PIECE CHIPPED OUT TAP CRACKED. ROOTS GROWING AROUND THE CAP
