Profile/Photo Observation Report

Date:	10/31/2021	Weather:		Coding:	PACP 7.0
Pipe Length (ft):	197.3	Owner:	City of Hobart	Pre Clean:	Heavy Cleaning
P.O.#:	YES502259	Surveyor:	S. Bucklin	PSR:	P-504-037-036
Customer:	City of Hobart	Clean Date:	10/26/2021	Shape:	C

Street:	North Cavender Street	Flow Control:	Not Controlled
City:	Hobart, IN	Year Renewed:	
Location:	Alley	Tape/Media #:	
Purpose:	Routine Assessment	Dia/Height:	10"
Use:	Sanitary Sewage Pipe	Material:	VCP
Drain Area:		Lining:	None
Category:	NA		
Comment:			
Location Details:		Direction of Survey:	Downstream
US MH:	M-504-036	DS MH:	M-504-037
		Total Length Surveyed (ft):	197.3

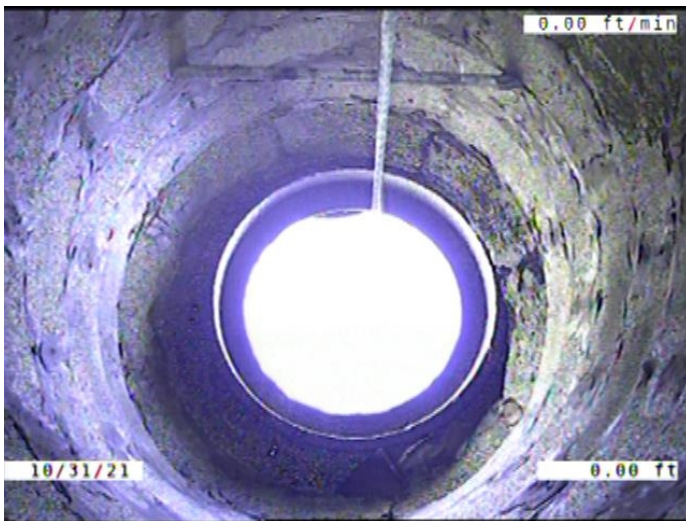
Code: **AMH**
Description: **Manhole**

Distance (ft): **.0**
Structural Grade: **0**
O&M Grade: **0**
Clock Start/From:
Clock To:
1st Value:
2nd Value:
Value Percent:
Continuous Index:
Within 8" of Joint: **NO**
Remarks: **M-504-036**

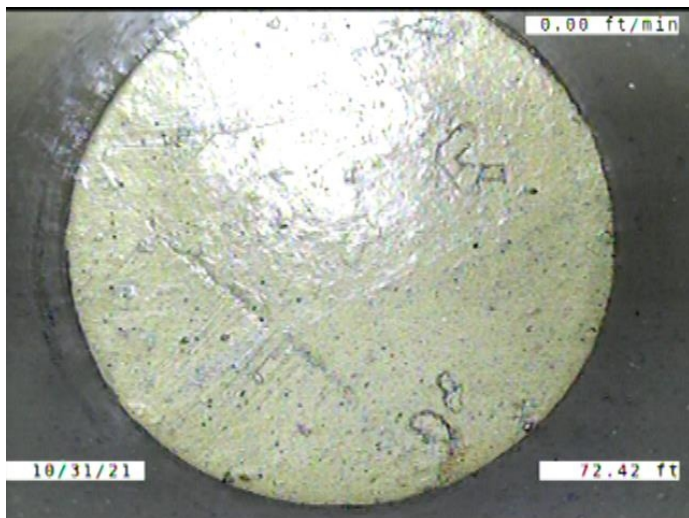
Code: **TFC**
Description: **Tap Factory Capped**

Distance (ft): **72.4**
Structural Grade: **0**
O&M Grade: **0**
Clock Start/From: **11**
Clock To:
1st Value: **4.000**
2nd Value:
Value Percent:
Continuous Index:
Within 8" of Joint: **YES**
Remarks:

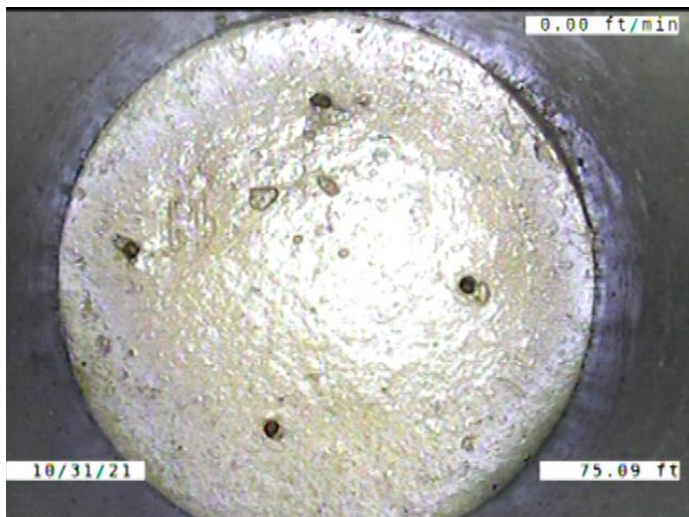
Code: **TFC**
 Description: **Tap Factory Capped**

Distance (ft): **75.1**
 Structural Grade: **0**
 O&M Grade: **0**
 Clock Start/From: **1**
 Clock To:
 1st Value: **4.000**
 2nd Value:
 Value Percent:
 Continuous Index:
 Within 8" of Joint: **YES**
 Remarks:

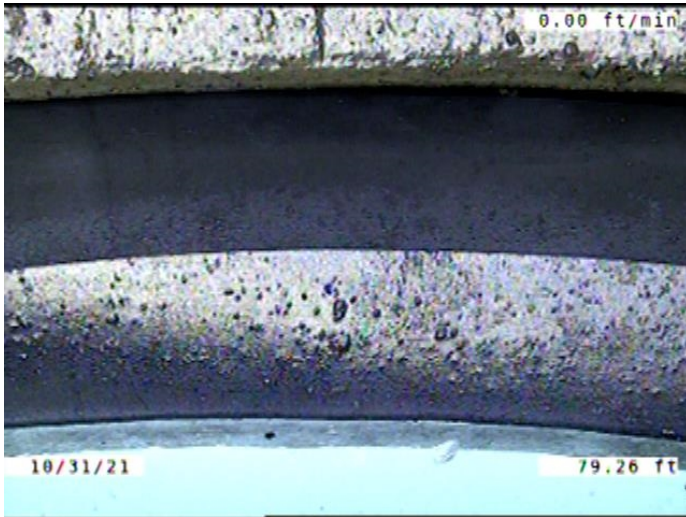
Code: **MMC**
Description: **Miscellaneous Material Change**

Distance (ft): **79.3**
Structural Grade: **0**
O&M Grade: **0**
Clock Start/From:
Clock To:
1st Value:
2nd Value:
Value Percent:
Continuous Index:
Within 8" of Joint: **NO**
Remarks: **VCP TO PVC**

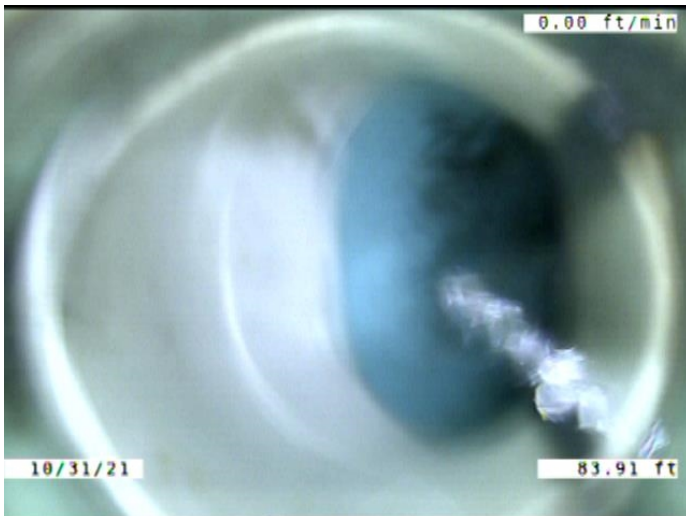
Code: **TF**
Description: **Tap Factory**

Distance (ft): **83.9**
Structural Grade: **0**
O&M Grade: **0**
Clock Start/From: **1**
Clock To:
1st Value: **4.000**
2nd Value:
Value Percent:
Continuous Index:
Within 8" of Joint: **YES**
Remarks: **CONSTANTLY RUNNING WATER.**

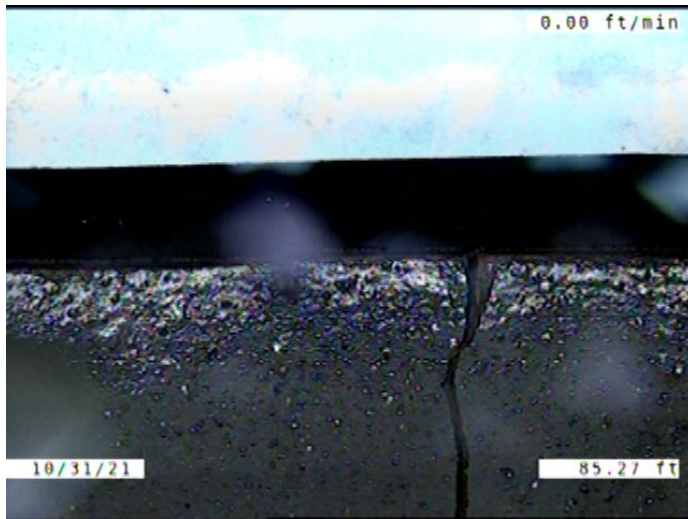
Code: **MMC**
 Description: **Miscellaneous Material Change**

Distance (ft): **85.3**
 Structural Grade: **0**
 O&M Grade: **0**
 Clock Start/From:
 Clock To:
 1st Value:
 2nd Value:
 Value Percent:
 Continuous Index:
 Within 8" of Joint: **NO**
 Remarks: **PVC TO VCP**

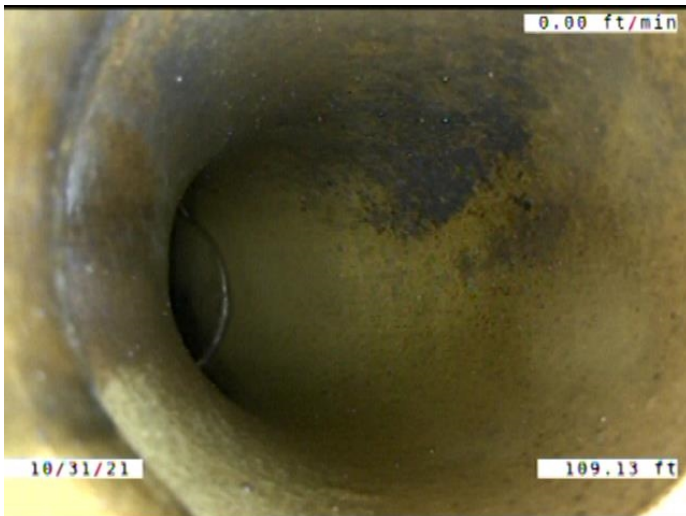
Code: **TBI**
Description: **Tap Break-in Intruding**

Distance (ft): **109.1**
Structural Grade: **0**
O&M Grade: **2**
Clock Start/From: **11**
Clock To:
1st Value: **4.000**
2nd Value: **1.000**
Value Percent:
Continuous Index:
Within 8" of Joint: **YES**
Remarks: **CONSTANTLY RUNNING WATER.**

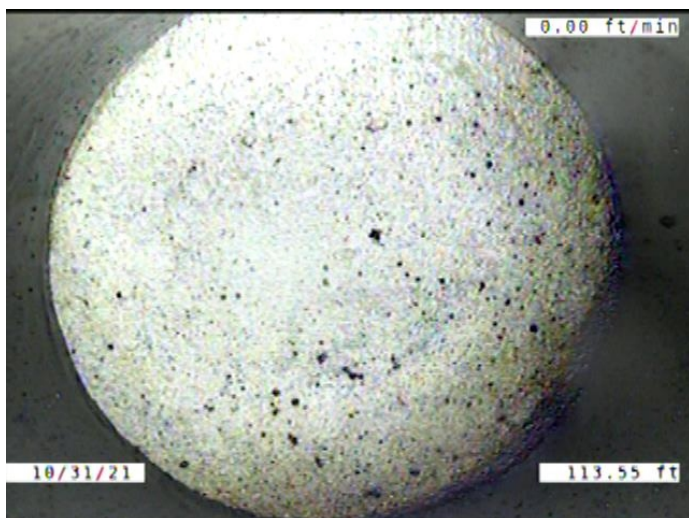
Code: **TFC**
 Description: **Tap Factory Capped**

Distance (ft): **113.5**
 Structural Grade: **0**
 O&M Grade: **0**
 Clock Start/From: **11**
 Clock To:
 1st Value: **4.000**
 2nd Value:
 Value Percent:
 Continuous Index:
 Within 8" of Joint: **YES**
 Remarks:

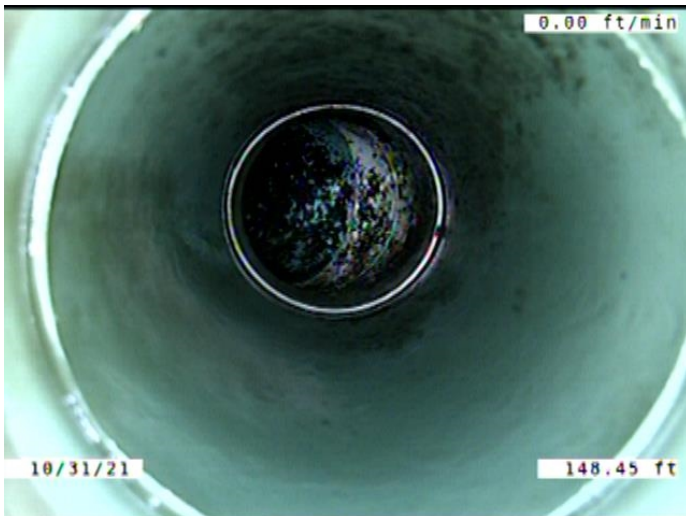
Code: **TF**
 Description: **Tap Factory**

Distance (ft): **148.5**
 Structural Grade: **0**
 O&M Grade: **0**
 Clock Start/From: **11**
 Clock To:
 1st Value: **4.000**
 2nd Value:
 Value Percent:
 Continuous Index:
 Within 8" of Joint: **YES**
 Remarks:

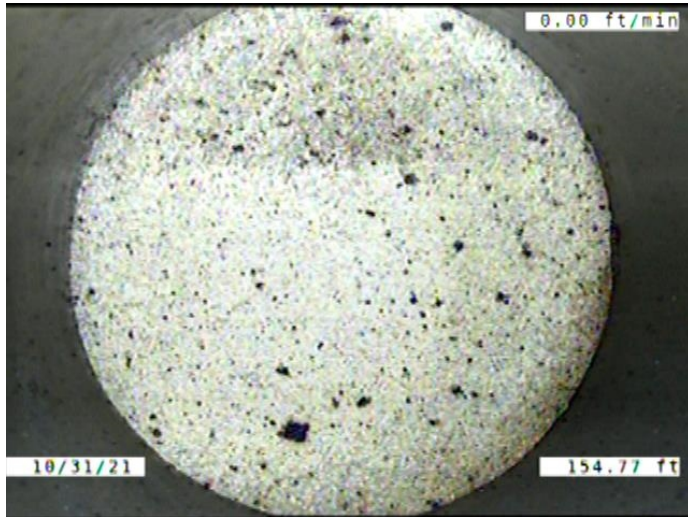
Code: **TFC**
 Description: **Tap Factory Capped**

Distance (ft): **154.8**
 Structural Grade: **0**
 O&M Grade: **0**
 Clock Start/From: **11**
 Clock To:
 1st Value: **4.000**
 2nd Value:
 Value Percent:
 Continuous Index:
 Within 8" of Joint: **YES**
 Remarks:

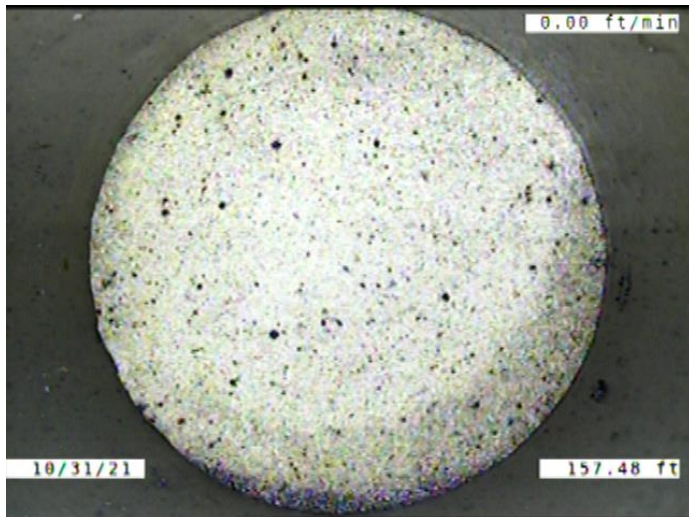
Code: **TFC**
 Description: **Tap Factory Capped**

Distance (ft): **157.5**
 Structural Grade: **0**
 O&M Grade: **0**
 Clock Start/From: **1**
 Clock To:
 1st Value: **4.000**
 2nd Value:
 Value Percent:
 Continuous Index:
 Within 8" of Joint: **YES**
 Remarks:

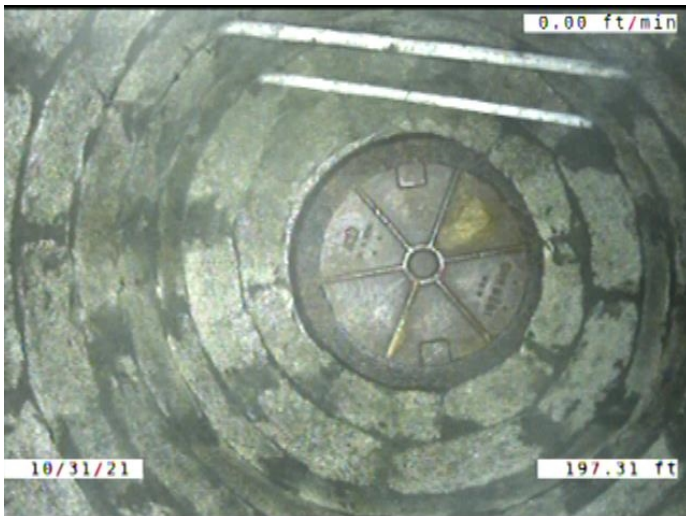
Code: **AMH**
 Description: **Manhole**

Distance (ft): **197.3**
 Structural Grade: **0**
 O&M Grade: **0**
 Clock Start/From:
 Clock To:
 1st Value:
 2nd Value:
 Value Percent:
 Continuous Index:
 Within 8" of Joint: **NO**
 Remarks: **M-504-037**
