# Profile/Photo Observation Report

Date:	<b>10/31/2021</b>	Weather:		Coding:	<b>PACP 7.0</b>
Pipe Length (ft):	<b>197.3</b>	Owner:	<b>City of Hobart</b>	Pre Clean:	<b>Heavy Cleaning</b>
P.O.#:	<b>YES502259</b>	Surveyor:	<b>S. Bucklin</b>	PSR:	<b>P-504-037-036</b>
Customer:	<b>City of Hobart</b>	Clean Date:	<b>10/26/2021</b>	Shape:	<b>C</b>

Street:	<b>North Cavender Street</b>	Flow Control:	<b>Not Controlled</b>
City:	<b>Hobart, IN</b>	Year Renewed:	
Location:	<b>Alley</b>	Tape/Media #:	
Purpose:	<b>Routine Assessment</b>	Dia/Height:	<b>10"</b>
Use:	<b>Sanitary Sewage Pipe</b>	Material:	<b>VCP</b>
Drain Area:		Lining:	<b>None</b>
Category:	<b>NA</b>		
Comment:			
Location Details:		Direction of Survey:	<b>Downstream</b>
US MH:	<b>M-504-036</b>	DS MH:	<b>M-504-037</b>
		Total Length Surveyed (ft):	<b>197.3</b>

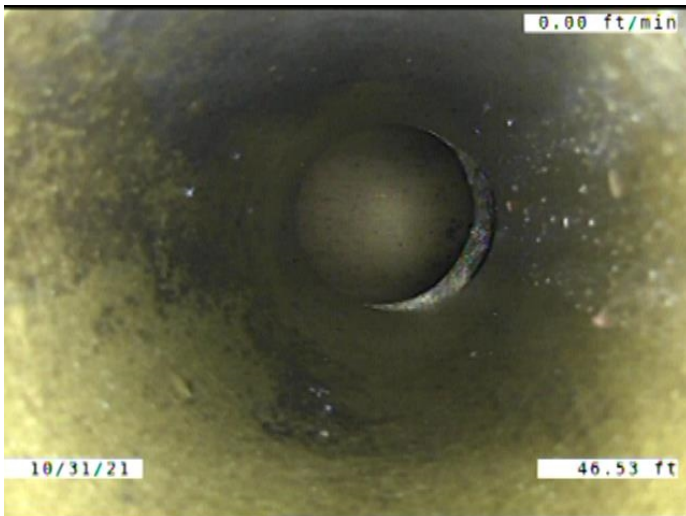
Code: **RFB**  
 Description: **Roots Fine Barrel**

Distance (ft): **46.2**  
 Structural Grade: **0**  
 O&M Grade: **2**  
 Clock Start/From: **11**  
 Clock To: **1**  
 1st Value:  
 2nd Value:  
 Value Percent:  
 Continuous Index:  
 Within 8" of Joint: **NO**  
 Remarks:

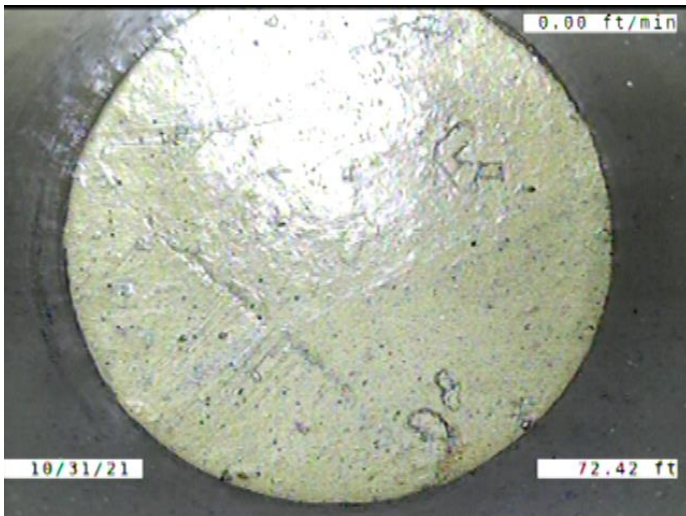
Code: **TBI**  
 Description: **Tap Break-in Intruding**

Distance (ft): **67.2**  
 Structural Grade: **0**  
 O&M Grade: **2**  
 Clock Start/From: **11**  
 Clock To:  
 1st Value: **4.000**  
 2nd Value: **1.000**  
 Value Percent:  
 Continuous Index:  
 Within 8" of Joint: **YES**  
 Remarks: **CONSTANTLY RUNNING WATER.**

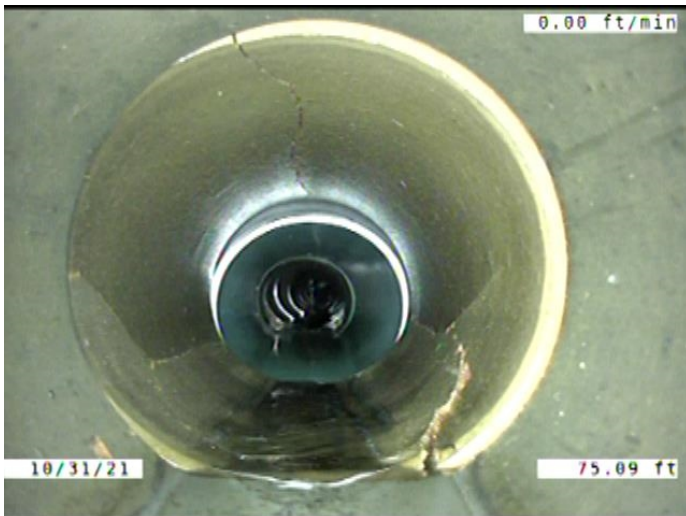
Code: **TFC**  
 Description: **Tap Factory Capped**

Distance (ft): **75.1**  
 Structural Grade: **0**  
 O&M Grade: **0**  
 Clock Start/From: **1**  
 Clock To:  
 1st Value: **4.000**  
 2nd Value:  
 Value Percent:  
 Continuous Index:  
 Within 8" of Joint: **YES**  
 Remarks:

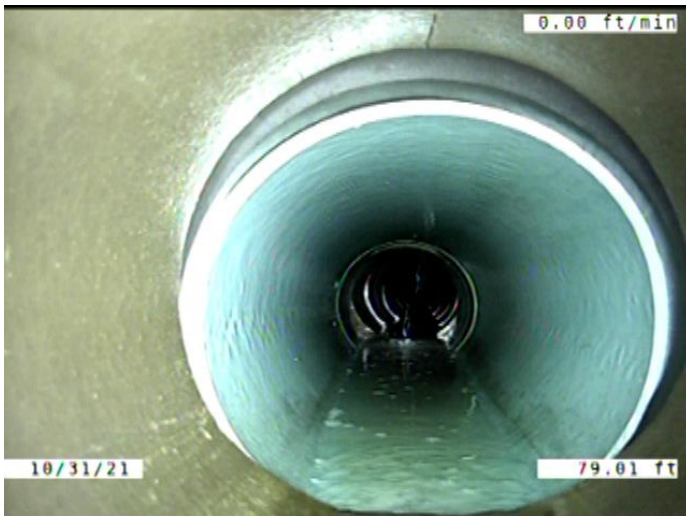
Code: **B**  
 Description: **Broken**

Distance (ft): **76.6**  
 Structural Grade: **4**  
 O&M Grade: **0**  
 Clock Start/From: **12**  
 Clock To: **12**  
 1st Value:  
 2nd Value:  
 Value Percent:  
 Continuous Index:  
 Within 8" of Joint: **YES**  
 Remarks:
