Profile/Photo Observation Report

Date:	11/02/2021	Weather:		Coding:	PACP 7.0
Pipe Length (ft):	213.2	Owner:	City of Hobart	Pre Clean:	Heavy Cleaning
P.O.#:	YES502259	Surveyor:	S. Bucklin	PSR:	P-504-039-038
Customer:	City of Hobart	Clean Date:	10/28/2021	Shape:	C

Street:	North Colorado Street	Flow Control:	Not Controlled
City:	Hobart, IN	Year Renewed:	
Location:	Alley	Tape/Media #:	
Purpose:	Routine Assessment	Dia/Height:	10"
Use:	Sanitary Sewage Pipe	Material:	VCP
Drain Area:		Lining:	None
Category:	NA		
Comment:			
Location Details:		Direction of Survey:	Downstream
US MH:	M-504-038	DS MH:	M-504-039
		Total Length Surveyed (ft):	213.2

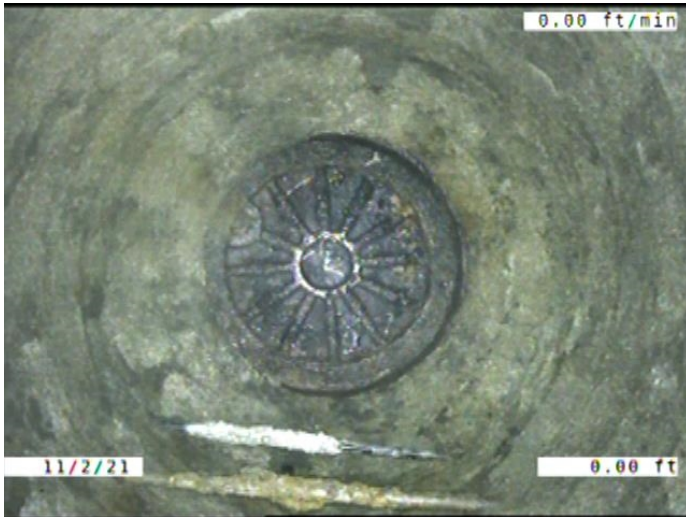
Code: **AMH**
 Description: **Manhole**

Distance (ft): **.0**
 Structural Grade: **0**
 O&M Grade: **0**
 Clock Start/From:
 Clock To:
 1st Value:
 2nd Value:
 Value Percent:
 Continuous Index:
 Within 8" of Joint: **NO**
 Remarks: **M-504-038**

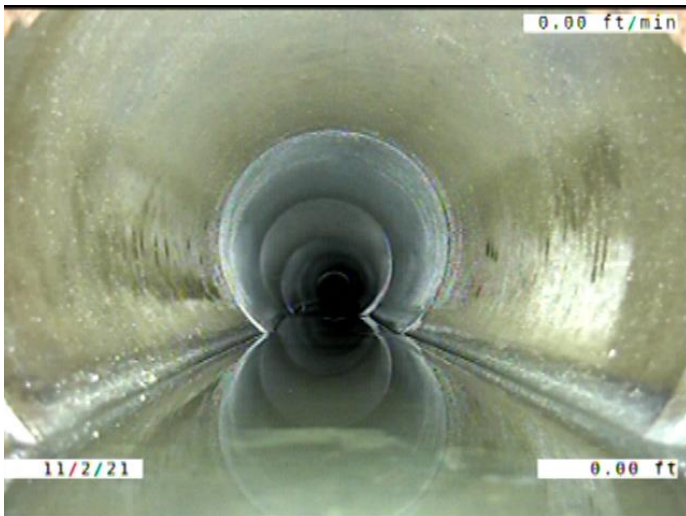
Code: **MWL**
 Description: **Miscellaneous Water Level**

Distance (ft): **.0**
 Structural Grade: **0**
 O&M Grade: **0**
 Clock Start/From:
 Clock To:
 1st Value:
 2nd Value:
 Value Percent: **5.000**
 Continuous Index:
 Within 8" of Joint: **NO**
 Remarks:

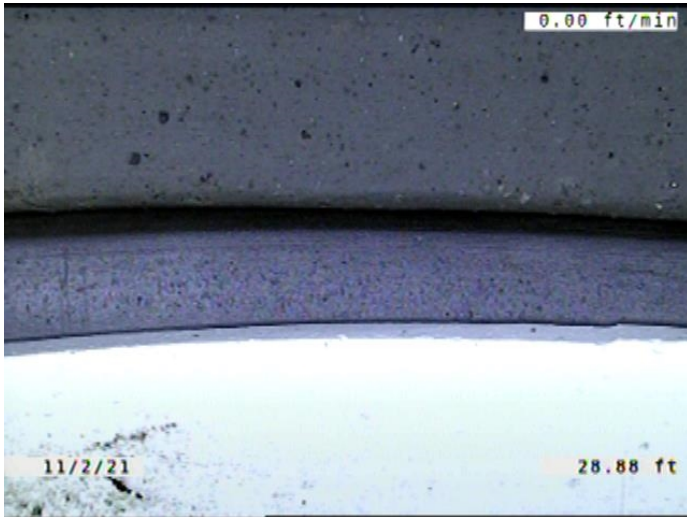
Code: **MMC**
Description: **Miscellaneous Material Change**

Distance (ft): **28.9**
Structural Grade: **0**
O&M Grade: **0**
Clock Start/From:
Clock To:
1st Value:
2nd Value:
Value Percent:
Continuous Index:
Within 8" of Joint: **NO**
Remarks: **VCP TO PVC**

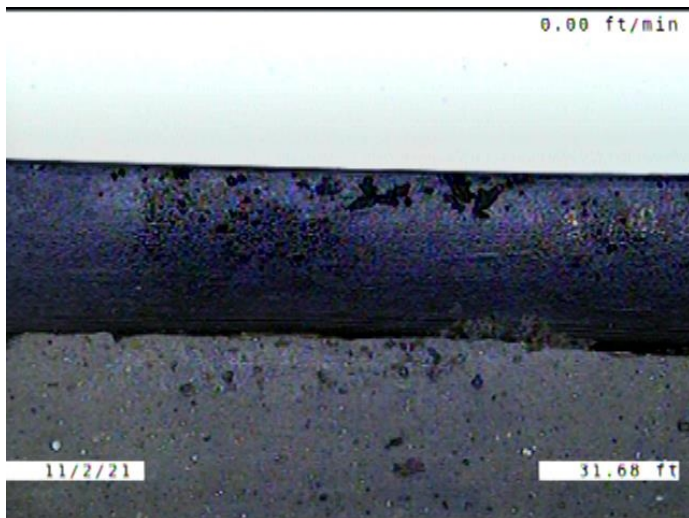
Code: **MMC**
Description: **Miscellaneous Material Change**

Distance (ft): **31.7**
Structural Grade: **0**
O&M Grade: **0**
Clock Start/From:
Clock To:
1st Value:
2nd Value:
Value Percent:
Continuous Index:
Within 8" of Joint: **NO**
Remarks: **PVC TO VCP**

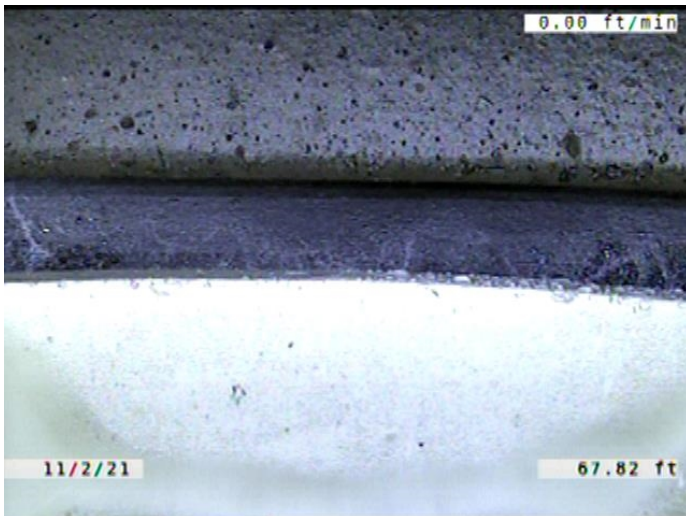
Code: **MMC**
Description: **Miscellaneous Material Change**

Distance (ft): **67.8**
Structural Grade: **0**
O&M Grade: **0**
Clock Start/From:
Clock To:
1st Value:
2nd Value:
Value Percent:
Continuous Index:
Within 8" of Joint: **NO**
Remarks: **VCP TO PVC**

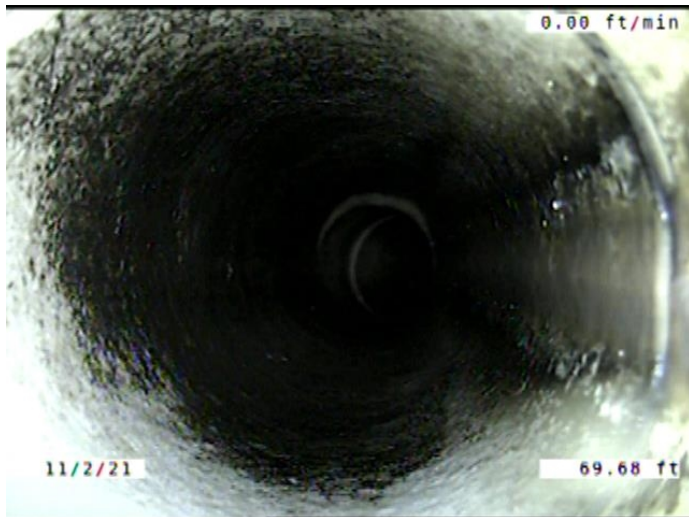
Code: **TF**
 Description: **Tap Factory**

Distance (ft): **69.7**
 Structural Grade: **0**
 O&M Grade: **0**
 Clock Start/From: **2**
 Clock To:
 1st Value: **4.000**
 2nd Value:
 Value Percent:
 Continuous Index:
 Within 8" of Joint: **YES**
 Remarks:

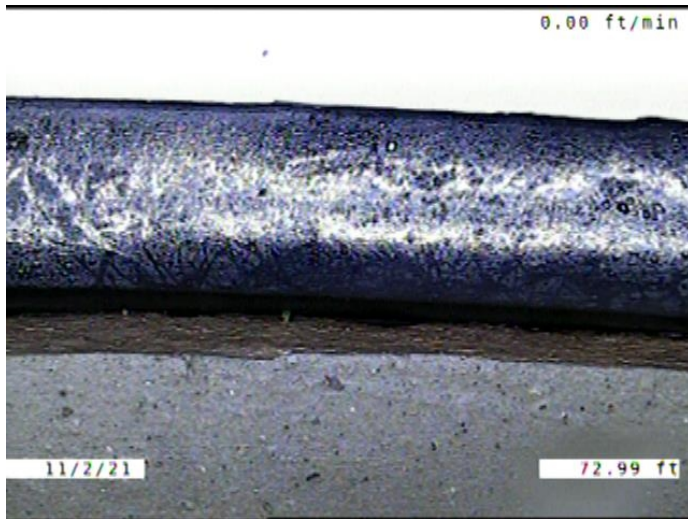
Code: **MMC**
Description: **Miscellaneous Material Change**

Distance (ft): **73.0**
Structural Grade: **0**
O&M Grade: **0**
Clock Start/From:
Clock To:
1st Value:
2nd Value:
Value Percent:
Continuous Index:
Within 8" of Joint: **NO**
Remarks: **PVC TO VCP**

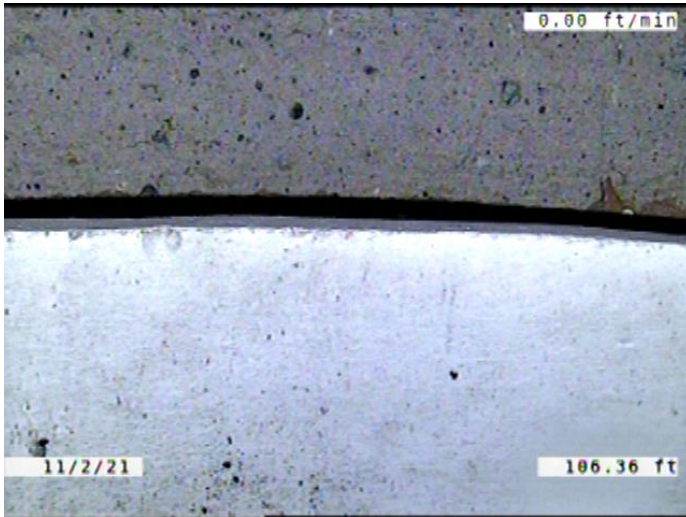
Code: **MMC**
Description: **Miscellaneous Material Change**

Distance (ft): **106.4**
Structural Grade: **0**
O&M Grade: **0**
Clock Start/From:
Clock To:
1st Value:
2nd Value:
Value Percent:
Continuous Index:
Within 8" of Joint: **NO**
Remarks: **VCP TO PVC**

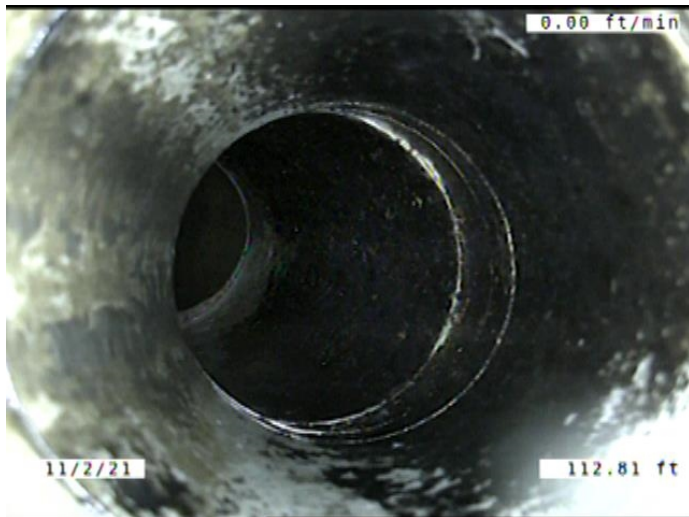
Code: **TF**
 Description: **Tap Factory**

Distance (ft): **112.8**
 Structural Grade: **0**
 O&M Grade: **0**
 Clock Start/From: **11**
 Clock To:
 1st Value: **4.000**
 2nd Value:
 Value Percent:
 Continuous Index:
 Within 8" of Joint: **YES**
 Remarks:

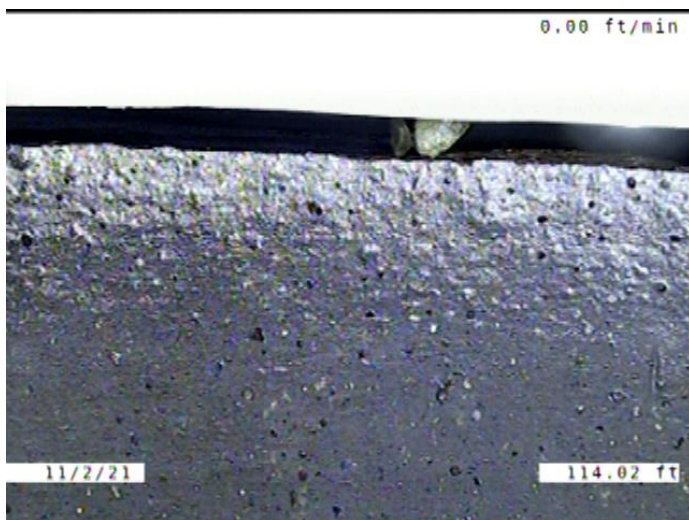
Code: **MMC**
 Description: **Miscellaneous Material Change**

Distance (ft): **114.0**
 Structural Grade: **0**
 O&M Grade: **0**
 Clock Start/From:
 Clock To:
 1st Value:
 2nd Value:
 Value Percent:
 Continuous Index:
 Within 8" of Joint: **NO**
 Remarks: **PVC TO VCP**

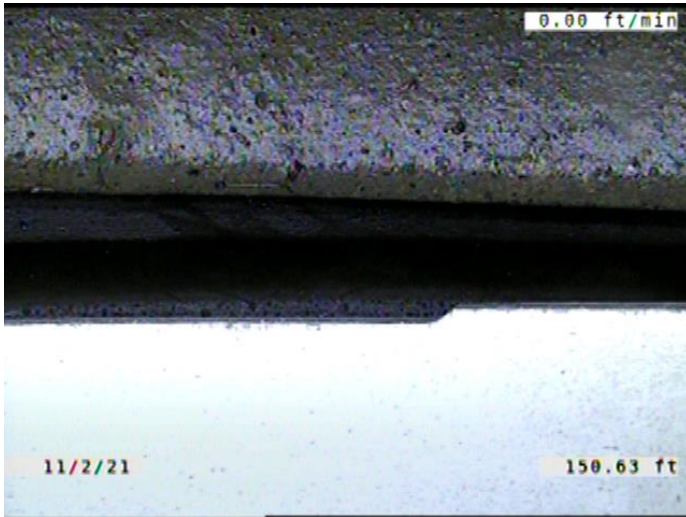
Code: **MMC**
Description: **Miscellaneous Material Change**

Distance (ft): **150.6**
Structural Grade: **0**
O&M Grade: **0**
Clock Start/From:
Clock To:
1st Value:
2nd Value:
Value Percent:
Continuous Index:
Within 8" of Joint: **NO**
Remarks: **VCP TO PVC**

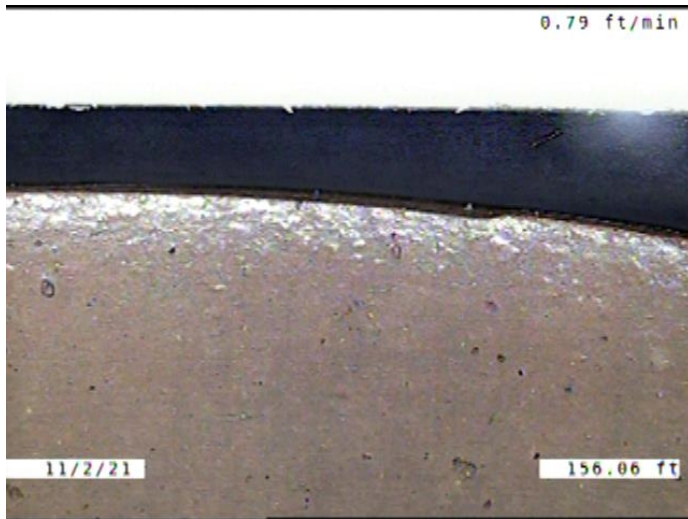
Code: **MMC**
Description: **Miscellaneous Material Change**

Distance (ft): **156.0**
Structural Grade: **0**
O&M Grade: **0**
Clock Start/From:
Clock To:
1st Value:
2nd Value:
Value Percent:
Continuous Index:
Within 8" of Joint: **NO**
Remarks: **PVC TO VCP**

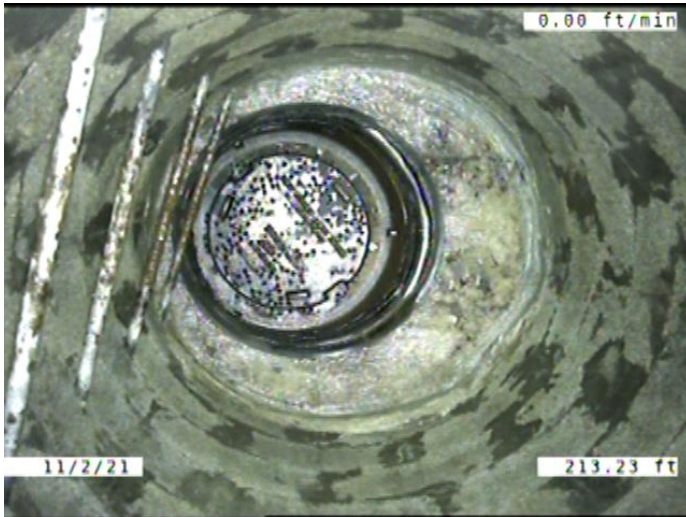
Code:	AMH
Description:	Manhole
Distance (ft):	213.2
Structural Grade:	0
O&M Grade:	0
Clock Start/From:	
Clock To:	
1st Value:	
2nd Value:	
Value Percent:	
Continuous Index:	
Within 8" of Joint:	NO
Remarks:	M-504-039
