Profile/Photo Observation Report

Date:	11/02/2021	Weather:		Coding:	PACP 7.0
Pipe Length (ft):	215.2	Owner:	City of Hobart	Pre Clean:	Heavy Cleaning
P.O.#:	YES502259	Surveyor:	S. Bucklin	PSR:	P-504-040-039
Customer:	City of Hobart	Clean Date:	10/28/2021	Shape:	C

Street:	North Cavender Street	Flow Control:	Not Controlled
City:	Hobart, IN	Year Renewed:	
Location:	Alley	Tape/Media #:	
Purpose:	Routine Assessment	Dia/Height:	10"
Use:	Sanitary Sewage Pipe	Material:	VCP
Drain Area:		Lining:	None
Category:	NA		
Comment:			
Location Details:		Direction of Survey:	Downstream
US MH:	M-504-039	DS MH:	M-504-040
		Total Length Surveyed (ft):	215.2

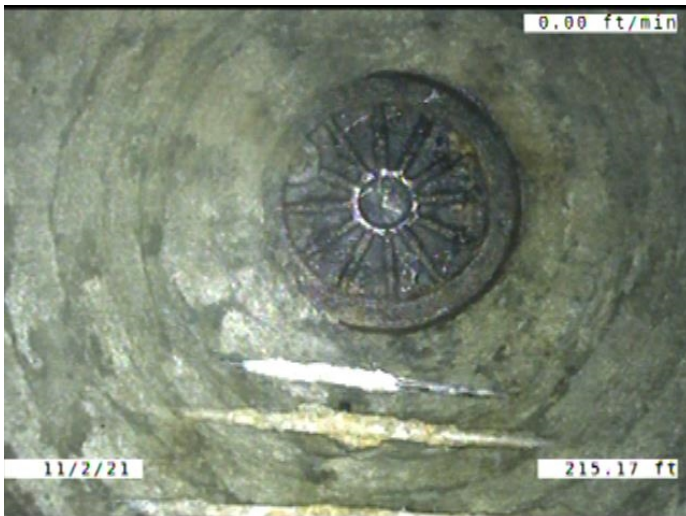
Code: **MWLS**
Description: **Miscellaneous Water Level Sag**

Distance (ft): **213.7**
Structural Grade: **2**
O&M Grade: **0**
Clock Start/From:
Clock To:
1st Value:
2nd Value:
Value Percent: **5.000**
Continuous Index: **F11**
Within 8" of Joint: **NO**
Remarks:
