# Profile/Photo Observation Report

Date:	11/02/2021	Weather:		Coding:	PACP 7.0
Pipe Length (ft):	215.2	Owner:	City of Hobart	Pre Clean:	Heavy Cleaning
P.O.#:	YES502259	Surveyor:	S. Bucklin	PSR:	P-504-040-039
Customer:	City of Hobart	Clean Date:	10/28/2021	Shape:	C

Street:	North Cavender Street	Flow Control:	Not Controlled
City:	Hobart, IN	Year Renewed:	
Location:	Alley	Tape/Media #:	
Purpose:	Routine Assessment	Dia/Height:	10"
Use:	Sanitary Sewage Pipe	Material:	VCP
Drain Area:		Lining:	None
Category:	NA		
Comment:			
Location Details:		Direction of Survey:	Downstream
US MH:	M-504-039	DS MH:	M-504-040
		Total Length Surveyed (ft):	215.2

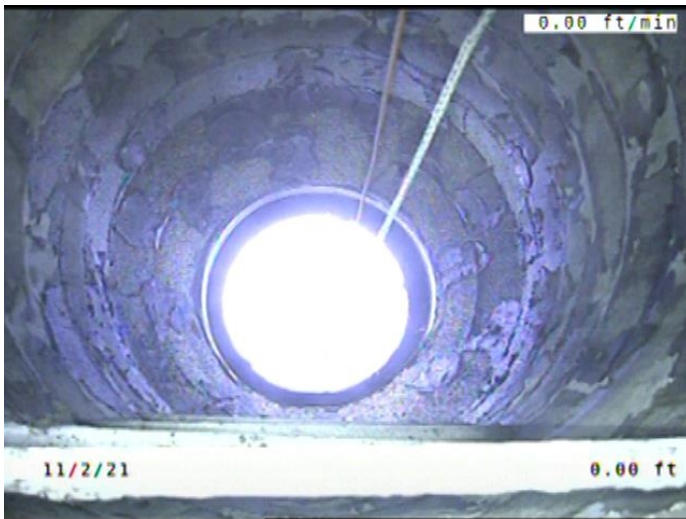
Code: **AMH**  
Description: **Manhole**

Distance (ft): **.0**  
Structural Grade: **0**  
O&M Grade: **0**  
Clock Start/From:  
Clock To:  
1st Value:  
2nd Value:  
Value Percent:  
Continuous Index:  
Within 8" of Joint: **NO**  
Remarks: **M-504-039**

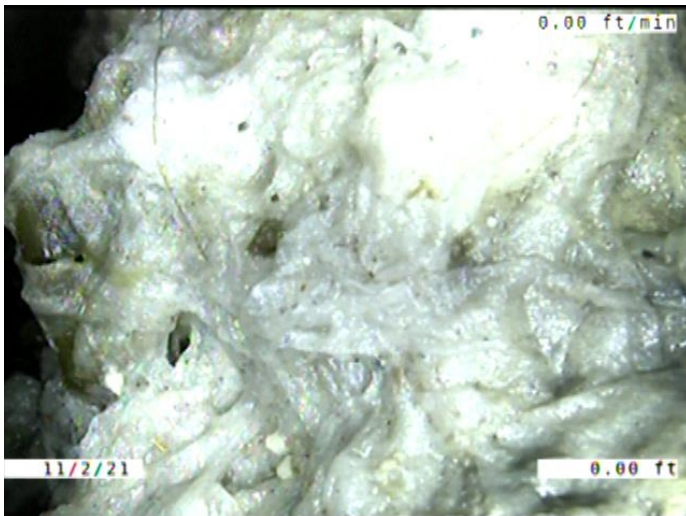
Code: **DAR**  
Description: **Deposits Attached Ragging**

Distance (ft): **.0**  
Structural Grade: **0**  
O&M Grade: **2**  
Clock Start/From: **6**  
Clock To: **8**  
1st Value:  
2nd Value:  
Value Percent: **5.000**  
Continuous Index:  
Within 8" of Joint: **YES**  
Remarks:

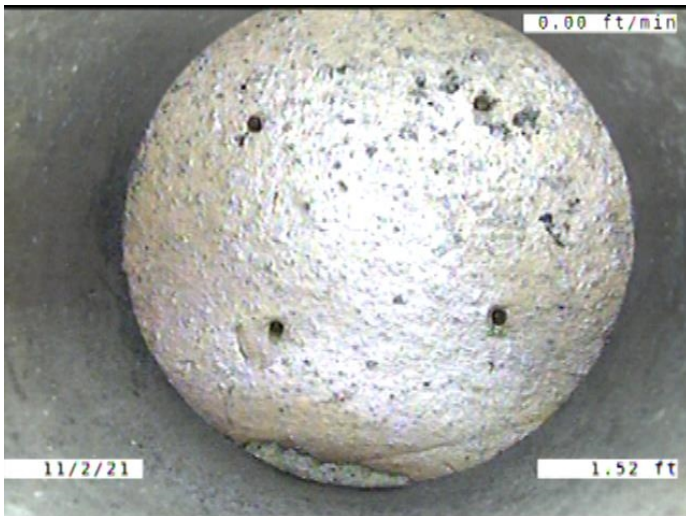
Code: **TFC**  
 Description: **Tap Factory Capped**

Distance (ft): **1.5**  
 Structural Grade: **0**  
 O&M Grade: **0**  
 Clock Start/From: **1**  
 Clock To:  
 1st Value: **4.000**  
 2nd Value:  
 Value Percent:  
 Continuous Index:  
 Within 8" of Joint: **YES**  
 Remarks:

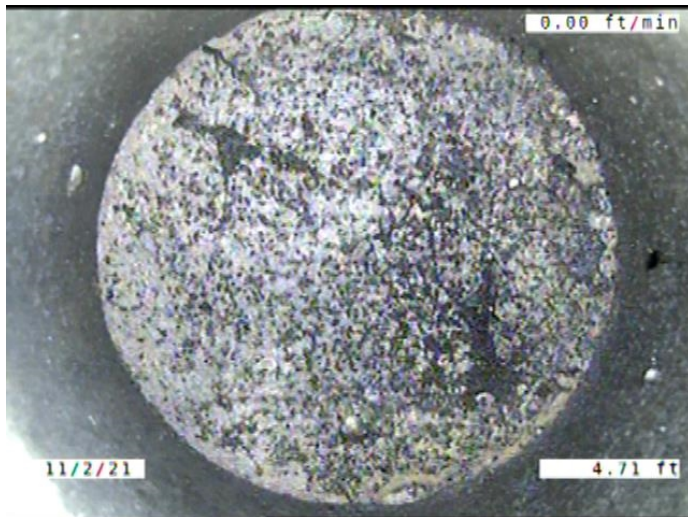
Code: **TFC**  
 Description: **Tap Factory Capped**

Distance (ft): **4.7**  
 Structural Grade: **0**  
 O&M Grade: **0**  
 Clock Start/From: **11**  
 Clock To:  
 1st Value: **4.000**  
 2nd Value:  
 Value Percent:  
 Continuous Index:  
 Within 8" of Joint: **YES**  
 Remarks:

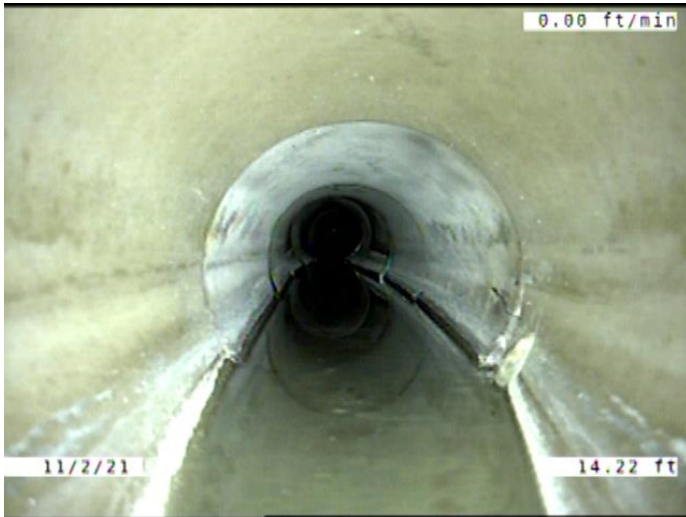
Code: **MWLS**  
Description: **Miscellaneous Water Level Sag**

Distance (ft): **14.2**  
Structural Grade: **2**  
O&M Grade: **0**  
Clock Start/From:  
Clock To:  
1st Value:  
2nd Value:  
Value Percent: **5.000**  
Continuous Index: **S02**  
Within 8" of Joint: **NO**  
Remarks:

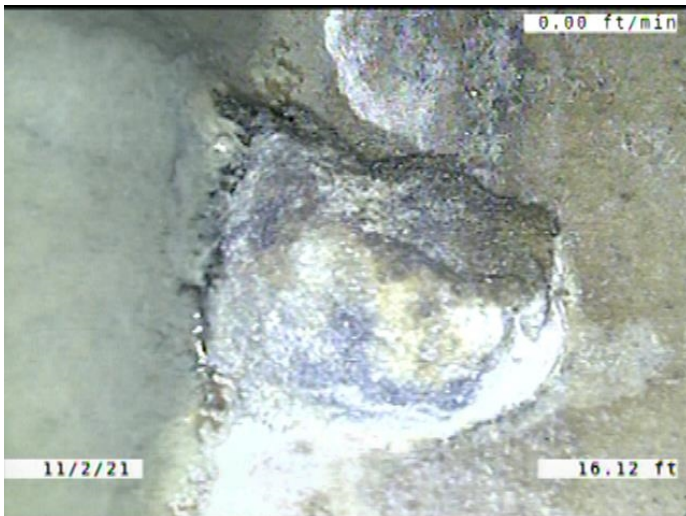
Code: **DAE**  
Description: **Deposits Attached Encrustation**

Distance (ft): **16.1**  
Structural Grade: **0**  
O&M Grade: **2**  
Clock Start/From: **4**  
Clock To:  
1st Value:  
2nd Value:  
Value Percent: **5.000**  
Continuous Index:  
Within 8" of Joint: **YES**  
Remarks:

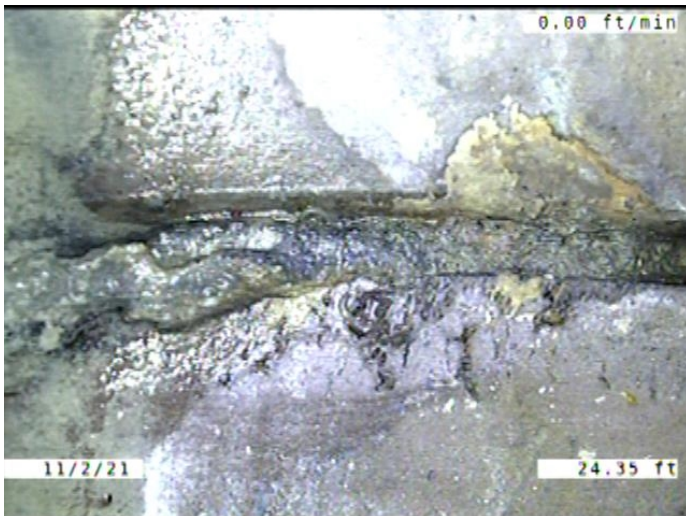
Code: **DAE**  
 Description: **Deposits Attached Encrustation**

Distance (ft): **24.3**  
 Structural Grade: **0**  
 O&M Grade: **2**  
 Clock Start/From: **4**  
 Clock To: **8**  
 1st Value:  
 2nd Value:  
 Value Percent: **5.000**  
 Continuous Index:  
 Within 8" of Joint: **YES**  
 Remarks:

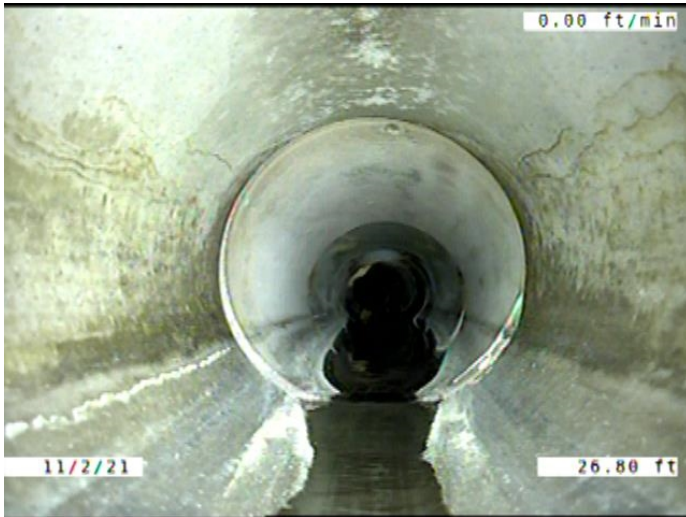
Code: **MWLS**  
 Description: **Miscellaneous Water Level Sag**

Distance (ft): **26.8**  
 Structural Grade: **2**  
 O&M Grade: **0**  
 Clock Start/From:  
 Clock To:  
 1st Value:  
 2nd Value:  
 Value Percent: **5.000**  
 Continuous Index: **F02**  
 Within 8" of Joint: **NO**  
 Remarks:

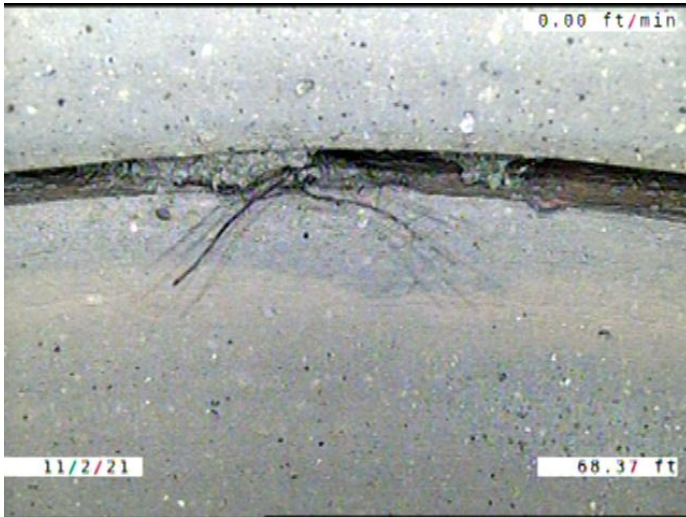
Code: **RFJ**  
 Description: **Roots Fine Joint**

Distance (ft): **68.4**  
 Structural Grade: **0**  
 O&M Grade: **1**  
 Clock Start/From: **12**  
 Clock To:  
 1st Value:  
 2nd Value:  
 Value Percent:  
 Continuous Index:  
 Within 8" of Joint: **YES**  
 Remarks:

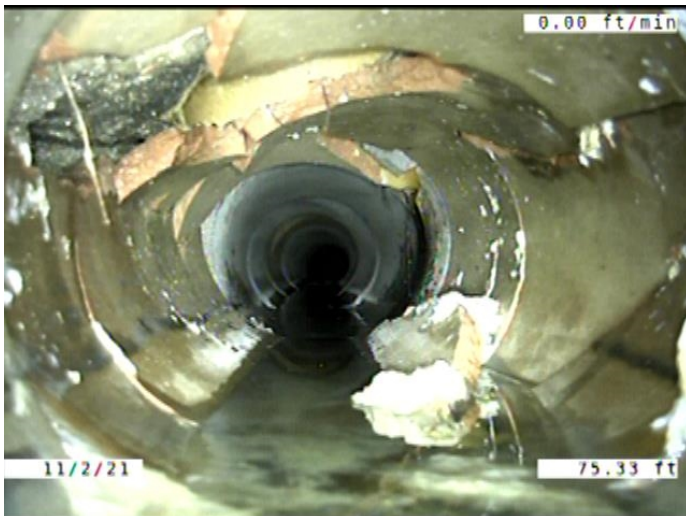
Code: **DR**  
 Description: **Deformed Rigid**

Distance (ft): **75.3**  
 Structural Grade: **5**  
 O&M Grade: **0**  
 Clock Start/From:  
 Clock To:  
 1st Value:  
 2nd Value:  
 Value Percent: **15.000**  
 Continuous Index: **S06**  
 Within 8" of Joint: **NO**  
 Remarks:

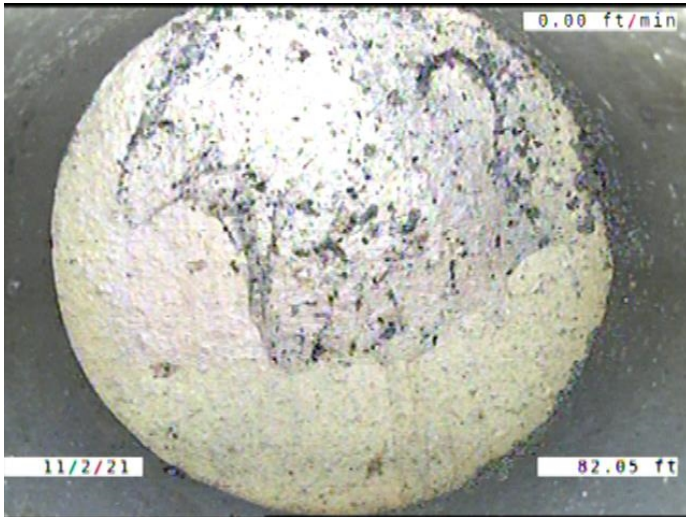
Code: **TFC**  
 Description: **Tap Factory Capped**

Distance (ft): **82.1**  
 Structural Grade: **0**  
 O&M Grade: **0**  
 Clock Start/From: **1**  
 Clock To:  
 1st Value: **4.000**  
 2nd Value:  
 Value Percent:  
 Continuous Index:  
 Within 8" of Joint: **YES**  
 Remarks:

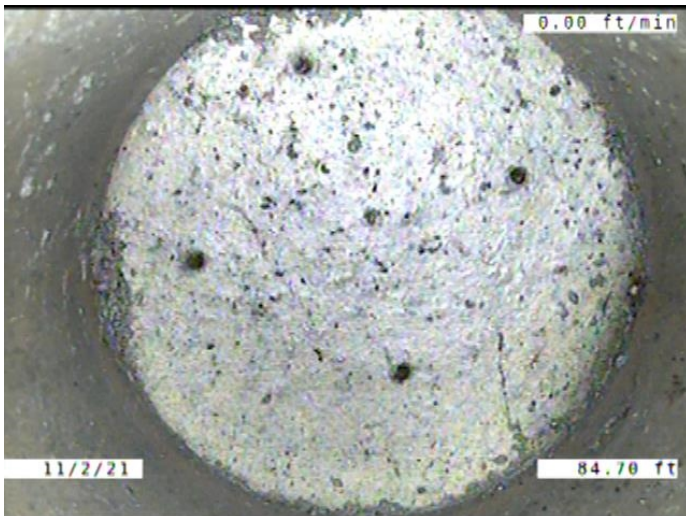
Code: **TFC**  
 Description: **Tap Factory Capped**

Distance (ft): **84.7**  
 Structural Grade: **0**  
 O&M Grade: **0**  
 Clock Start/From: **11**  
 Clock To:  
 1st Value: **4.000**  
 2nd Value:  
 Value Percent:  
 Continuous Index:  
 Within 8" of Joint: **YES**  
 Remarks:

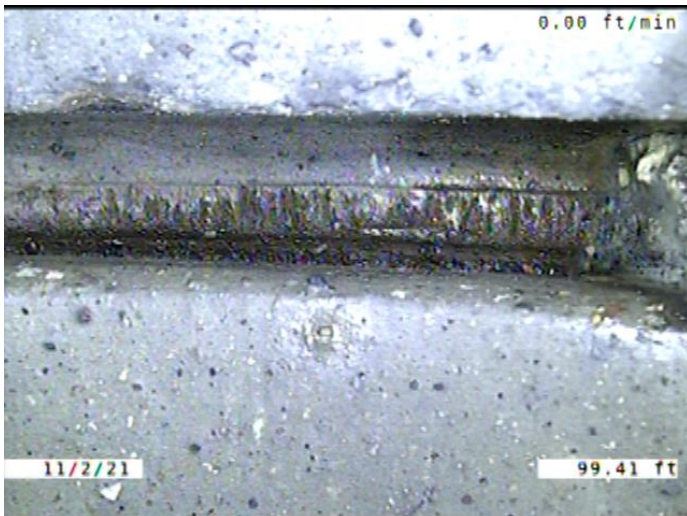
Code: **JAM**  
Description: **Joint Angular Medium**

Distance (ft): **99.4**  
Structural Grade: **3**  
O&M Grade: **0**  
Clock Start/From:  
Clock To:  
1st Value:  
2nd Value:  
Value Percent:  
Continuous Index:  
Within 8" of Joint: **NO**  
Remarks:

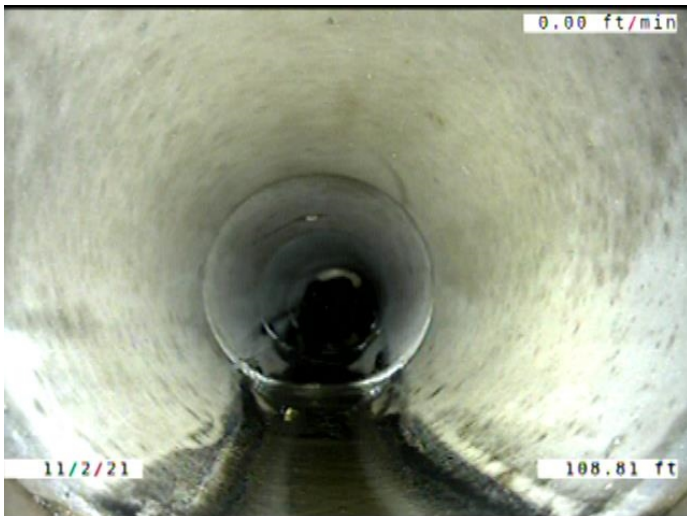
Code: **MWLS**  
Description: **Miscellaneous Water Level Sag**

Distance (ft): **108.8**  
Structural Grade: **2**  
O&M Grade: **0**  
Clock Start/From:  
Clock To:  
1st Value:  
2nd Value:  
Value Percent: **5.000**  
Continuous Index: **F05**  
Within 8" of Joint: **NO**  
Remarks:

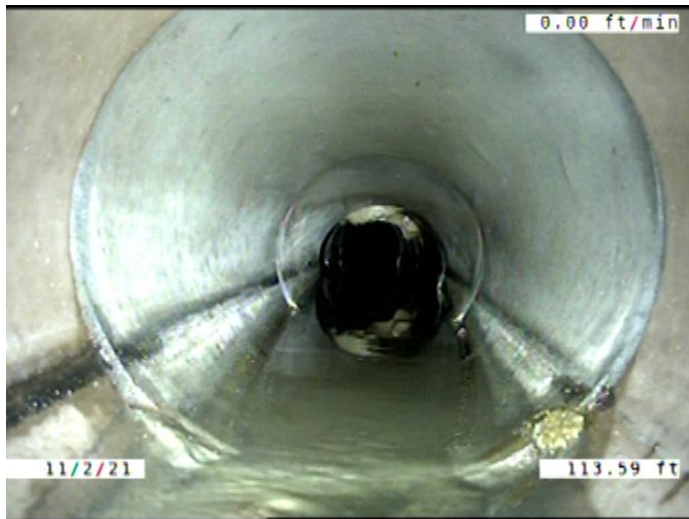
Code: **MWLS**  
 Description: **Miscellaneous Water Level Sag**

Distance (ft): **113.6**  
 Structural Grade: **2**  
 O&M Grade: **0**  
 Clock Start/From:  
 Clock To:  
 1st Value:  
 2nd Value:  
 Value Percent: **10.000**  
 Continuous Index: **S08**  
 Within 8" of Joint: **NO**  
 Remarks:

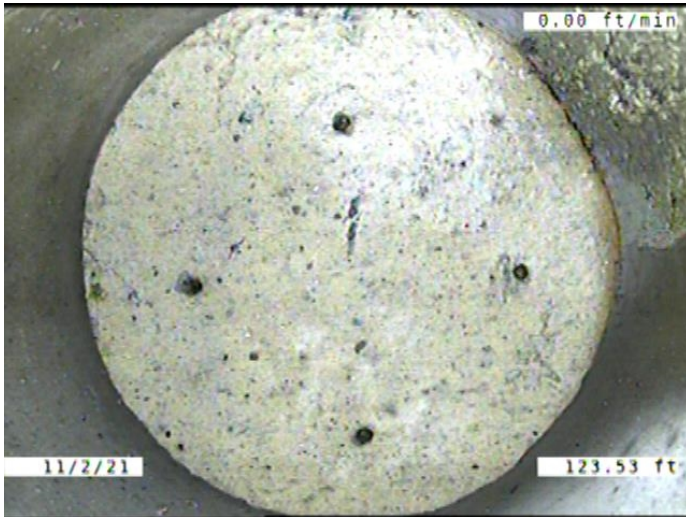
Code: **TFC**  
Description: **Tap Factory Capped**

Distance (ft): **123.5**  
Structural Grade: **0**  
O&M Grade: **0**  
Clock Start/From: **1**  
Clock To:  
1st Value: **4.000**  
2nd Value:  
Value Percent:  
Continuous Index:  
Within 8" of Joint: **YES**  
Remarks: **ENCRUSTATION COMING AROUND THE CAP**

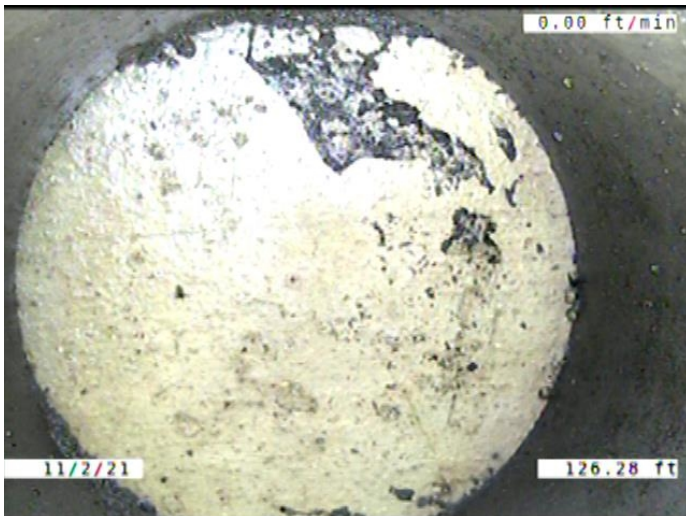
Code: **TFC**  
Description: **Tap Factory Capped**

Distance (ft): **126.3**  
Structural Grade: **0**  
O&M Grade: **0**  
Clock Start/From: **11**  
Clock To:  
1st Value: **4.000**  
2nd Value:  
Value Percent:  
Continuous Index:  
Within 8" of Joint: **YES**  
Remarks:

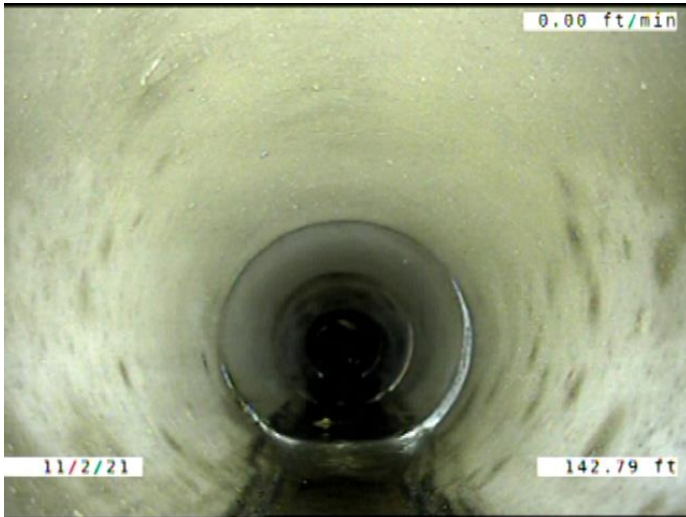
Code: **MWLS**  
Description: **Miscellaneous Water Level Sag**

Distance (ft): **142.8**  
Structural Grade: **2**  
O&M Grade: **0**  
Clock Start/From:  
Clock To:  
1st Value:  
2nd Value:  
Value Percent: **10.000**  
Continuous Index: **F08**  
Within 8" of Joint: **NO**  
Remarks:

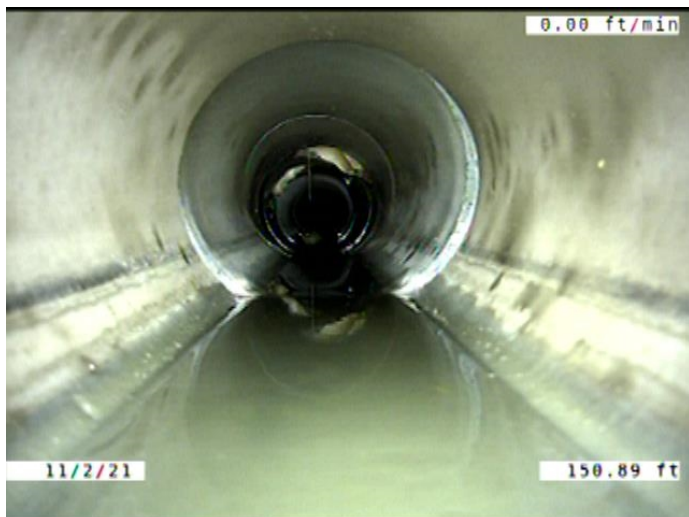
Code: **MWLS**  
 Description: **Miscellaneous Water Level Sag**

Distance (ft): **150.9**  
 Structural Grade: **2**  
 O&M Grade: **0**  
 Clock Start/From:  
 Clock To:  
 1st Value:  
 2nd Value:  
 Value Percent: **5.000**  
 Continuous Index:  
 Within 8" of Joint: **NO**  
 Remarks:

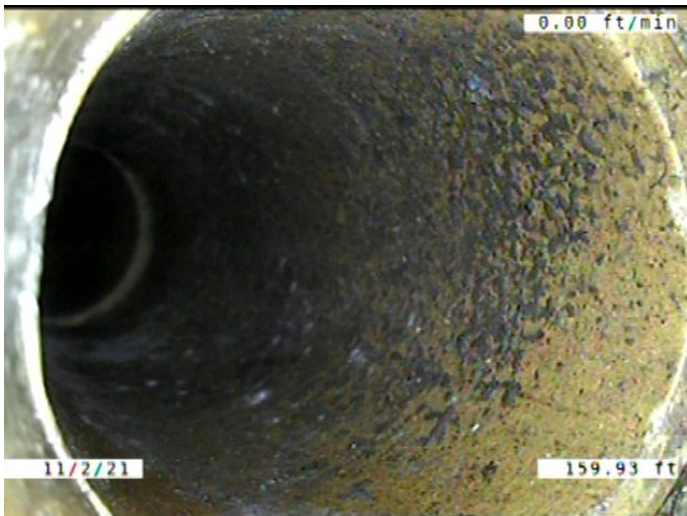
Code: **TBI**  
 Description: **Tap Break-in Intruding**

Distance (ft): **159.9**  
 Structural Grade: **0**  
 O&M Grade: **2**  
 Clock Start/From: **11**  
 Clock To:  
 1st Value: **4.000**  
 2nd Value: **1.000**  
 Value Percent:  
 Continuous Index:  
 Within 8" of Joint: **YES**  
 Remarks: **CONSTANTLY RUNNING WATER.**

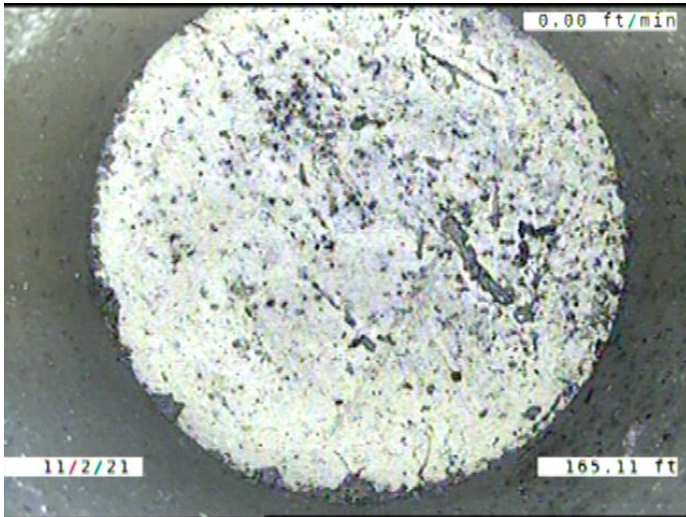
Code: **TFC**  
 Description: **Tap Factory Capped**

Distance (ft): **165.1**  
 Structural Grade: **0**  
 O&M Grade: **0**  
 Clock Start/From: **11**  
 Clock To:  
 1st Value: **4.000**  
 2nd Value:  
 Value Percent:  
 Continuous Index:  
 Within 8" of Joint: **YES**  
 Remarks:

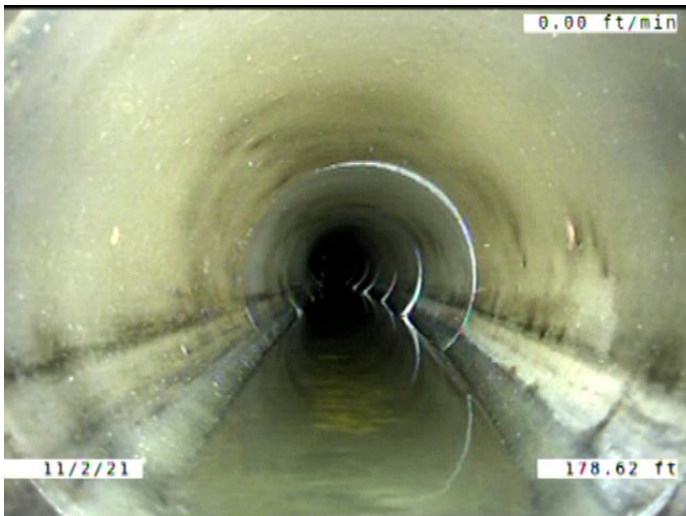
Code: **MWLS**  
 Description: **Miscellaneous Water Level Sag**

Distance (ft): **178.6**  
 Structural Grade: **2**  
 O&M Grade: **0**  
 Clock Start/From:  
 Clock To:  
 1st Value:  
 2nd Value:  
 Value Percent: **5.000**  
 Continuous Index: **S10**  
 Within 8" of Joint: **NO**  
 Remarks:

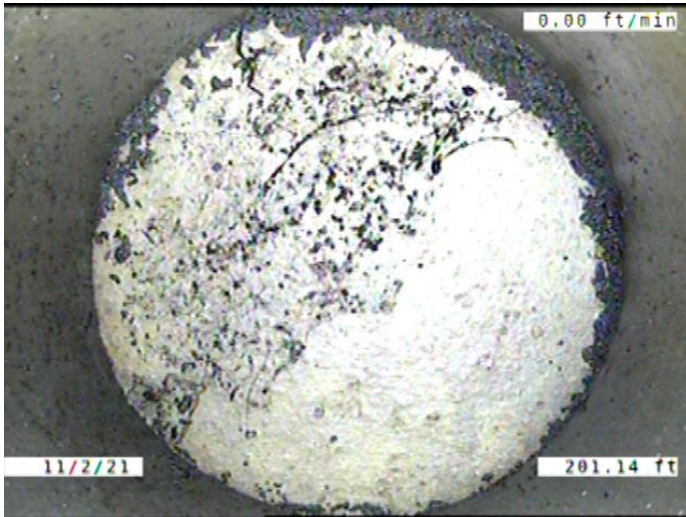
Code: **TFC**  
 Description: **Tap Factory Capped**

Distance (ft): **201.1**  
 Structural Grade: **0**  
 O&M Grade: **0**  
 Clock Start/From: **1**  
 Clock To:  
 1st Value: **4.000**  
 2nd Value:  
 Value Percent:  
 Continuous Index:  
 Within 8" of Joint: **YES**  
 Remarks:

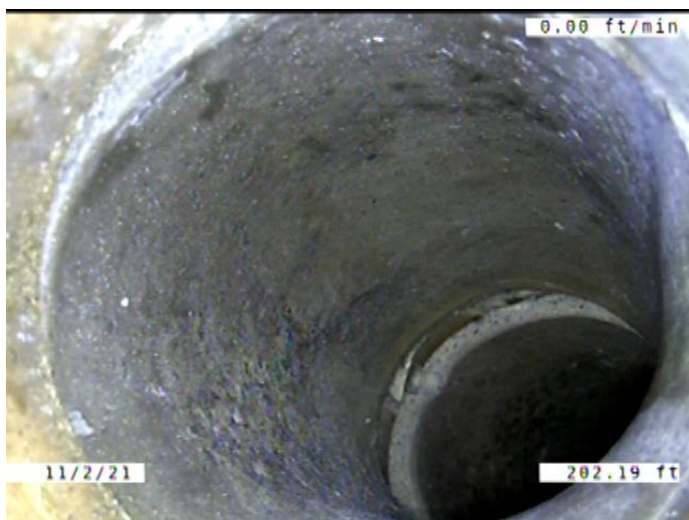
Code: **TB**  
 Description: **Tap Break-in/Hammer**

Distance (ft): **202.2**  
 Structural Grade: **0**  
 O&M Grade: **0**  
 Clock Start/From: **2**  
 Clock To:  
 1st Value: **4.000**  
 2nd Value:  
 Value Percent:  
 Continuous Index:  
 Within 8" of Joint: **YES**  
 Remarks:

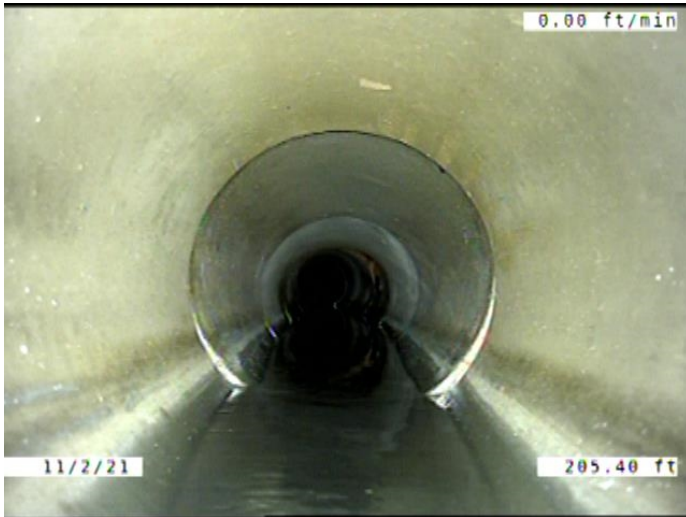
Code: **MWLS**  
 Description: **Miscellaneous Water Level Sag**

Distance (ft): **205.4**  
 Structural Grade: **2**  
 O&M Grade: **0**  
 Clock Start/From:  
 Clock To:  
 1st Value:  
 2nd Value:  
 Value Percent: **5.000**  
 Continuous Index: **S11**  
 Within 8" of Joint: **NO**  
 Remarks:

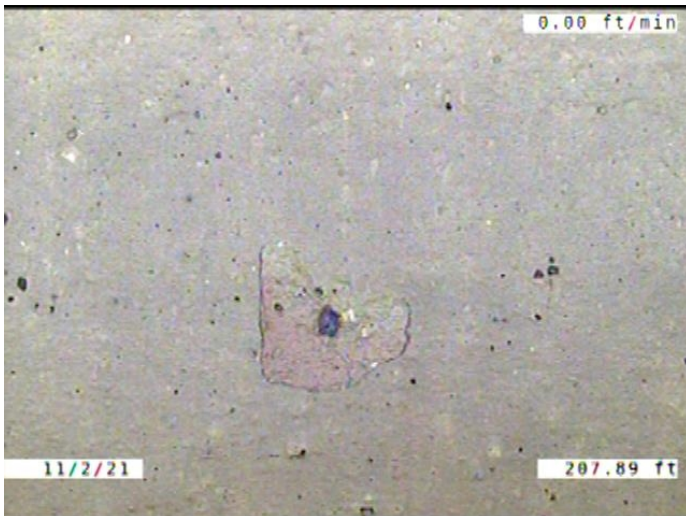
Code: **SSS**  
 Description: **Surface Damage Surface Spalling**

Distance (ft): **207.9**  
 Structural Grade: **2**  
 O&M Grade: **0**  
 Clock Start/From: **12**  
 Clock To:  
 1st Value:  
 2nd Value:  
 Value Percent:  
 Continuous Index:  
 Within 8" of Joint: **NO**  
 Remarks:

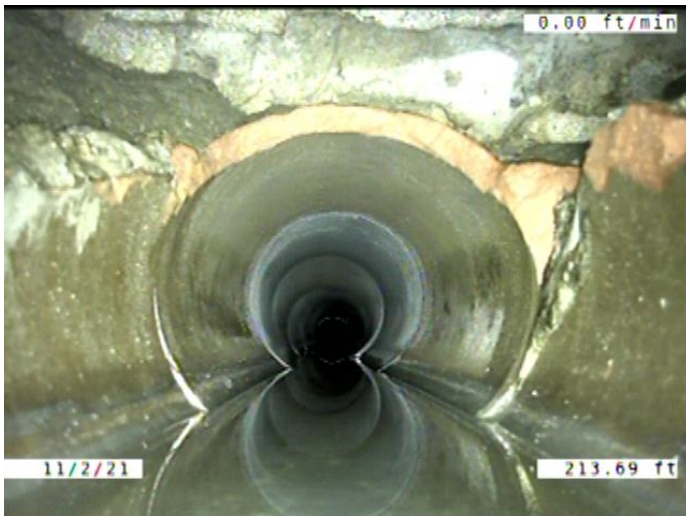
Code: **DAE**  
 Description: **Deposits Attached Encrustation**

Distance (ft): **213.7**  
 Structural Grade: **0**  
 O&M Grade: **2**  
 Clock Start/From: **8**  
 Clock To: **4**  
 1st Value:  
 2nd Value:  
 Value Percent: **5.000**  
 Continuous Index: **F03**  
 Within 8" of Joint: **YES**  
 Remarks:

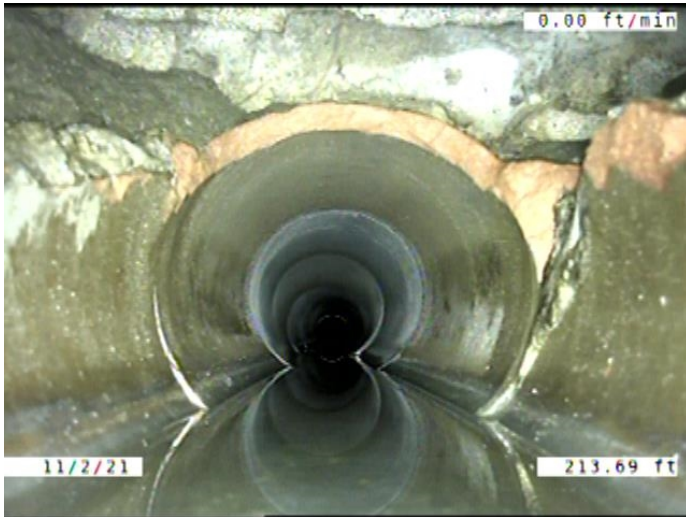
Code: **MWLS**  
 Description: **Miscellaneous Water Level Sag**

Distance (ft): **213.7**  
 Structural Grade: **2**  
 O&M Grade: **0**  
 Clock Start/From:  
 Clock To:  
 1st Value:  
 2nd Value:  
 Value Percent: **5.000**  
 Continuous Index: **F11**  
 Within 8" of Joint: **NO**  
 Remarks:

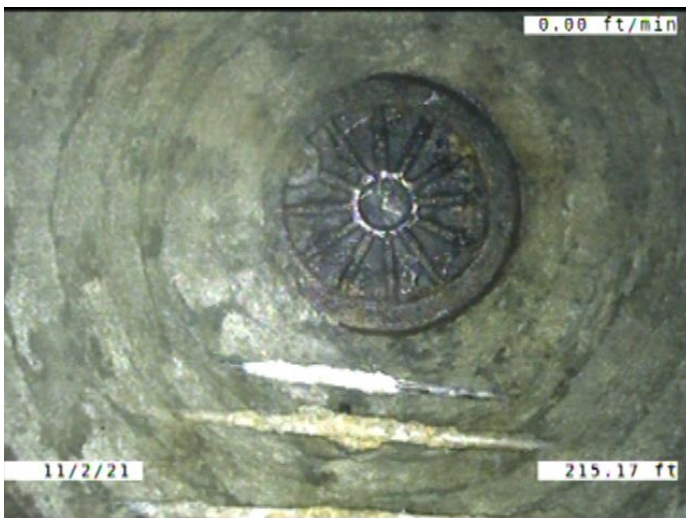
Code: **AMH**  
 Description: **Manhole**

Distance (ft): **215.2**  
 Structural Grade: **0**  
 O&M Grade: **0**  
 Clock Start/From:  
 Clock To:  
 1st Value:  
 2nd Value:  
 Value Percent:  
 Continuous Index:  
 Within 8" of Joint: **NO**  
 Remarks: **M-504-040**
