# Profile/Photo Observation Report

Date:	<b>10/30/2021</b>	Weather:		Coding:	<b>PACP 7.0</b>
Pipe Length (ft):	<b>170.1</b>	Owner:	<b>City of Hobart</b>	Pre Clean:	<b>Heavy Cleaning</b>
P.O.#:	<b>YES502259</b>	Surveyor:	<b>S. Bucklin</b>	PSR:	<b>P-504-046-045</b>
Customer:	<b>City of Hobart</b>	Clean Date:	<b>10/26/2021</b>	Shape:	<b>C</b>

Street:	<b>North Colorado Street</b>	Flow Control:	<b>Not Controlled</b>
City:	<b>Hobart, IN</b>	Year Renewed:	
Location:	<b>Alley</b>	Tape/Media #:	
Purpose:	<b>Routine Assessment</b>	Dia/Height:	<b>12"</b>
Use:	<b>Sanitary Sewage Pipe</b>	Material:	<b>VCP</b>
Drain Area:		Lining:	<b>None</b>
Category:	<b>NA</b>		
Comment:			
Location Details:		Direction of Survey:	<b>Downstream</b>
US MH:	<b>M-504-045</b>	DS MH:	<b>M-504-046</b>
		Total Length Surveyed (ft):	<b>170.1</b>

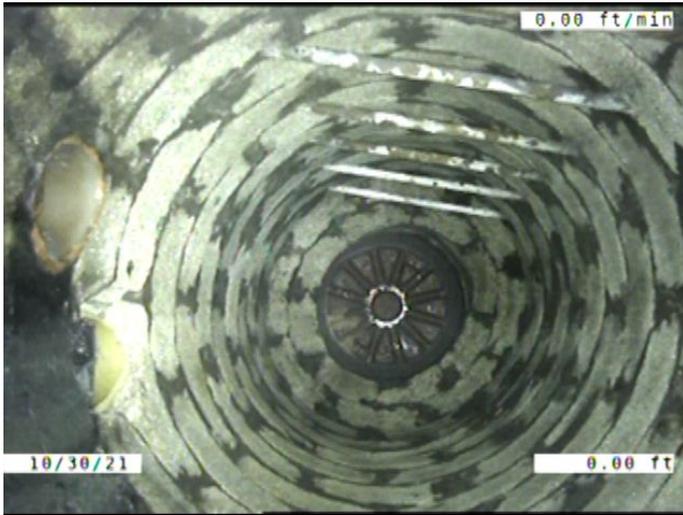
Code: **AMH**  
 Description: **Manhole**

Distance (ft): **.0**  
 Structural Grade: **0**  
 O&M Grade: **0**  
 Clock Start/From:  
 Clock To:  
 1st Value:  
 2nd Value:  
 Value Percent:  
 Continuous Index:  
 Within 8" of Joint: **NO**

Remarks: **M-504-045**

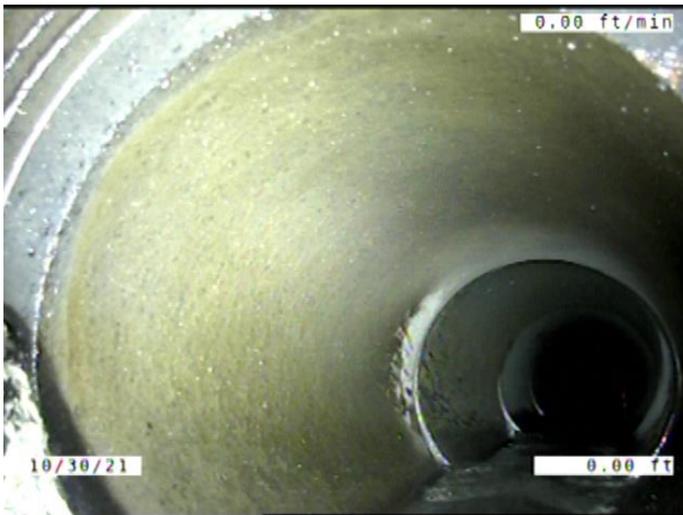
Code: **MWL**  
 Description: **Miscellaneous Water Level**

Distance (ft): **.0**  
 Structural Grade: **0**  
 O&M Grade: **0**  
 Clock Start/From:  
 Clock To:  
 1st Value:  
 2nd Value:  
 Value Percent: **5.000**  
 Continuous Index:  
 Within 8" of Joint: **NO**

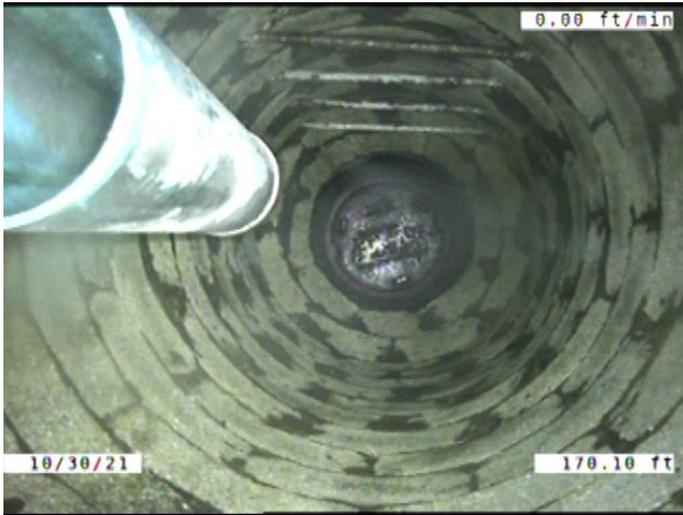
Code: **AMH**  
Description: **Manhole**

Distance (ft): **170.1**  
Structural Grade: **0**  
O&M Grade: **0**  
Clock Start/From:  
Clock To:  
1st Value:  
2nd Value:  
Value Percent:  
Continuous Index:  
Within 8" of Joint: **NO**  
Remarks: **M-504-046**
