Profile/Photo Observation Report

Date:	10/30/2021	Weather:		Coding:	PACP 7.0
Pipe Length (ft):	205.0	Owner:	City of Hobart	Pre Clean:	Heavy Cleaning
P.O.#:	YES502259	Surveyor:	S. Bucklin	PSR:	P-504-048-046
Customer:	City of Hobart	Clean Date:	10/27/2021	Shape:	C

Street:	North Colorado Street	Flow Control:	Not Controlled
City:	Hobart, IN	Year Renewed:	
Location:	Alley	Tape/Media #:	
Purpose:	Routine Assessment	Dia/Height:	12"
Use:	Sanitary Sewage Pipe	Material:	VCP
Drain Area:		Lining:	None
Category:	NA		
Comment:

Location Details:		Direction of Survey:	Downstream
US MH:	M-504-046	DS MH:	M-504-048
		Total Length Surveyed (ft):	205.0

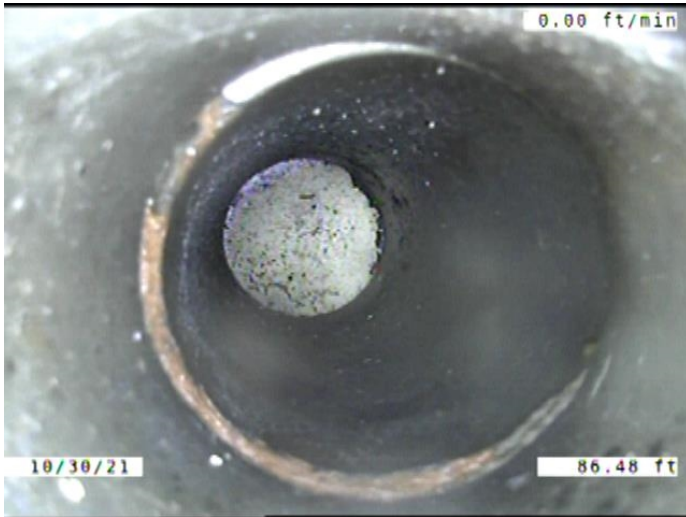
Code: **RFJ**
 Description: **Roots Fine Joint**

Distance (ft): **69.7**
 Structural Grade: **0**
 O&M Grade: **1**
 Clock Start/From: **8**
 Clock To:
 1st Value:
 2nd Value:
 Value Percent:
 Continuous Index:
 Within 8" of Joint: **YES**
 Remarks:

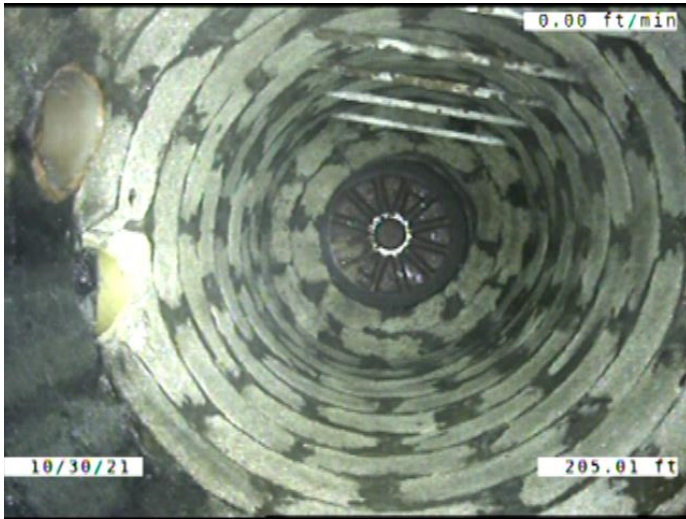
Code: **DSF**
 Description: **Deposits Settled Fine**

Distance (ft): **203.4**
 Structural Grade: **0**
 O&M Grade: **2**
 Clock Start/From: **5**
 Clock To: **7**
 1st Value:
 2nd Value:
 Value Percent: **5.000**
 Continuous Index: **F02**
 Within 8" of Joint: **YES**
 Remarks:
