RedZone<sup>®</sup>  
ROBOTICS

Street:	North Delaware Street		Flow Control:	Not Controlled	
City:	Hobart, IN		Year Renewed:		
Location:	Alley		Tape/Media #:		
Purpose:	Routine Assessment		Dia/Height:	10"	
Use:	Sanitary Sewage Pipe		Material:	VCP	
Drain Area:			Lining:	None	
Category:	NA				
Comment:					
Location Details:			Direction of Survey: Downstream		
US MH:	M-504-048	DS MH:	M-504-047	Total Length Surveyed (ft):	167.0

**Tuesday, April 25, 2023**

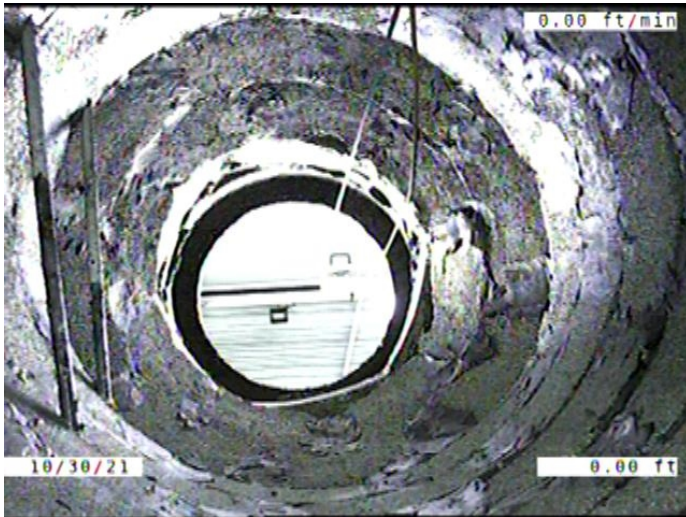
Code: **AMH**  
Description: **Manhole**

Distance (ft): **.0**  
Structural Grade: **0**  
O&M Grade: **0**  
Clock Start/From:  
Clock To:  
1st Value:  
2nd Value:  
Value Percent:  
Continuous Index:  
Within 8" of Joint: **NO**  
Remarks: **M-504-048**

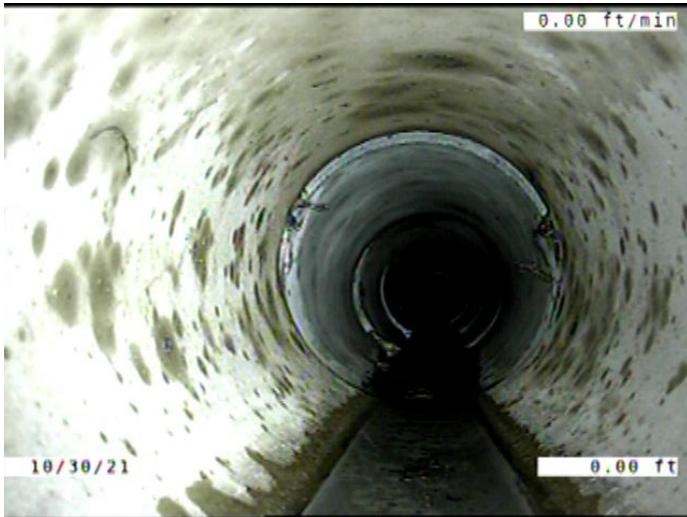
Code: **MWL**  
 Description: **Miscellaneous Water Level**

Distance (ft): **.0**  
 Structural Grade: **0**  
 O&M Grade: **0**  
 Clock Start/From:  
 Clock To:  
 1st Value:  
 2nd Value:  
 Value Percent: **5.000**  
 Continuous Index:  
 Within 8" of Joint: **NO**  
 Remarks:

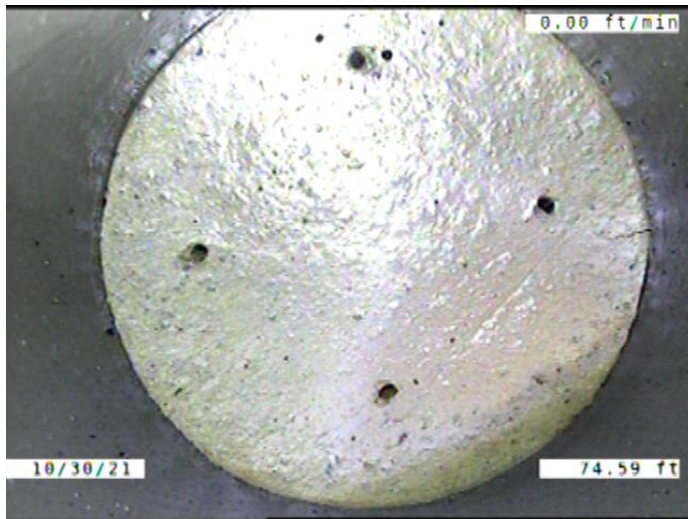
Code: **TFC**  
 Description: **Tap Factory Capped**

Distance (ft): **74.6**  
 Structural Grade: **0**  
 O&M Grade: **0**  
 Clock Start/From: **11**  
 Clock To:  
 1st Value: **4.000**  
 2nd Value:  
 Value Percent:  
 Continuous Index:  
 Within 8" of Joint: **YES**  
 Remarks:

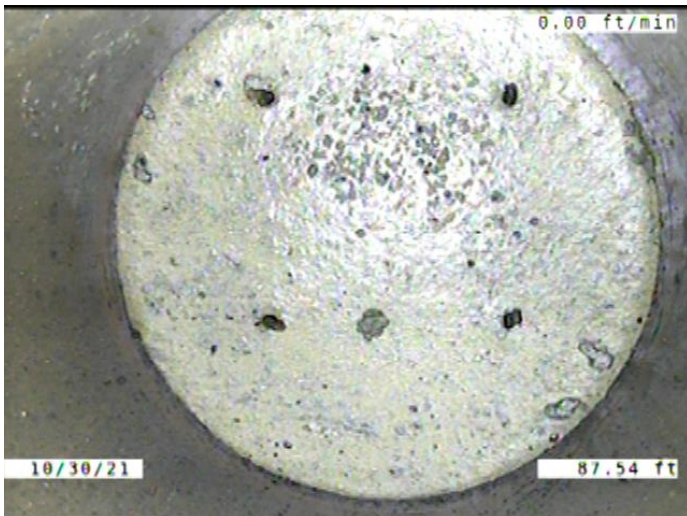
Code: **TFC**  
Description: **Tap Factory Capped**

Distance (ft): **87.5**  
Structural Grade: **0**  
O&M Grade: **0**  
Clock Start/From: **1**  
Clock To:  
1st Value: **4.000**  
2nd Value:  
Value Percent:  
Continuous Index:  
Within 8" of Joint: **YES**  
Remarks:

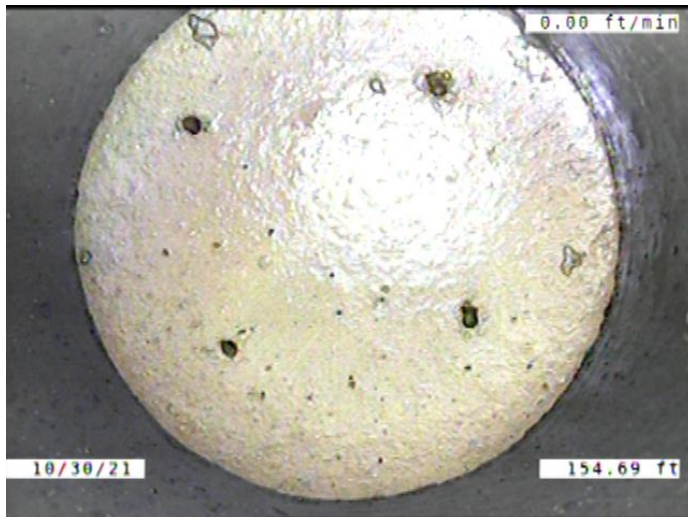
Code: **TFC**  
 Description: **Tap Factory Capped**

Distance (ft): **154.7**  
 Structural Grade: **0**  
 O&M Grade: **0**  
 Clock Start/From: **1**  
 Clock To:  
 1st Value: **4.000**  
 2nd Value:  
 Value Percent:  
 Continuous Index:  
 Within 8" of Joint: **YES**  
 Remarks:

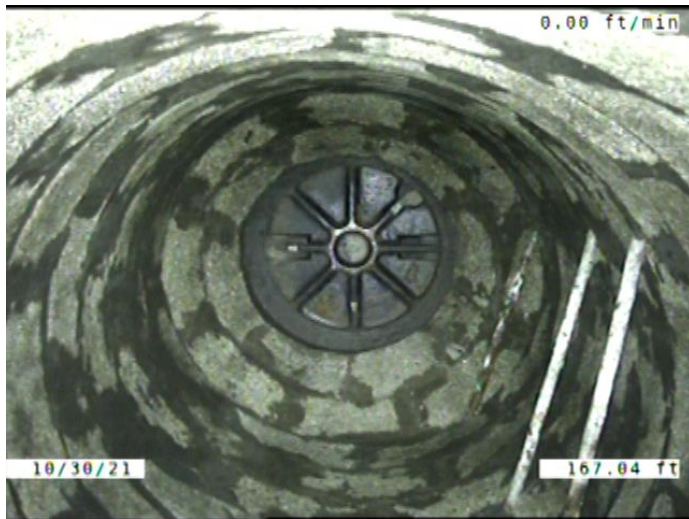
Code:	<b>AMH</b>
Description:	<b>Manhole</b>
Distance (ft):	<b>167.0</b>
Structural Grade:	<b>0</b>
O&M Grade:	<b>0</b>
Clock Start/From:	
Clock To:	
1st Value:	
2nd Value:	
Value Percent:	
Continuous Index:	
Within 8" of Joint:	<b>NO</b>
Remarks:	<b>M-504-047</b>
