RedZone  
ROBOTICS

Street:	North Delaware Street		Flow Control:	Not Controlled	
City:	Hobart, IN		Year Renewed:		
Location:	Alley		Tape/Media #:		
Purpose:	Routine Assessment		Dia/Height:	10"	
Use:	Sanitary Sewage Pipe		Material:	VCP	
Drain Area:			Lining:	None	
Category:	NA				
Comment:					
Location Details:			Direction of Survey: Downstream		
US MH:	M-504-048	DS MH:	M-504-047	Total Length Surveyed (ft):	167.0

**Thursday, December 30, 2021**

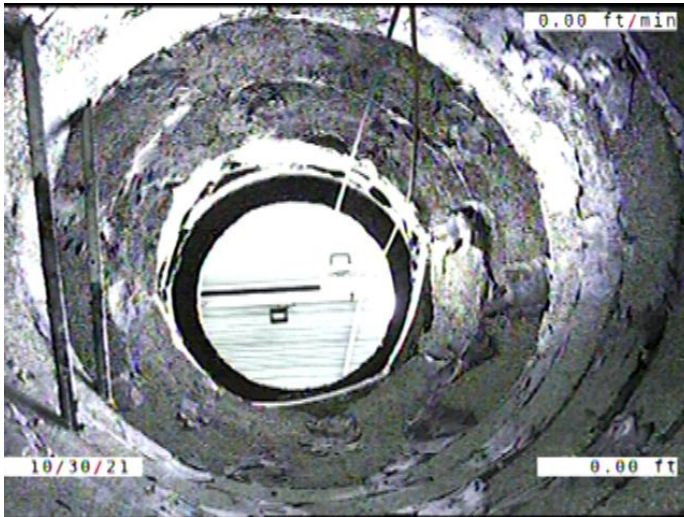
Code: **AMH**  
Description: **Manhole**

Distance (ft): **.0**  
Structural Grade: **0**  
O&M Grade: **0**  
Clock Start/From:  
Clock To:  
1st Value:  
2nd Value:  
Value Percent:  
Continuous Index:  
Within 8" of Joint: **NO**  
Remarks: **M-504-048**

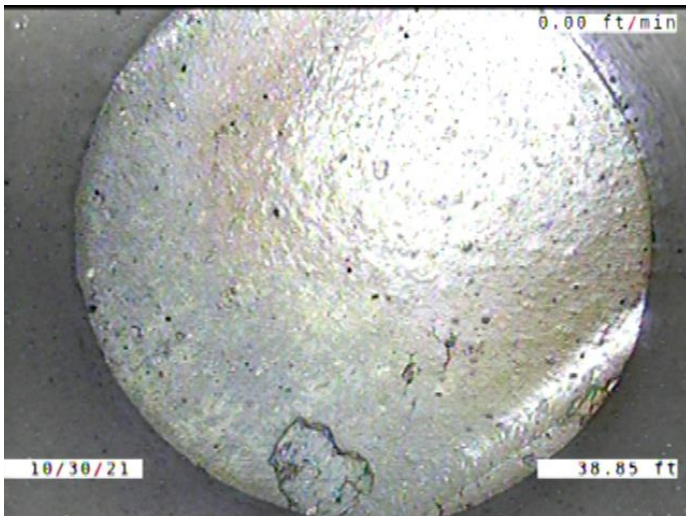
Code: **TFC**  
 Description: **Tap Factory Capped**

Distance (ft): **38.8**  
 Structural Grade: **0**  
 O&M Grade: **0**  
 Clock Start/From: **1**  
 Clock To:  
 1st Value: **4.000**  
 2nd Value:  
 Value Percent:  
 Continuous Index:  
 Within 8" of Joint: **YES**  
 Remarks:

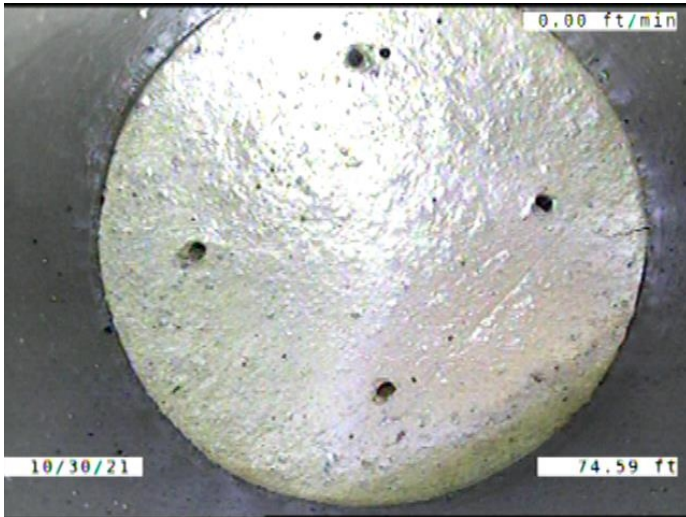
Code: **TFC**  
 Description: **Tap Factory Capped**

Distance (ft): **74.6**  
 Structural Grade: **0**  
 O&M Grade: **0**  
 Clock Start/From: **11**  
 Clock To:  
 1st Value: **4.000**  
 2nd Value:  
 Value Percent:  
 Continuous Index:  
 Within 8" of Joint: **YES**  
 Remarks:

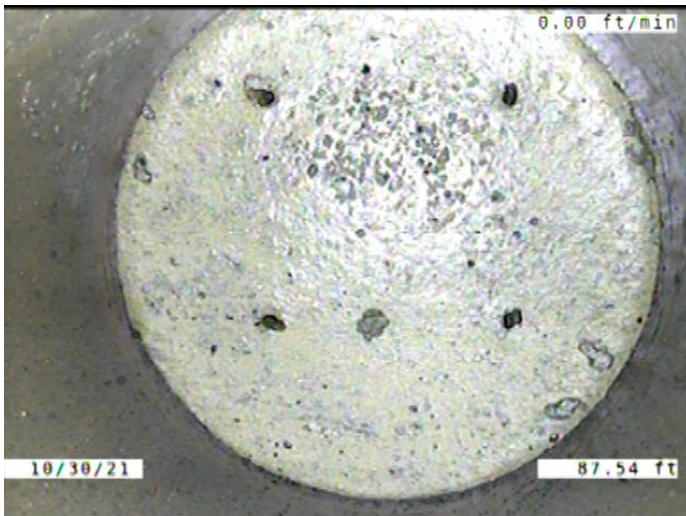
Code: **TFC**  
 Description: **Tap Factory Capped**

Distance (ft): **87.5**  
 Structural Grade: **0**  
 O&M Grade: **0**  
 Clock Start/From: **1**  
 Clock To:  
 1st Value: **4.000**  
 2nd Value:  
 Value Percent:  
 Continuous Index:  
 Within 8" of Joint: **YES**  
 Remarks:

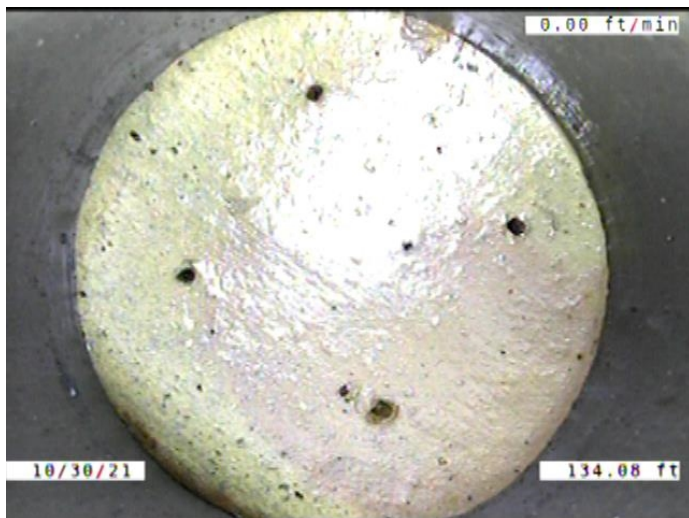
Code: **TFC**  
 Description: **Tap Factory Capped**

Distance (ft): **134.1**  
 Structural Grade: **0**  
 O&M Grade: **0**  
 Clock Start/From: **1**  
 Clock To:  
 1st Value: **4.000**  
 2nd Value:  
 Value Percent:  
 Continuous Index:  
 Within 8" of Joint: **YES**  
 Remarks:

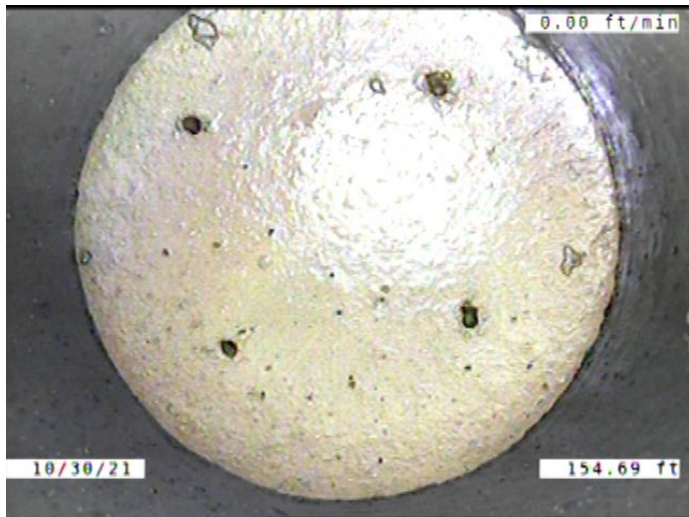
Code: **TFC**  
 Description: **Tap Factory Capped**

Distance (ft): **154.7**  
 Structural Grade: **0**  
 O&M Grade: **0**  
 Clock Start/From: **1**  
 Clock To:  
 1st Value: **4.000**  
 2nd Value:  
 Value Percent:  
 Continuous Index:  
 Within 8" of Joint: **YES**  
 Remarks:

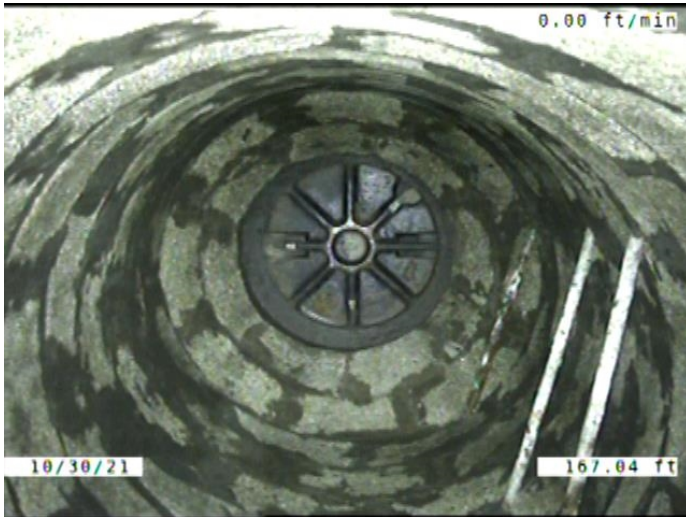
Code:	<b>AMH</b>
Description:	<b>Manhole</b>
Distance (ft):	<b>167.0</b>
Structural Grade:	<b>0</b>
O&M Grade:	<b>0</b>
Clock Start/From:	
Clock To:	
1st Value:	
2nd Value:	
Value Percent:	
Continuous Index:	
Within 8" of Joint:	<b>NO</b>
Remarks:	<b>M-504-047</b>
