Profile/Photo Observation Report

Date:	10/30/2021	Weather:		Coding:	PACP 7.0
Pipe Length (ft):	202.6	Owner:	City of Hobart	Pre Clean:	Heavy Cleaning
P.O.#:	YES502259	Surveyor:	S. Bucklin	PSR:	P-504-050-049
Customer:	City of Hobart	Clean Date:	10/26/2021	Shape:	C

Street:	North Cavender Street	Flow Control:	Not Controlled
City:	Hobart, IN	Year Renewed:	
Location:	Alley	Tape/Media #:	
Purpose:	Routine Assessment	Dia/Height:	10"
Use:	Sanitary Sewage Pipe	Material:	VCP
Drain Area:		Lining:	None
Category:	NA		
Comment:			
Location Details:		Direction of Survey:	Upstream
US MH:	M-504-049	DS MH:	M-504-050
		Total Length Surveyed (ft):	202.6

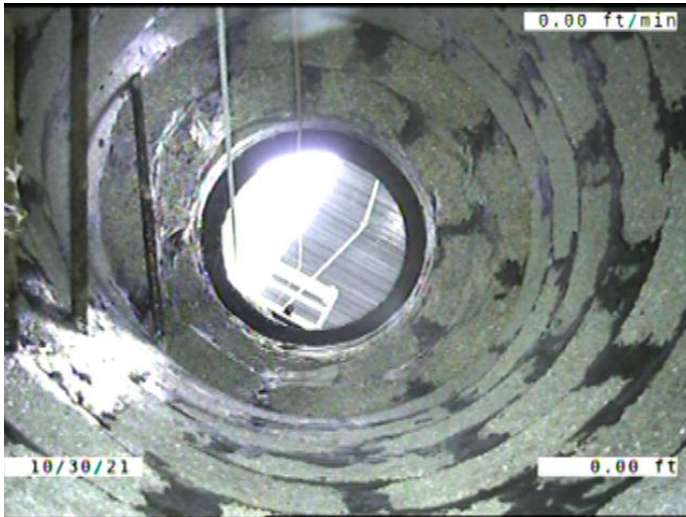
Code: **AMH**
 Description: **Manhole**

Distance (ft): **.0**
 Structural Grade: **0**
 O&M Grade: **0**
 Clock Start/From:
 Clock To:
 1st Value:
 2nd Value:
 Value Percent:
 Continuous Index:
 Within 8" of Joint: **NO**
 Remarks: **M-504-050**

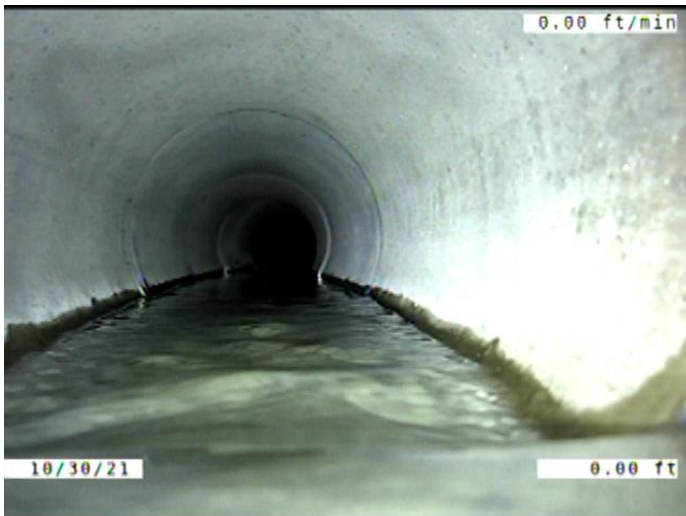
Code: **MWL**
 Description: **Miscellaneous Water Level**

Distance (ft): **.0**
 Structural Grade: **0**
 O&M Grade: **0**
 Clock Start/From:
 Clock To:
 1st Value:
 2nd Value:
 Value Percent: **10.000**
 Continuous Index:
 Within 8" of Joint: **NO**
 Remarks:

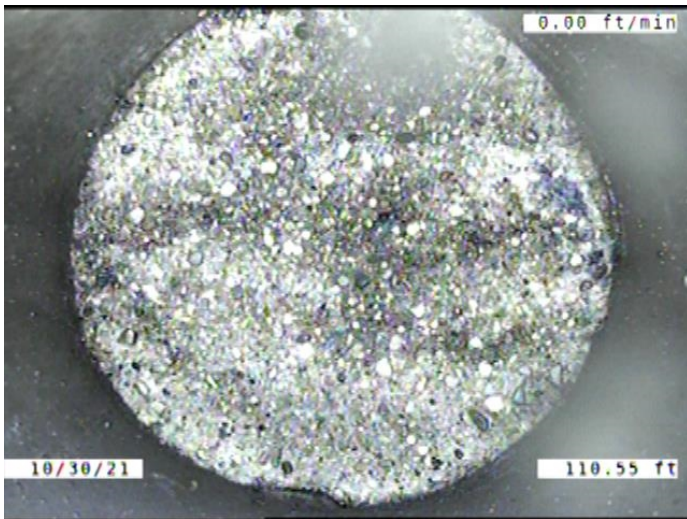
Code: **TFC**
 Description: **Tap Factory Capped**

Distance (ft): **110.5**
 Structural Grade: **0**
 O&M Grade: **0**
 Clock Start/From: **11**
 Clock To:
 1st Value: **4.000**
 2nd Value:
 Value Percent:
 Continuous Index:
 Within 8" of Joint: **YES**
 Remarks:

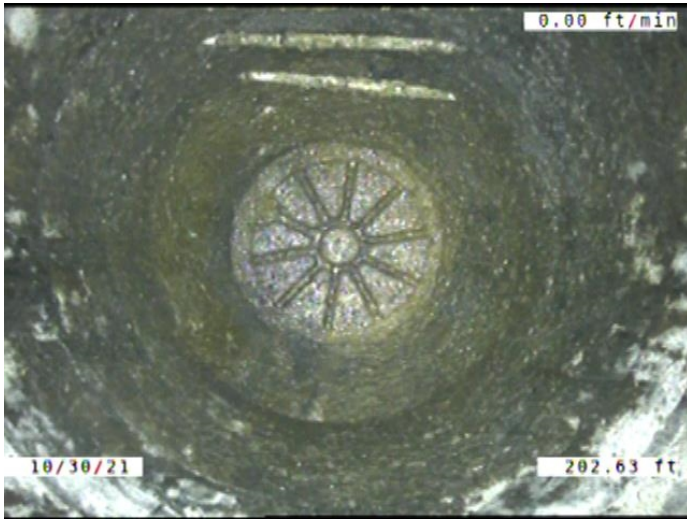
Code:	AMH
Description:	Manhole
Distance (ft):	202.6
Structural Grade:	0
O&M Grade:	0
Clock Start/From:	
Clock To:	
1st Value:	
2nd Value:	
Value Percent:	
Continuous Index:	
Within 8" of Joint:	NO
Remarks:	M-504-049
