Profile/Photo Observation Report

Date:	04/19/2018	Weather:		Coding:	PACP 6.0
Pipe Length (ft):	371.5	Owner:	NA	Pre Clean:	Not Known
P.O.#:		Surveyor:	Byrd Fitzgerald	PSR:	P-504-065.1-051
Customer:		Clean Date:	01/01/1900	Shape:	C

Street:	Summerlin	Flow Control:	Not Controlled		
City:	Hobart, IN	Year Renewed:			
Location:	Light Highway	Tape/Media #:			
Purpose:	Not Known	Dia/Height:	8"		
Use:	Sanitary	Material:	CP		
Drain Area:	NA	Lining:			
Category:	NA				
Comment:					
Location Details:		Direction of Survey:	Downstream		
US MH:	M-504-051	DS MH:	M-504-065.1	Total Length Surveyed (ft):	165.5

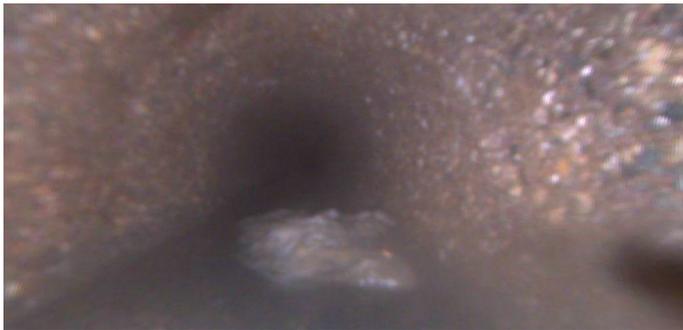
Code: **AMH**
Description: **Manhole**
Distance (ft): **.0**
Structural Grade: **0**
O&M Grade: **0**
Clock Start/From:
Clock To:
1st Value:
2nd Value:
Value Percent:
Continuous Index:
Within 8" of Joint: **NO**
Remarks: **M-504-051**

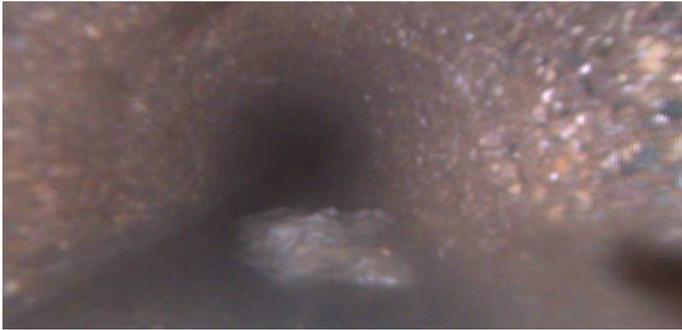
Code: **MWL**
Description: **Water Level**

Distance (ft): **.0**
Structural Grade: **0**
O&M Grade: **0**
Clock Start/From:
Clock To:
1st Value:
2nd Value:
Value Percent: **5.000**
Continuous Index:
Within 8" of Joint: **NO**
Remarks:

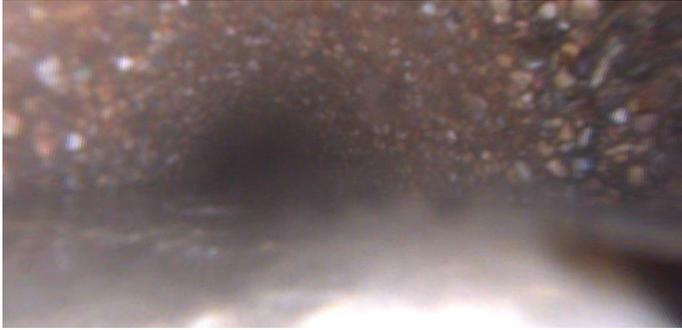
Code: **MWL**
Description: **Water Level**

Distance (ft): **85.2**
Structural Grade: **0**
O&M Grade: **0**
Clock Start/From:
Clock To:
1st Value:
2nd Value:
Value Percent: **40.000**
Continuous Index:
Within 8" of Joint: **NO**
Remarks:

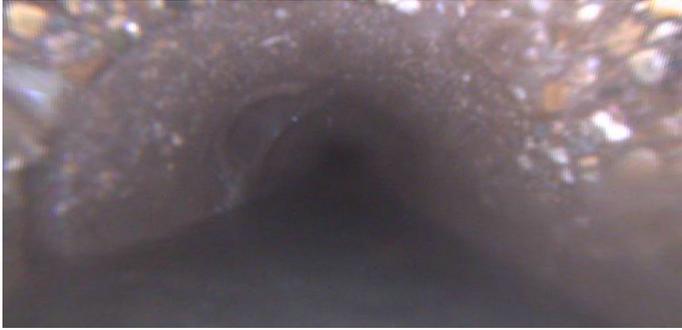
Code: **MSA**
Description: **Abandoned Survey**

Distance (ft): **165.5**
Structural Grade: **0**
O&M Grade: **0**
Clock Start/From:
Clock To:
1st Value:
2nd Value:
Value Percent:
Continuous Index:
Within 8" of Joint: **NO**
Remarks: **DSF**
