Profile/Photo Observation Report

Date:	09/13/2021	Weather:		Coding:	PACP 7.0
Pipe Length (ft):	372.0	Owner:	City of Hobart	Pre Clean:	Light Cleaning
P.O.#:	YES502259	Surveyor:	S. Bucklin	PSR:	P-504-065.1-051
Customer:	City of Hobart	Clean Date:	09/09/2021	Shape:	C

Location Details:		Direction of Survey:	Downstream
US MH:	M-504-051	DS MH:	M-504-065.1
		Total Length Surveyed (ft):	166.3

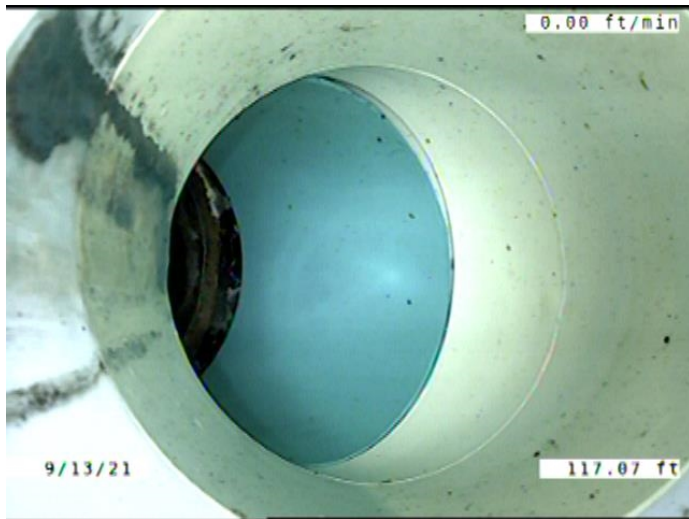
Code: **TF**
Description: **Tap Factory**

Distance (ft): **108.9**
Structural Grade: **0**
O&M Grade: **0**
Clock Start/From: **12**
Clock To:
1st Value: **4.000**
2nd Value:
Value Percent:
Continuous Index:
Within 8" of Joint: **YES**
Remarks:
