# Profile/Photo Observation Report

Date:	<b>04/22/2018</b>	Weather:		Coding:	<b>PACP 6.0</b>
Pipe Length (ft):	<b>329.5</b>	Owner:	<b>NA</b>	Pre Clean:	<b>No Pre-Cleaning</b>
P.O.#:		Surveyor:	<b>Byrd Fitzgerald</b>	PSR:	<b>P-504-053-052</b>
Customer:		Clean Date:	<b>01/01/1900</b>	Shape:	<b>C</b>

Street:	<b>FOXCROFT STREET</b>	Flow Control:	<b>Not Controlled</b>
City:	<b>Hobart, IN</b>	Year Renewed:	
Location:	<b>Light Highway</b>	Tape/Media #:	
Purpose:	<b>Routine Assessment</b>	Dia/Height:	<b>12"</b>
Use:	<b>Sanitary</b>	Material:	<b>CP</b>
Drain Area:	<b>NA</b>	Lining:	
Category:	<b>NA</b>		
Comment:	<b>P_C at 298ft nothing visible . Flow direction wrong</b>		
Location Details:		Direction of Survey:	<b>Upstream</b>
US MH:	<b>M-504-052</b>	DS MH:	<b>M-504-053</b>
		Total Length Surveyed (ft):	<b>299.1</b>

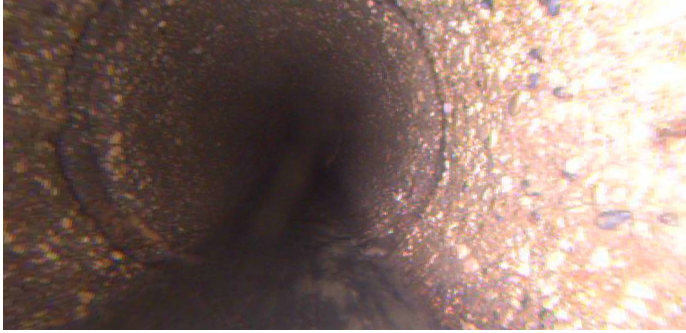
Code: **AMH**  
Description: **Manhole**

Distance (ft): **.0**  
Structural Grade: **0**  
O&M Grade: **0**  
Clock Start/From:  
Clock To:  
1st Value:  
2nd Value:  
Value Percent:  
Continuous Index:  
Within 8" of Joint: **NO**  
Remarks: **M-504-053**

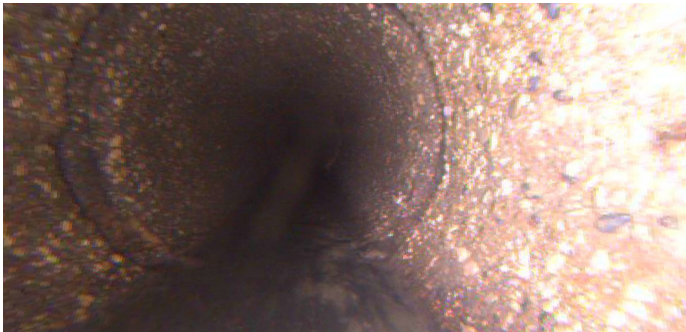
Code: **MWL**  
Description: **Water Level**

Distance (ft): **.0**  
Structural Grade: **0**  
O&M Grade: **0**  
Clock Start/From:  
Clock To:  
1st Value:  
2nd Value:  
Value Percent: **5.000**  
Continuous Index:  
Within 8" of Joint: **NO**  
Remarks:

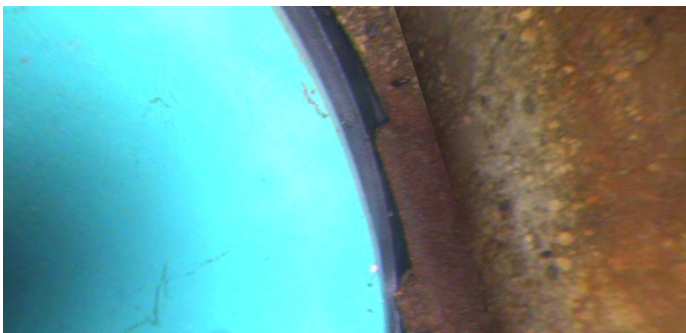
Code: **MMC**  
Description: **Material Change**

Distance (ft): **52.3**  
Structural Grade: **0**  
O&M Grade: **0**  
Clock Start/From:  
Clock To:  
1st Value:  
2nd Value:  
Value Percent:  
Continuous Index:  
Within 8" of Joint: **NO**  
Remarks: **pvc**

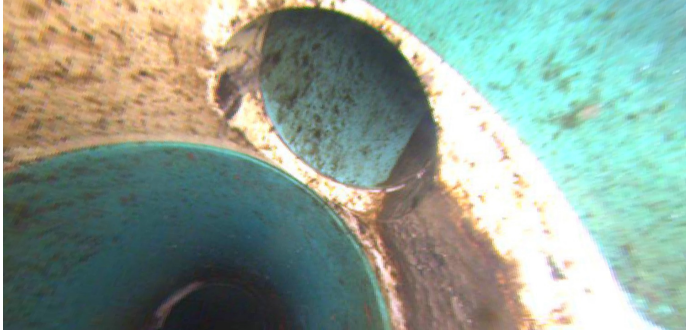
Code: **TF**  
Description: **Tap Factory**

Distance (ft): **57.8**  
Structural Grade: **0**  
O&M Grade: **0**  
Clock Start/From: **1**  
Clock To:  
1st Value: **4.000**  
2nd Value:  
Value Percent:  
Continuous Index:  
Within 8" of Joint: **YES**  
Remarks:

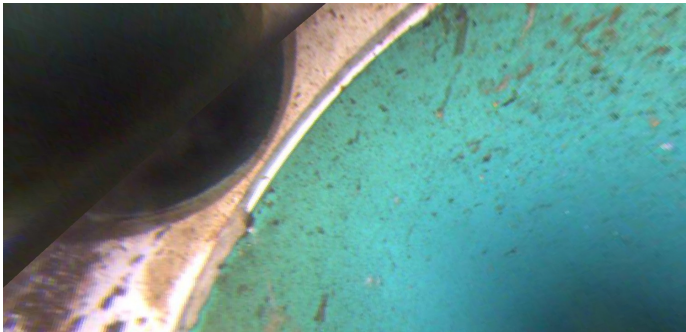
Code: **TF**  
Description: **Tap Factory**

Distance (ft): **61.1**  
Structural Grade: **0**  
O&M Grade: **0**  
Clock Start/From: **11**  
Clock To:  
1st Value: **4.000**  
2nd Value:  
Value Percent:  
Continuous Index:  
Within 8" of Joint: **YES**  
Remarks:

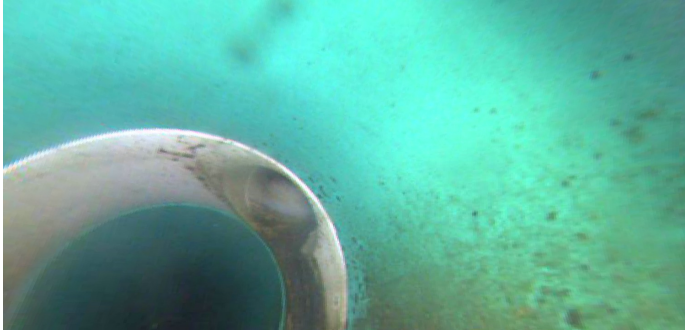
Code: **TF**  
Description: **Tap Factory**

Distance (ft): **92.0**  
Structural Grade: **0**  
O&M Grade: **0**  
Clock Start/From: **11**  
Clock To:  
1st Value: **4.000**  
2nd Value:  
Value Percent:  
Continuous Index:  
Within 8" of Joint: **YES**  
Remarks:

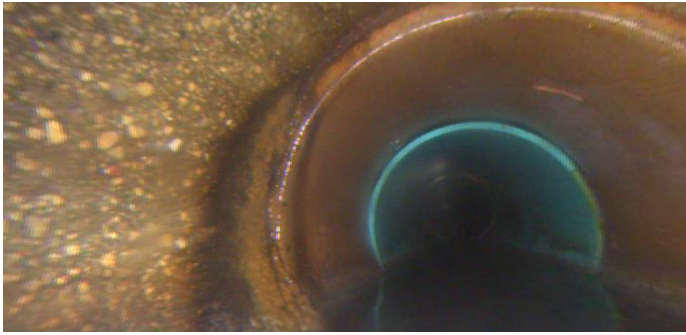
Code: **MMC**  
Description: **Material Change**

Distance (ft): **95.3**  
Structural Grade: **0**  
O&M Grade: **0**  
Clock Start/From:  
Clock To:  
1st Value:  
2nd Value:  
Value Percent:  
Continuous Index:  
Within 8" of Joint: **NO**  
Remarks: **concrete**

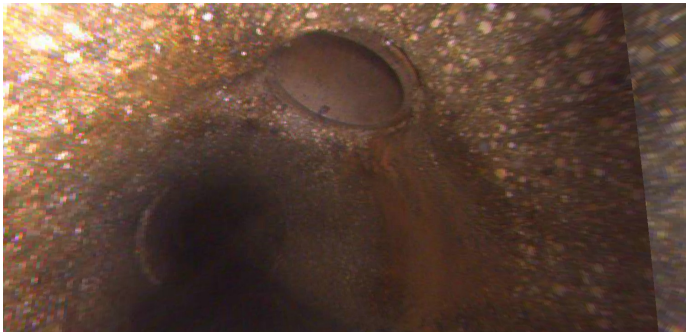
Code: **TF**  
Description: **Tap Factory**

Distance (ft): **95.3**  
Structural Grade: **0**  
O&M Grade: **0**  
Clock Start/From: **1**  
Clock To:  
1st Value: **4.000**  
2nd Value:  
Value Percent:  
Continuous Index:  
Within 8" of Joint: **YES**  
Remarks:

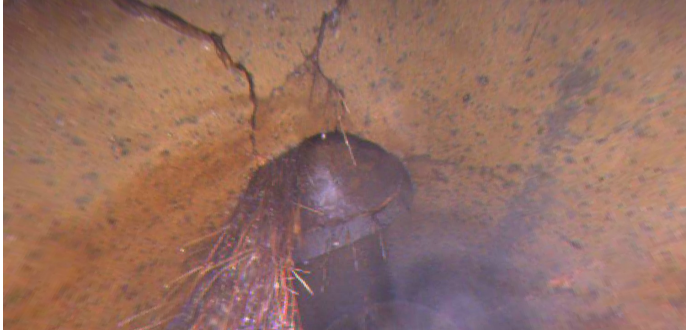
Code: **TF**  
Description: **Tap Factory**

Distance (ft): **130.1**  
Structural Grade: **0**  
O&M Grade: **0**  
Clock Start/From: **11**  
Clock To:  
1st Value: **4.000**  
2nd Value:  
Value Percent:  
Continuous Index:  
Within 8" of Joint:  
Remarks:

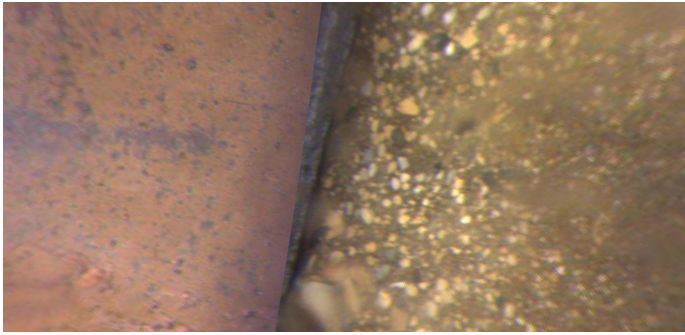
Code: **MMC**  
Description: **Material Change**

Distance (ft): **130.1**  
Structural Grade: **0**  
O&M Grade: **0**  
Clock Start/From:  
Clock To:  
1st Value:  
2nd Value:  
Value Percent:  
Continuous Index:  
Within 8" of Joint: **NO**  
Remarks: **vcp**

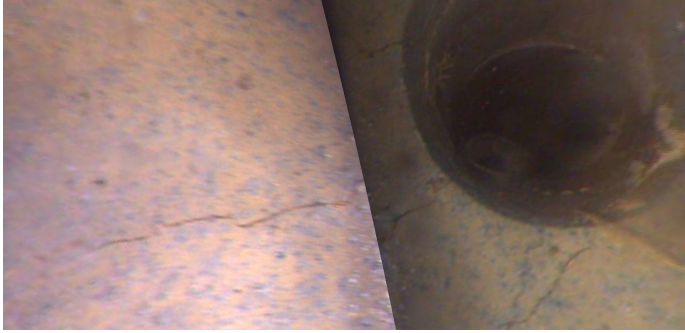
Code: **TF**  
Description: **Tap Factory**

Distance (ft): **133.2**  
Structural Grade: **0**  
O&M Grade: **0**  
Clock Start/From: **1**  
Clock To:  
1st Value: **4.000**  
2nd Value:  
Value Percent:  
Continuous Index:  
Within 8" of Joint:  
Remarks:

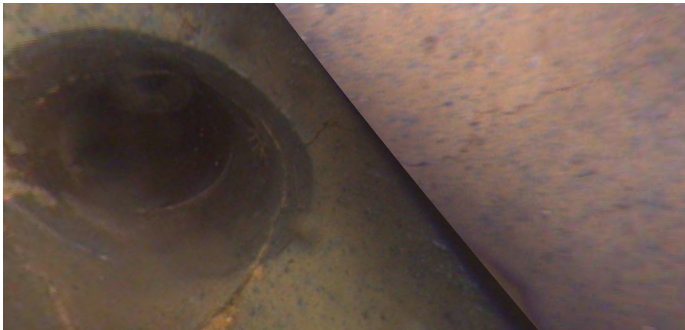
Code: **TF**  
Description: **Tap Factory**

Distance (ft): **133.2**  
Structural Grade: **0**  
O&M Grade: **0**  
Clock Start/From: **11**  
Clock To:  
1st Value: **4.000**  
2nd Value:  
Value Percent:  
Continuous Index:  
Within 8" of Joint:  
Remarks:

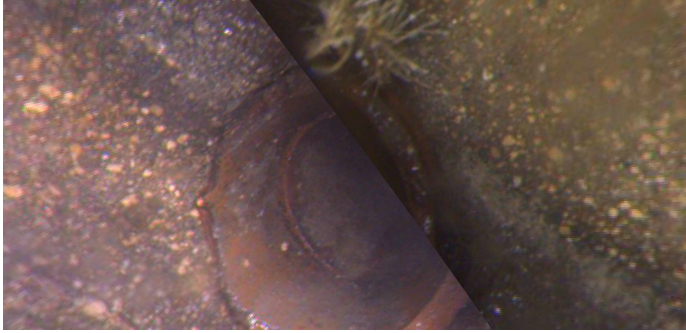
Code: **TF**  
Description: **Tap Factory**

Distance (ft): **151.1**  
Structural Grade: **0**  
O&M Grade: **0**  
Clock Start/From: **1**  
Clock To:  
1st Value: **4.000**  
2nd Value:  
Value Percent:  
Continuous Index:  
Within 8" of Joint:  
Remarks:

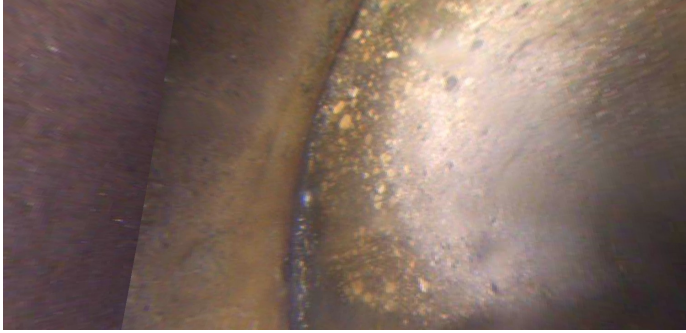
Code: **MMC**  
Description: **Material Change**

Distance (ft): **167.1**  
Structural Grade: **0**  
O&M Grade: **0**  
Clock Start/From:  
Clock To:  
1st Value:  
2nd Value:  
Value Percent:  
Continuous Index:  
Within 8" of Joint: **NO**  
Remarks: **vcp**

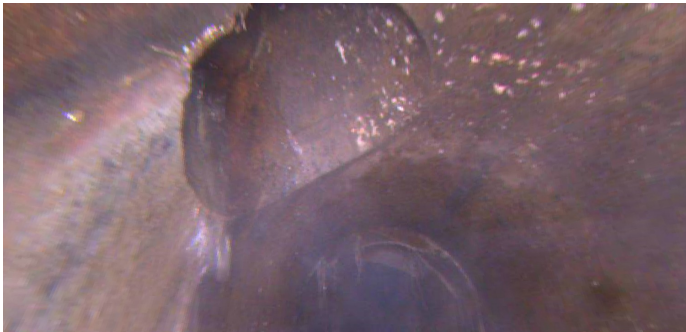
Code: **TF**  
Description: **Tap Factory**

Distance (ft): **167.1**  
Structural Grade: **0**  
O&M Grade: **0**  
Clock Start/From: **11**  
Clock To:  
1st Value: **4.000**  
2nd Value:  
Value Percent:  
Continuous Index:  
Within 8" of Joint:  
Remarks:

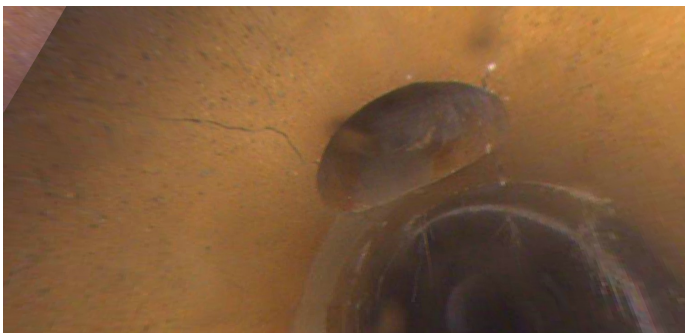
Code: **TF**  
Description: **Tap Factory**

Distance (ft): **170.3**  
Structural Grade: **0**  
O&M Grade: **0**  
Clock Start/From: **1**  
Clock To:  
1st Value: **4.000**  
2nd Value:  
Value Percent:  
Continuous Index:  
Within 8" of Joint: **YES**  
Remarks:

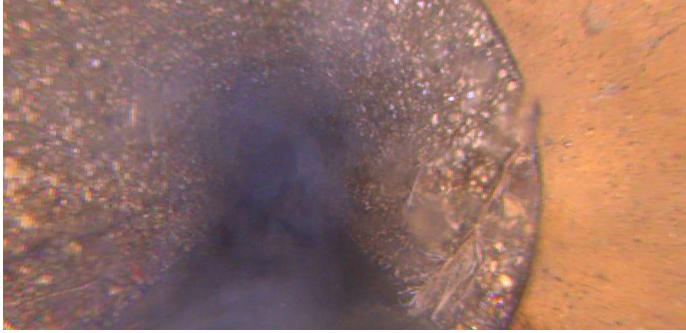
Code: **MMC**  
Description: **Material Change**

Distance (ft): **170.3**  
Structural Grade: **0**  
O&M Grade: **0**  
Clock Start/From:  
Clock To:  
1st Value:  
2nd Value:  
Value Percent:  
Continuous Index:  
Within 8" of Joint: **NO**  
Remarks: **concrete**

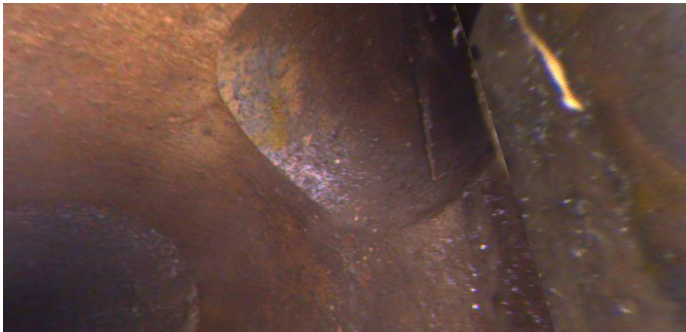
Code: **TF**  
Description: **Tap Factory**

Distance (ft): **203.3**  
Structural Grade: **0**  
O&M Grade: **0**  
Clock Start/From: **1**  
Clock To:  
1st Value: **4.000**  
2nd Value:  
Value Percent:  
Continuous Index:  
Within 8" of Joint:  
Remarks:

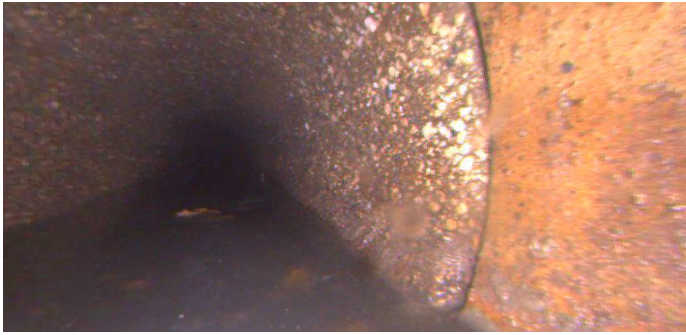
Code: **MMC**  
Description: **Material Change**

Distance (ft): **204.5**  
Structural Grade: **0**  
O&M Grade: **0**  
Clock Start/From:  
Clock To:  
1st Value:  
2nd Value:  
Value Percent:  
Continuous Index:  
Within 8" of Joint: **NO**  
Remarks: **concrete**

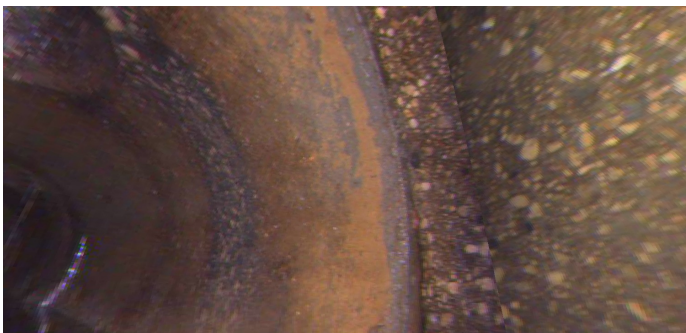
Code: **MMC**  
Description: **Material Change**

Distance (ft): **240.1**  
Structural Grade: **0**  
O&M Grade: **0**  
Clock Start/From:  
Clock To:  
1st Value:  
2nd Value:  
Value Percent:  
Continuous Index:  
Within 8" of Joint: **NO**  
Remarks: **vcp**

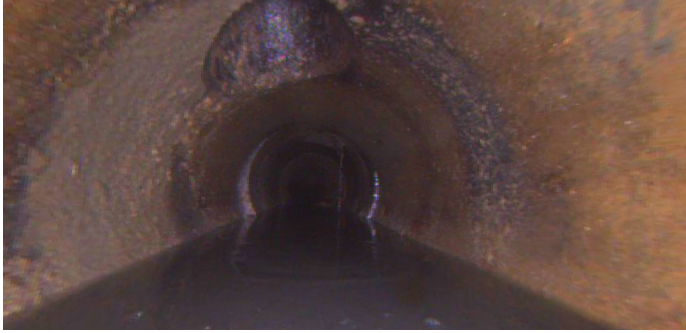
Code: **TF**  
Description: **Tap Factory**

Distance (ft): **240.1**  
Structural Grade: **0**  
O&M Grade: **0**  
Clock Start/From: **12**  
Clock To:  
1st Value: **4.000**  
2nd Value:  
Value Percent:  
Continuous Index:  
Within 8" of Joint:  
Remarks:

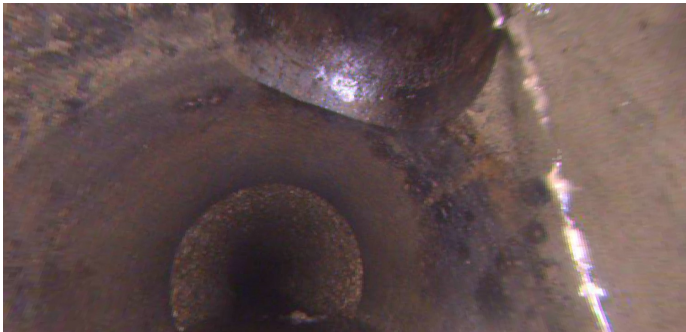
Code: **TF**  
Description: **Tap Factory**

Distance (ft): **242.6**  
Structural Grade: **0**  
O&M Grade: **0**  
Clock Start/From: **1**  
Clock To:  
1st Value: **4.000**  
2nd Value:  
Value Percent:  
Continuous Index:  
Within 8" of Joint:  
Remarks:

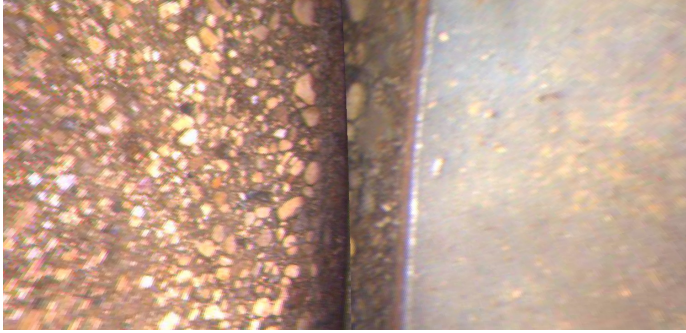
Code: **MMC**  
Description: **Material Change**

Distance (ft): **244.3**  
Structural Grade: **0**  
O&M Grade: **0**  
Clock Start/From:  
Clock To:  
1st Value:  
2nd Value:  
Value Percent:  
Continuous Index:  
Within 8" of Joint: **NO**  
Remarks: **concrete**

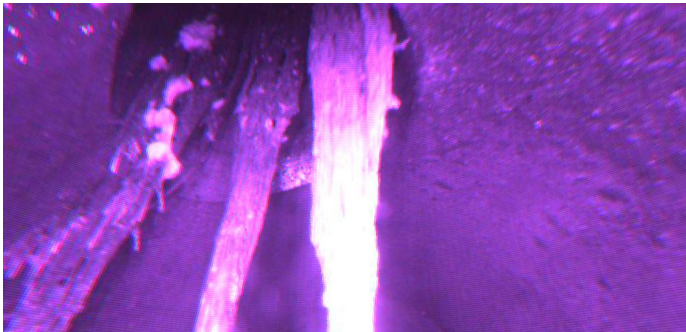
Code: **TF**  
Description: **Tap Factory**

Distance (ft): **280.5**  
Structural Grade: **0**  
O&M Grade: **0**  
Clock Start/From: **11**  
Clock To:  
1st Value: **4.000**  
2nd Value:  
Value Percent:  
Continuous Index:  
Within 8" of Joint:  
Remarks:

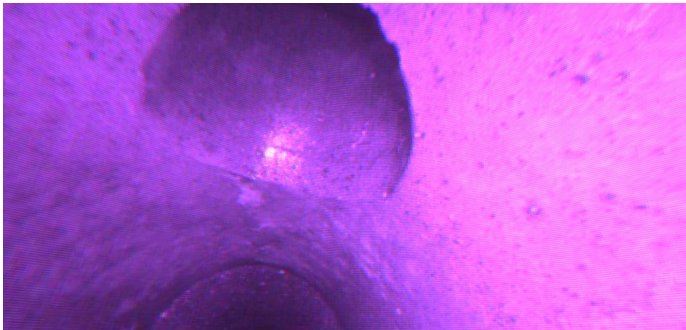
Code: **TF**  
Description: **Tap Factory**

Distance (ft): **282.4**  
Structural Grade: **0**  
O&M Grade: **0**  
Clock Start/From: **1**  
Clock To:  
1st Value: **4.000**  
2nd Value:  
Value Percent:  
Continuous Index:  
Within 8" of Joint: **YES**  
Remarks:
