Profile/Photo Observation Report

RUBUIICS
Date:	09/15/2021	Weather:		0	PACP 7.0
Pipe Length (ft)	: 318.3	Owner:	City of Hobart	Pre Clean:	Heavy Cleaning
P.O.#:	YES502259	Surveyor:	S. Bucklin	PSR:	P-504-053-052
Customer:	City of Hobart	Clean Date:	09/07/2021	Shape:	С
Street:	North Guyer Stree	t	Flow Control:	Not Controlled	
City:	Hobart, IN		Year Renewed:		
Location:	Local rural streets	with light traffic, t	Tape/Media #:		
Purpose:	Routine Assessme	nt	Dia/Height:	12"	
Use:	Sanitary Sewage P	ipe	Material:	СР	
Drain Area:			Lining:	None	
Category:	NA				
Comment:					
Location Details	5:		Direction of Survey:	Downstream	
US MH:	M-504-052	DS MH: M	-504-053	Total Length Surveyed (ft):	318.3
0&M Index:	2.09	O&M Quick:	372M	O&M Rating:	167.00
tructural Index:	3.00	Structural Quick	c: 4533	Structural Rating:	39.00
overall Index:	2.22	Overall Quick:	453A	Overall Rating:	206.00

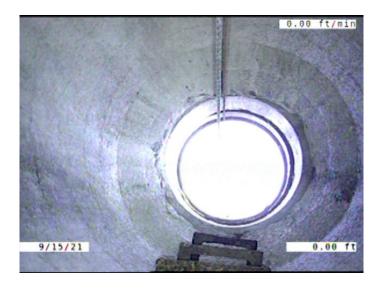
Code:	AMH
Description:	Manhole
Distance (ft):	.0
. ,	
Structural Grade:	0
O&M Grade:	0
Clock Start/From:	
Clock To:	
1st Value:	
2nd Value:	
Value Percent:	
Continuous Index:	
Within 8" of Joint:	NO
Remarks:	M-504-052

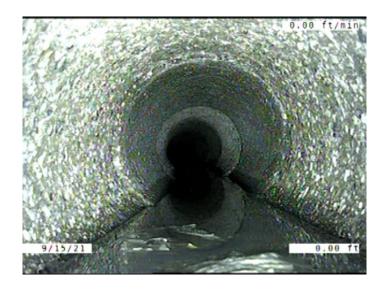
Code: Description:	MWL Miscellaneous Water Level
Distance (ft):	.0
Structural Grade:	0
O&M Grade:	0
Clock Start/From:	
Clock To:	
1st Value:	
2nd Value:	
Value Percent:	5.000
Continuous Index:	
Within 8" of Joint:	NO
Remarks:

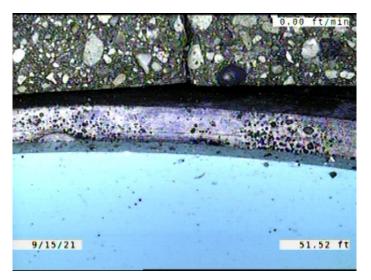
Code: Description:	MMC Miscellaneous Material Change
Distance (ft):	51.5
Structural Grade:	0
O&M Grade:	0
Clock Start/From:	
Clock To:	
1st Value:	
2nd Value:	
Value Percent:	
Continuous Index:	
Within 8" of Joint:	NO
Remarks:	CONCRETE TO PVC

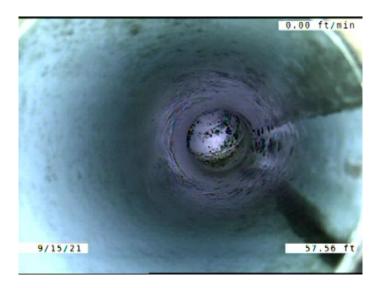
Code: Description:	TFA Tap Factory Activity
Distance (ft): Structural Grade: O&M Grade: Clock Start/From: Clock To: 1st Value: 2nd Value: Value Percent: Continuous Index: Within 8" of Joint: Remarks:	57.6 0 2 4.000 YES

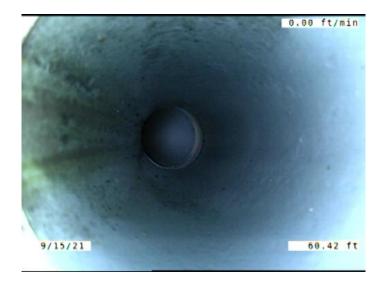
Code:	TF
Description:	Tap Factory
Distance (ft):	60.4
	-
Structural Grade:	0
O&M Grade:	0
Clock Start/From:	11
Clock To:	
1st Value:	4.000
2nd Value:	
Value Percent:	
Continuous Index:	
Within 8" of Joint:	YES
Remarks:

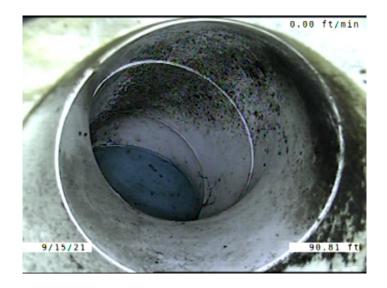
Code: Description:	TF Tap Factory
Distance (ft): Structural Grade: O&M Grade: Clock Start/From: Clock To: 1st Value: 2nd Value: Value Percent: Continuous Index: Within 8" of Joint:	90.8 0 0 11 4.000 YES
Remarks:

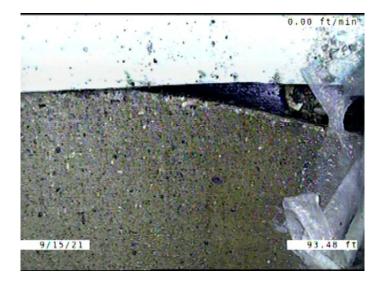
Code: Description:	MMC Miscellaneous Material Change
Distance (ft):	93.5
Structural Grade:	0
O&M Grade:	0
Clock Start/From:	
Clock To:	
1st Value:	
2nd Value:	
Value Percent:	
Continuous Index:	
Within 8" of Joint:	NO
Remarks:	ΡVC ΤΟ VCP

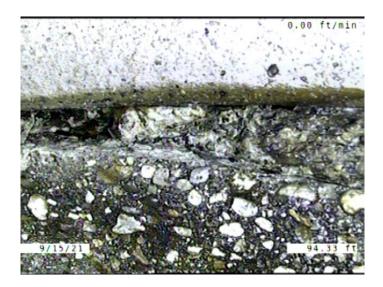
Code: Description:	MMC Miscellaneous Material Change
Distance (ft):	94.3
Structural Grade:	0
O&M Grade:	0
Clock Start/From:	
Clock To:	
1st Value:	
2nd Value:	
Value Percent:	
Continuous Index:	
Within 8" of Joint:	NO
Remarks:	VCP TO CONCRETE

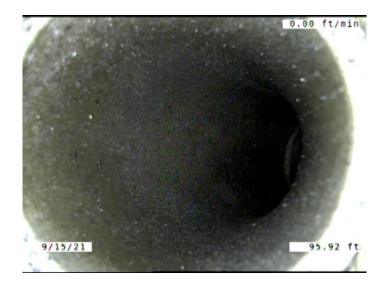
Code:	TF
Description:	Tap Factory
Distance (ft):	95.9
Structural Grade:	0
O&M Grade:	0
Clock Start/From:	1
Clock To:	
1st Value:	4.000
2nd Value:	
Value Percent:	
Continuous Index:	
Within 8" of Joint:	YES
Remarks:

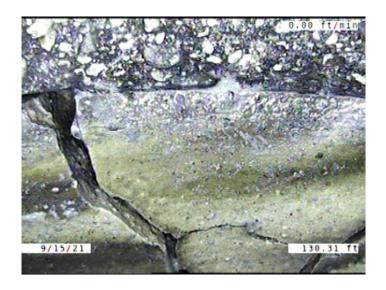
Code: Description:	MMC Miscellaneous Material Change
Distance (ft):	130.3
Structural Grade:	0
O&M Grade:	0
Clock Start/From:	
Clock To:	
1st Value:	
2nd Value:	
Value Percent:	
Continuous Index:	
Within 8" of Joint:	NO
Remarks:	CONCRETE TO VCP

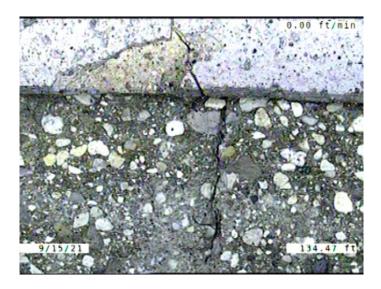
Code: Description:	MMC Miscellaneous Material Change
Distance (ft):	134.5
Structural Grade:	0
O&M Grade:	0
Clock Start/From:	
Clock To:	
1st Value:	
2nd Value:	
Value Percent:	
Continuous Index:	
Within 8" of Joint:	NO
Remarks:	VCP TO CONCRETE

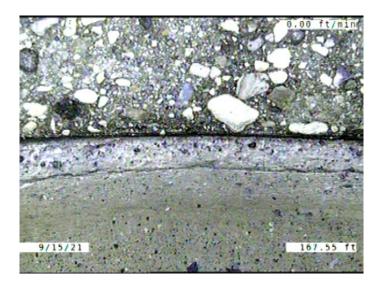
Code: Description:	MMC Miscellaneous Material Change
Distance (ft):	167.5
Structural Grade:	0
O&M Grade:	0
Clock Start/From:	
Clock To:	
1st Value:	
2nd Value:	
Value Percent:	
Continuous Index:	
Within 8" of Joint:	NO
Remarks:	CONCRETE TO VCP

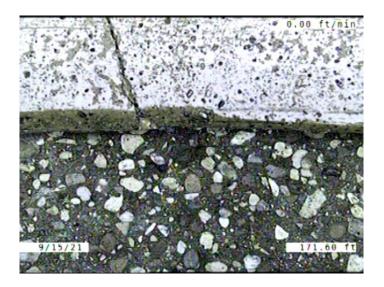
Code: Description:	MMC Miscellaneous Material Change
Distance (ft):	171.6
Structural Grade:	0
O&M Grade:	0
Clock Start/From:	
Clock To:	
1st Value:	
2nd Value:	
Value Percent:	
Continuous Index:	
Within 8" of Joint:	NO
Remarks:	VCP TO CONCRETE

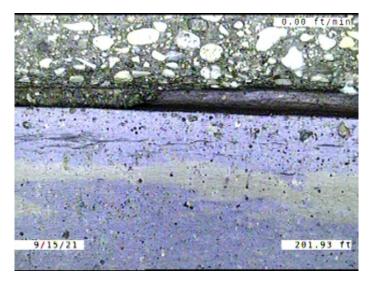
Code: MMC Description: **Miscellaneous Material Change** Distance (ft): 201.9 Structural Grade: 0 O&M Grade: 0 Clock Start/From: Clock To: 1st Value: 2nd Value: Value Percent: Continuous Index: Within 8" of Joint: NO Remarks: CONCRETE TO VCP

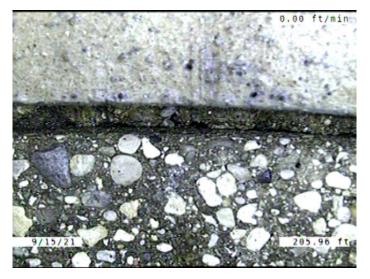
Code: MMC Description: **Miscellaneous Material Change** Distance (ft): 206.0 Structural Grade: 0 O&M Grade: 0 Clock Start/From: Clock To: 1st Value: 2nd Value: Value Percent: Continuous Index: Within 8" of Joint: NO Remarks: **VCP TO CONCRETE**

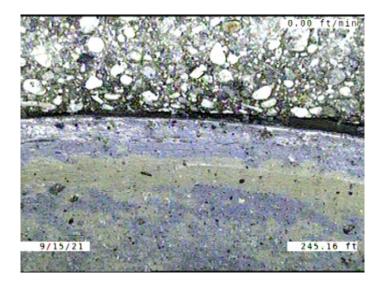
Code: Description:	MMC Miscellaneous Material Change
Distance (ft):	245.2
Structural Grade:	0
O&M Grade:	0
Clock Start/From:	
Clock To:	
1st Value:	
2nd Value:	
Value Percent:	
Continuous Index:	
Within 8" of Joint:	NO
Remarks:	CONCRETE TO VCP

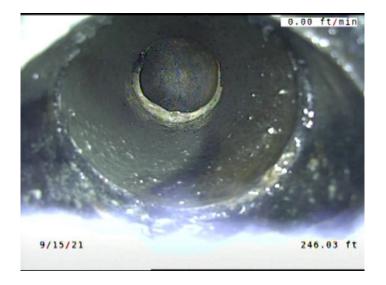
Code:	TF
Description:	Tap Factory
Distance (ft):	246.0
Distance (ft):	240.0
Structural Grade:	0
O&M Grade:	0
Clock Start/From:	11
Clock To:	
1st Value:	4.000
2nd Value:	
Value Percent:	
Continuous Index:	
Within 8" of Joint:	YES
Remarks:

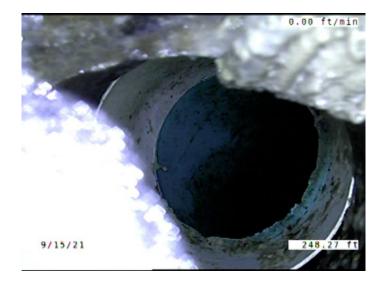
Code:	TF
Description:	Tap Factory
	240.2
Distance (ft):	248.3
Structural Grade:	0
O&M Grade:	0
Clock Start/From:	1
Clock To:	
1st Value:	4.000
2nd Value:	
Value Percent:	
Continuous Index:	
Within 8" of Joint:	YES
Remarks:

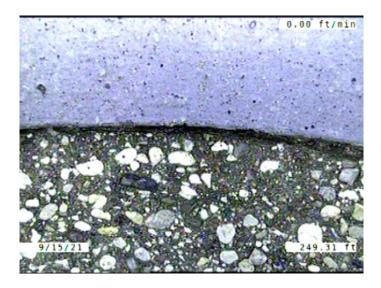
Code: Description:	MMC Miscellaneous Material Change
Distance (ft):	249.3
Structural Grade:	0
O&M Grade:	0
Clock Start/From:	
Clock To:	
1st Value:	
2nd Value:	
Value Percent:	
Continuous Index:	
Within 8" of Joint:	NO
Remarks:	VCP TO CONCRETE

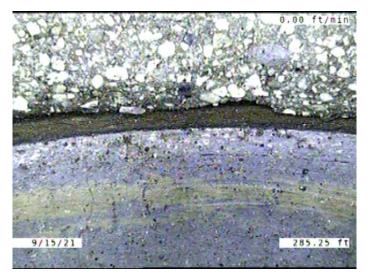
Code: MMC Description: **Miscellaneous Material Change** Distance (ft): 285.3 Structural Grade: 0 O&M Grade: 0 Clock Start/From: Clock To: 1st Value: 2nd Value: Value Percent: Continuous Index: Within 8" of Joint: NO Remarks: CONCRETE TO VCP

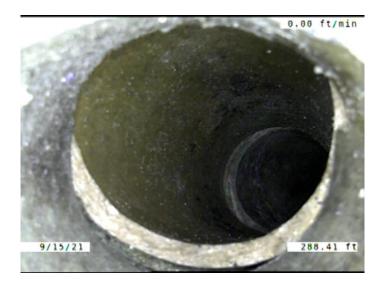
Code:	TF
Description:	Tap Factory
Distance (ft):	288.4
Structural Grade:	0
O&M Grade:	0
Clock Start/From:	1
Clock To:	
1st Value:	4.000
2nd Value:	
Value Percent:	
Continuous Index:	
Within 8" of Joint:	YES
Remarks:

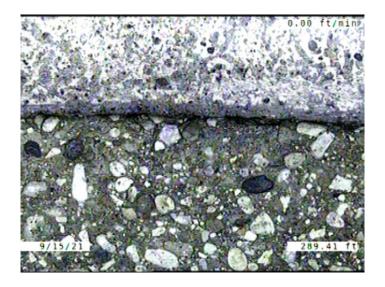
Code: Description:	MMC Miscellaneous Material Change
Distance (ft):	289.4
Structural Grade:	0
O&M Grade:	0
Clock Start/From:	
Clock To:	
1st Value:	
2nd Value:	
Value Percent:	
Continuous Index:	
Within 8" of Joint:	NO
Remarks:	VCP TO CONCRETE

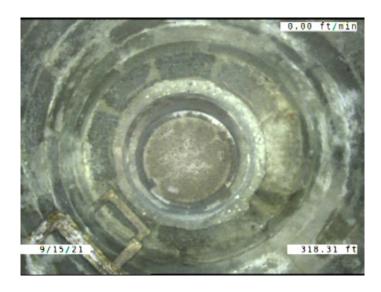
Code: Description:	AMH Manhole
Distance (ft):	318.3
Structural Grade:	0
O&M Grade:	0
Clock Start/From:	
Clock To:	
1st Value:	
2nd Value:	
Value Percent:	
Continuous Index:	
Within 8" of Joint:	NO
Remarks:	M-504-053
