Profile/Photo Observation Report

Street:	FOXCROFT STREET	Flow Control:	Not Controlled
City:	Hobart, IN	Year Renewed:	
Location:	Light Highway	Tape/Media #:	
Purpose:	Routine Assessment	Dia/Height:	12"
Use:	Sanitary	Material:	VCP
Drain Area:	NA	Lining:	
Category:	NA		
Comment:	P_C at 46 ft roots. Flow direction wrong		
Location Details:		Direction of Survey:	Downstream
US MH:	M-504-053	DS MH:	M-504-054
		Total Length Surveyed (ft):	47.1

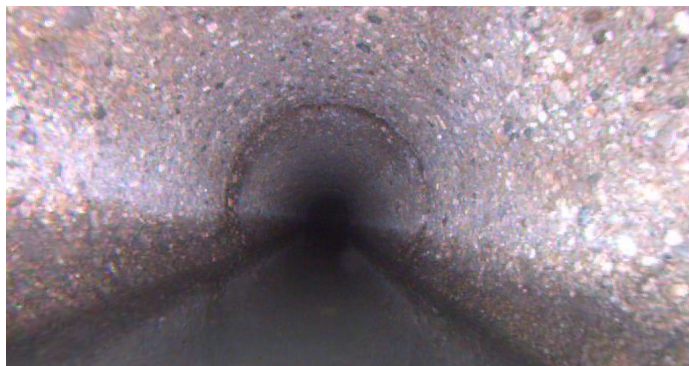
Code: **AMH**
Description: **Manhole**

Distance (ft): **.0**
Structural Grade: **0**
O&M Grade: **0**
Clock Start/From:
Clock To:
1st Value:
2nd Value:
Value Percent:
Continuous Index:
Within 8" of Joint: **NO**
Remarks: **M-504-053**

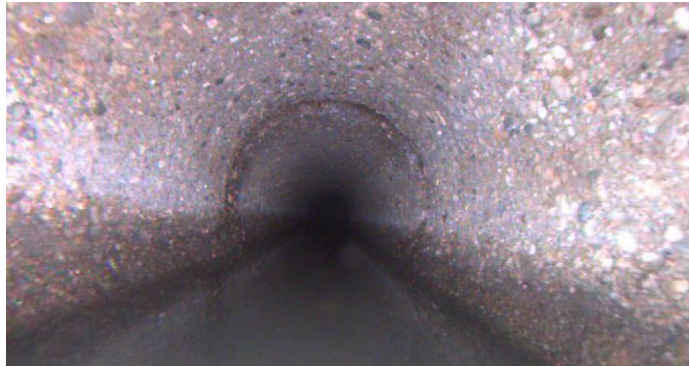
Code: **MWL**
Description: **Water Level**

Distance (ft): **.0**
Structural Grade: **0**
O&M Grade: **0**
Clock Start/From:
Clock To:
1st Value:
2nd Value:
Value Percent: **10.000**
Continuous Index:
Within 8" of Joint: **NO**
Remarks:
