Profile/Photo Observation Report

Street:	W HOME AVE	Flow Control:	Not Controlled
City:	Hobart, IN	Year Renewed:	
Location:	Light Highway	Tape/Media #:	
Purpose:	Routine Assessment	Dia/Height:	12"
Use:	Sanitary	Material:	CP
Drain Area:	NA	Lining:	
Category:	NA		
Comment:	F_S_P_C at 10 ft grit / debris Flow direction wrong		
Location Details:		Direction of Survey:	Upstream
US MH:	M-504-053	DS MH:	M-504-054
		Total Length Surveyed (ft):	12.0

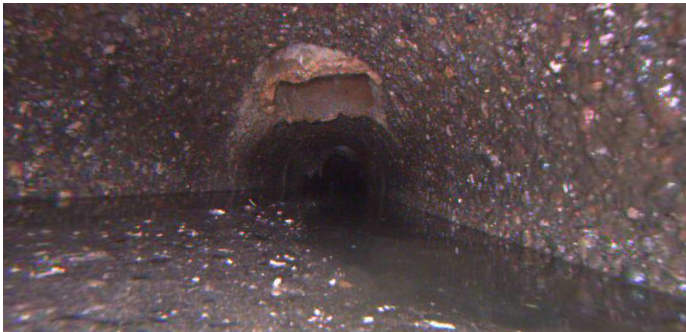
Code: **MSA**
Description: **Abandoned Survey**

Distance (ft): **12.0**
Structural Grade: **0**
O&M Grade: **0**
Clock Start/From:
Clock To:
1st Value:
2nd Value:
Value Percent:
Continuous Index:
Within 8" of Joint: **NO**
Remarks: **debris under water**
