Profile/Photo Observation Report

Date:	09/15/2021	Weather:		Coding:	PACP 7.0
Pipe Length (ft):	307.1	Owner:	City of Hobart	Pre Clean:	Light Cleaning
P.O.#:	YES502259	Surveyor:	S. Bucklin	PSR:	P-504-054-053
Customer:	City of Hobart	Clean Date:	09/10/2021	Shape:	C

Street:	North Guyer Street	Flow Control:	Not Controlled
City:	Hobart, IN	Year Renewed:	
Location:	Alley	Tape/Media #:	
Purpose:	Routine Assessment	Dia/Height:	10"
Use:	Sanitary Sewage Pipe	Material:	CP
Drain Area:		Lining:	None
Category:	NA		
Comment:			
Location Details:		Direction of Survey:	Downstream
US MH:	M-504-053	DS MH:	M-504-054
		Total Length Surveyed (ft):	307.1

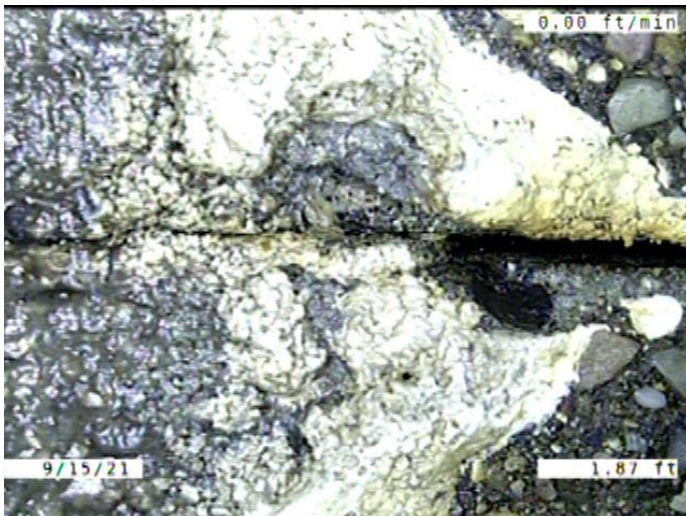
Code: **MWL**
 Description: **Miscellaneous Water Level**

Distance (ft): **.0**
 Structural Grade: **0**
 O&M Grade: **0**
 Clock Start/From:
 Clock To:
 1st Value:
 2nd Value:
 Value Percent: **10.000**
 Continuous Index:
 Within 8" of Joint: **NO**
 Remarks:

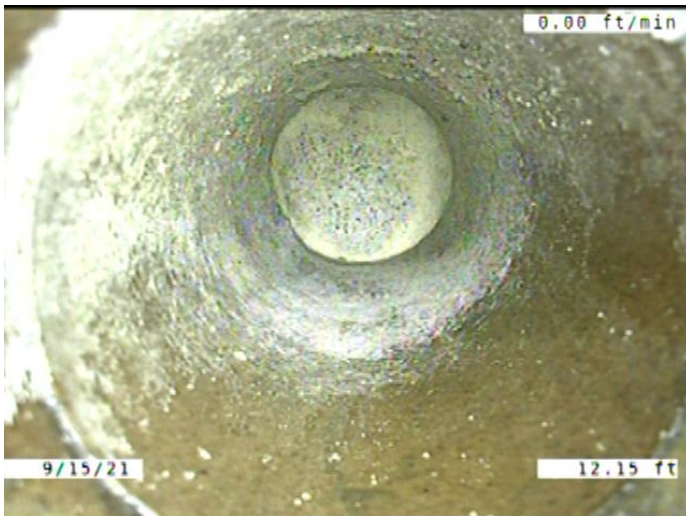
Code: **DAE**
 Description: **Deposits Attached Encrustation**

Distance (ft): **11.8**
 Structural Grade: **0**
 O&M Grade: **2**
 Clock Start/From: **10**
 Clock To: **2**
 1st Value:
 2nd Value:
 Value Percent: **5.000**
 Continuous Index:
 Within 8" of Joint: **YES**
 Remarks:

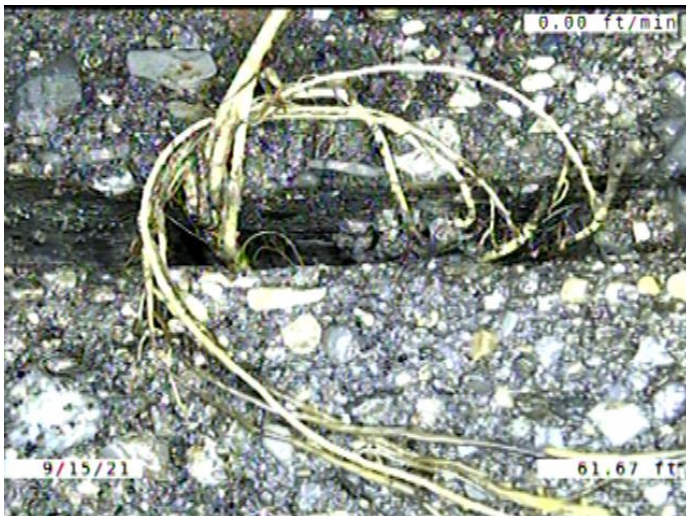
Code: **RFJ**
 Description: **Roots Fine Joint**

Distance (ft): **61.7**
 Structural Grade: **0**
 O&M Grade: **1**
 Clock Start/From: **3**
 Clock To:
 1st Value:
 2nd Value:
 Value Percent:
 Continuous Index:
 Within 8" of Joint: **YES**
 Remarks:

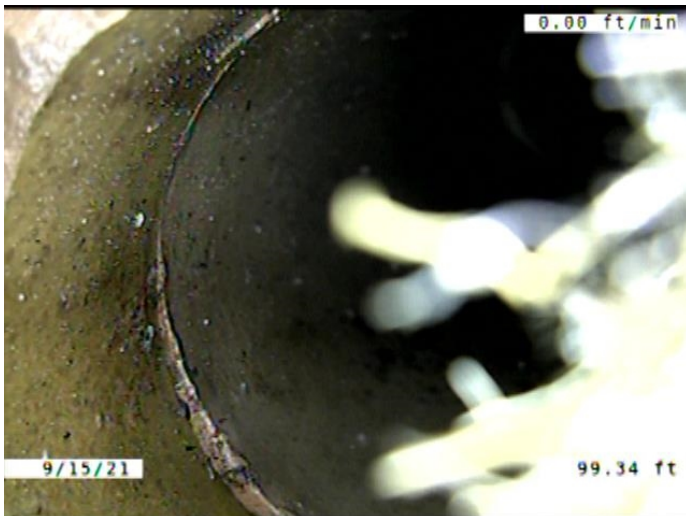
Code: **DAE**
 Description: **Deposits Attached Encrustation**

Distance (ft): **99.3**
 Structural Grade: **0**
 O&M Grade: **2**
 Clock Start/From: **1**
 Clock To: **3**
 1st Value:
 2nd Value:
 Value Percent: **5.000**
 Continuous Index:
 Within 8" of Joint: **NO**
 Remarks:

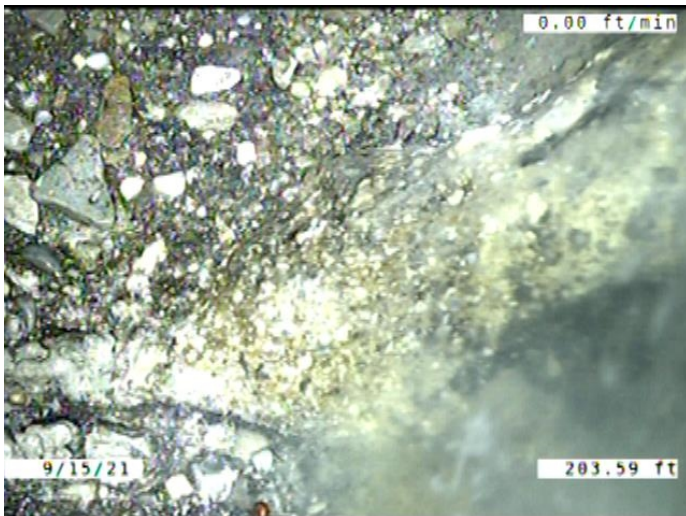
Code: **DAE**
Description: **Deposits Attached Encrustation**

Distance (ft): **200.4**
Structural Grade: **0**
O&M Grade: **2**
Clock Start/From: **6**
Clock To: **8**
1st Value:
2nd Value:
Value Percent: **5.000**
Continuous Index:
Within 8" of Joint: **YES**
Remarks:

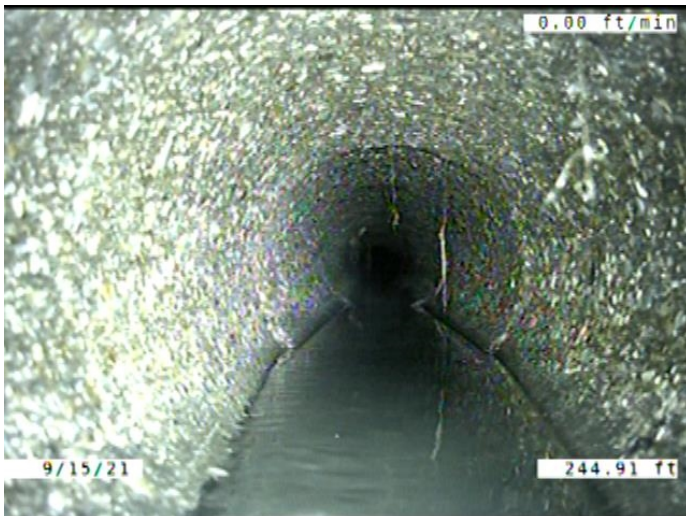
Code: **DAE**
 Description: **Deposits Attached Encrustation**

Distance (ft): **238.8**
 Structural Grade: **0**
 O&M Grade: **2**
 Clock Start/From: **3**
 Clock To: **4**
 1st Value:
 2nd Value:
 Value Percent: **5.000**
 Continuous Index:
 Within 8" of Joint: **YES**
 Remarks:

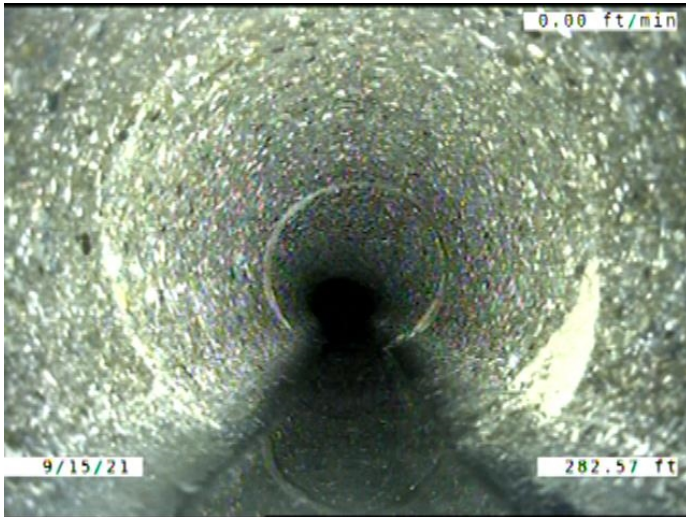
Code: **DAE**
 Description: **Deposits Attached Encrustation**

Distance (ft): **278.2**
 Structural Grade: **0**
 O&M Grade: **2**
 Clock Start/From: **10**
 Clock To:
 1st Value:
 2nd Value:
 Value Percent: **5.000**
 Continuous Index:
 Within 8" of Joint: **YES**
 Remarks:

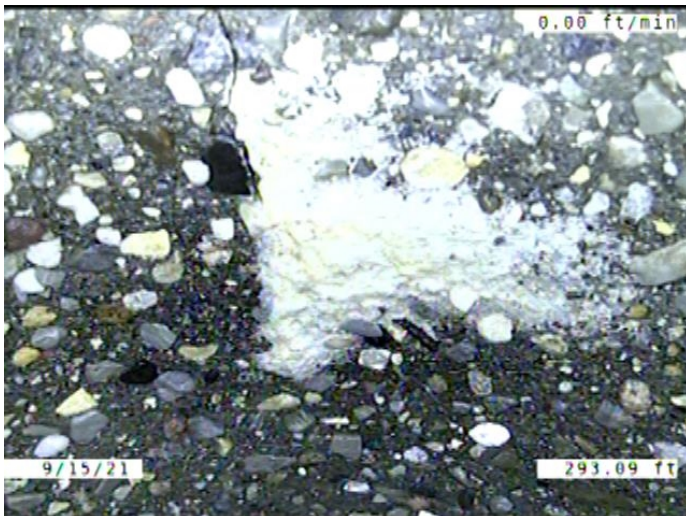
Code: **CL**
 Description: **Crack Longitudinal**

Distance (ft): **293.1**
 Structural Grade: **2**
 O&M Grade: **0**
 Clock Start/From: **1**
 Clock To:
 1st Value:
 2nd Value:
 Value Percent:
 Continuous Index:
 Within 8" of Joint: **YES**
 Remarks:

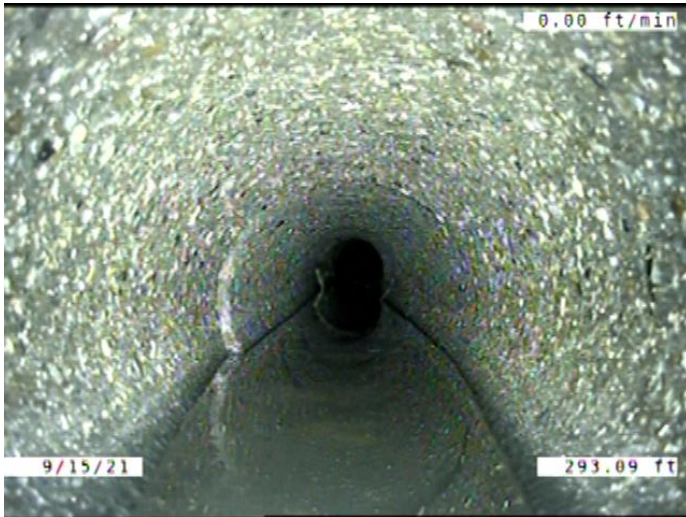
Code: **DAE**
 Description: **Deposits Attached Encrustation**

Distance (ft): **293.1**
 Structural Grade: **0**
 O&M Grade: **2**
 Clock Start/From: **1**
 Clock To:
 1st Value:
 2nd Value:
 Value Percent: **5.000**
 Continuous Index:
 Within 8" of Joint: **YES**
 Remarks:

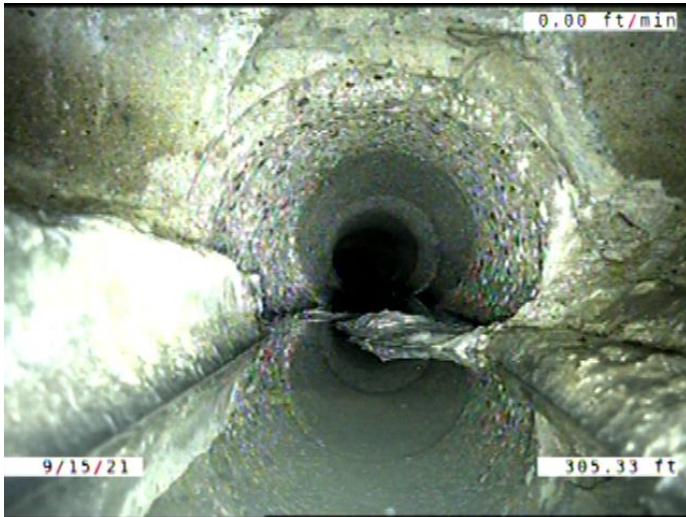
Code: **DSF**
 Description: **Deposits Settled Fine**

Distance (ft): **305.3**
 Structural Grade: **0**
 O&M Grade: **2**
 Clock Start/From: **5**
 Clock To: **7**
 1st Value:
 2nd Value:
 Value Percent: **5.000**
 Continuous Index: **F01**
 Within 8" of Joint: **YES**
 Remarks:
