# Profile/Photo Observation Report

| Street: | North Guyer Street | Flow Control: | Not Controlled |
| US MH: | M-504-054 | DS MH: | M-504-055 |

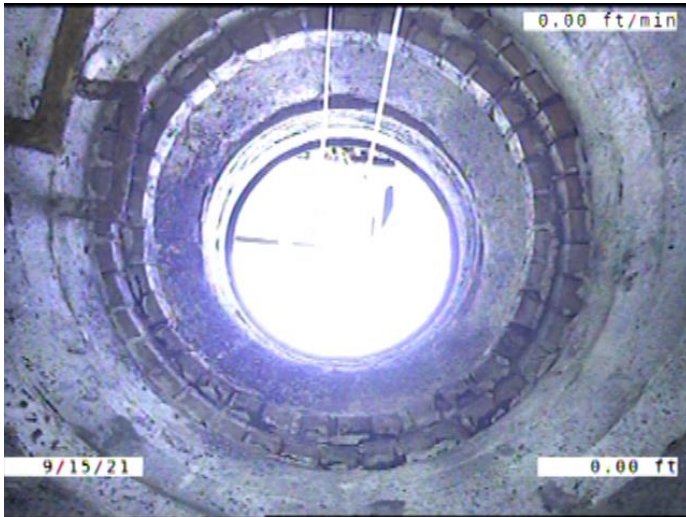
Code: **AMH**  
 Description: **Manhole**

Distance (ft): **.0**  
 Structural Grade: **0**  
 O&M Grade: **0**  
 Clock Start/From:  
 Clock To:  
 1st Value:  
 2nd Value:  
 Value Percent:  
 Continuous Index:  
 Within 8" of Joint: **NO**  
 Remarks: **M-504-055**

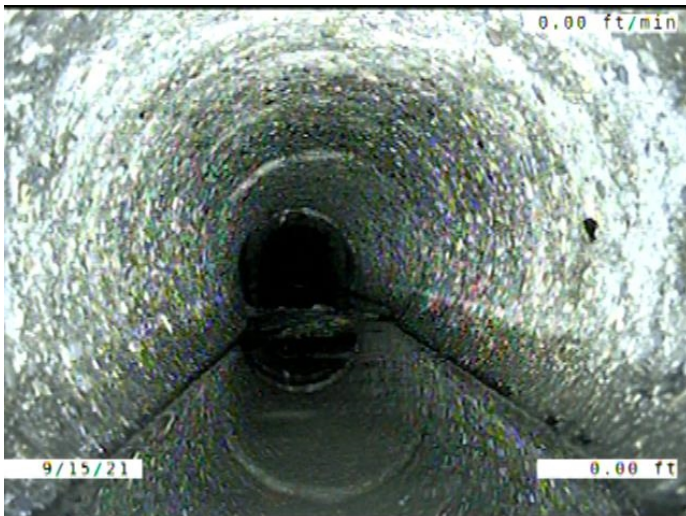
Code: **MWL**  
 Description: **Miscellaneous Water Level**

Distance (ft): **.0**  
 Structural Grade: **0**  
 O&M Grade: **0**  
 Clock Start/From:  
 Clock To:  
 1st Value:  
 2nd Value:  
 Value Percent: **10.000**  
 Continuous Index:  
 Within 8" of Joint: **NO**  
 Remarks:

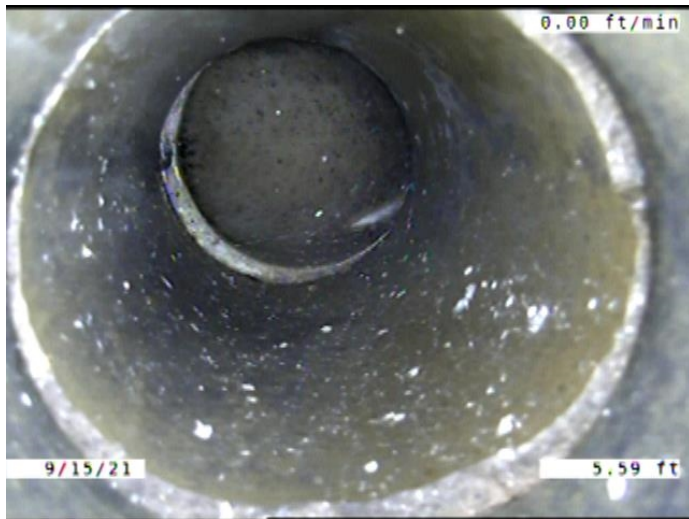
Code: **TB**  
 Description: **Tap Break-in/Hammer**

Distance (ft): **5.6**  
 Structural Grade: **0**  
 O&M Grade: **0**  
 Clock Start/From: **12**  
 Clock To:  
 1st Value: **4.000**  
 2nd Value:  
 Value Percent:  
 Continuous Index:  
 Within 8" of Joint: **YES**  
 Remarks:

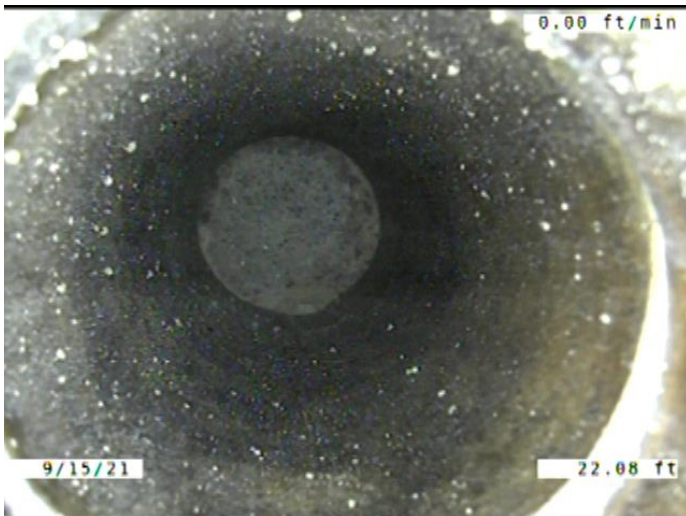
Code: **TBC**  
Description: **Tap Break-in Capped**

Distance (ft): **22.1**  
Structural Grade: **0**  
O&M Grade: **0**  
Clock Start/From: **12**  
Clock To:  
1st Value: **4.000**  
2nd Value:  
Value Percent:  
Continuous Index:  
Within 8" of Joint: **YES**  
Remarks:

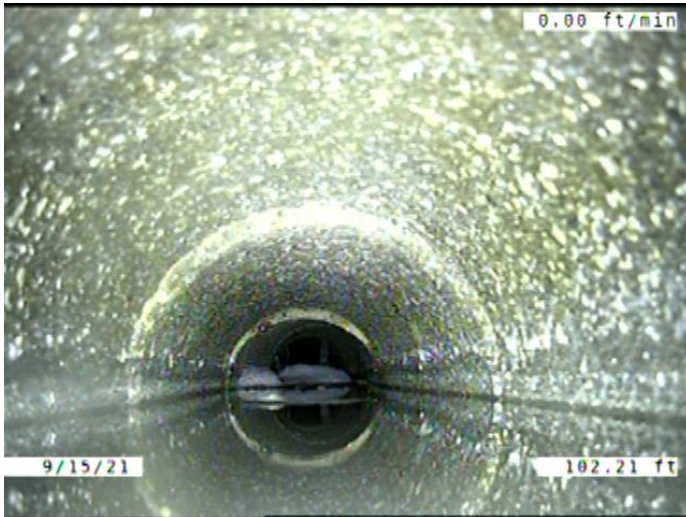
Code: **MWL**  
 Description: **Miscellaneous Water Level**

Distance (ft): **102.2**  
 Structural Grade: **0**  
 O&M Grade: **0**  
 Clock Start/From:  
 Clock To:  
 1st Value:  
 2nd Value:  
 Value Percent: **20.000**  
 Continuous Index:  
 Within 8" of Joint: **NO**  
 Remarks:

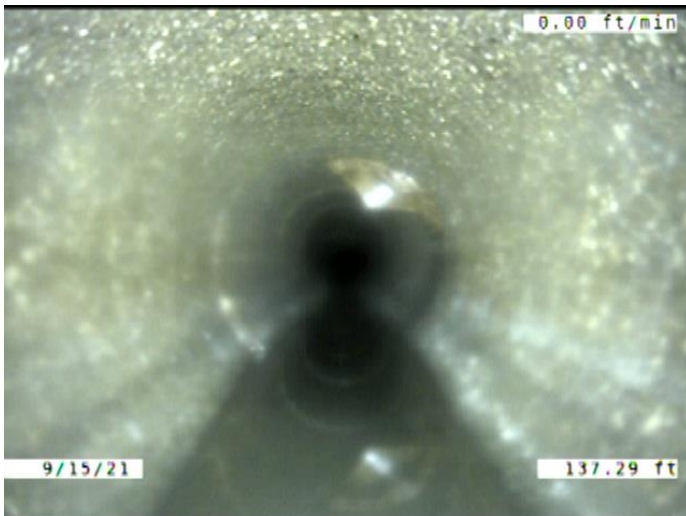
Code: **MWL**  
 Description: **Miscellaneous Water Level**

Distance (ft): **137.3**  
 Structural Grade: **0**  
 O&M Grade: **0**  
 Clock Start/From:  
 Clock To:  
 1st Value:  
 2nd Value:  
 Value Percent: **5.000**  
 Continuous Index:  
 Within 8" of Joint: **NO**  
 Remarks:

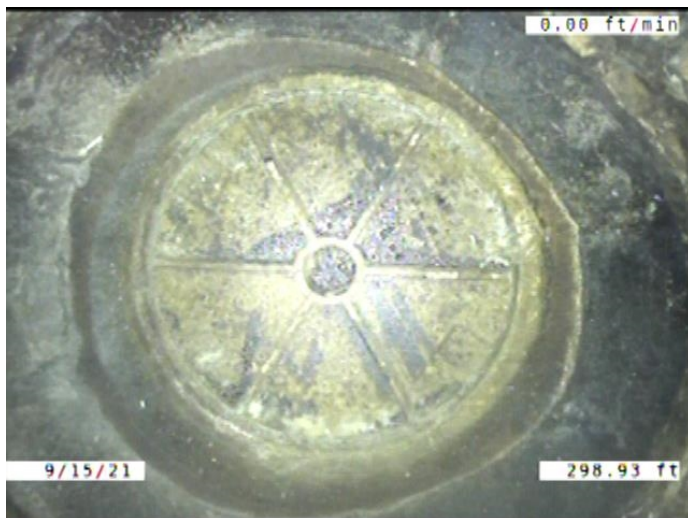
Code: **AMH**  
 Description: **Manhole**

Distance (ft): **298.9**  
 Structural Grade: **0**  
 O&M Grade: **0**  
 Clock Start/From:  
 Clock To:  
 1st Value:  
 2nd Value:  
 Value Percent:  
 Continuous Index:  
 Within 8" of Joint: **NO**  
 Remarks: **M-504-054**
