Profile/Photo Observation Report

Street:	FOXCROFT STREET	Flow Control:	Not Controlled
City:	Hobart, IN	Year Renewed:	
Location:	Light Highway	Tape/Media #:	
Purpose:	Routine Assessment	Dia/Height:	12"
Use:	Sanitary	Material:	VCP
Drain Area:	NA	Lining:	
Category:	NA		
Comment:	F_S_P_C at 8 ft grit/debris . Flow direction wrong		
Location Details:		Direction of Survey:	Downstream
US MH:	M-504-056	DS MH:	M-504-057
		Total Length Surveyed (ft):	9.7

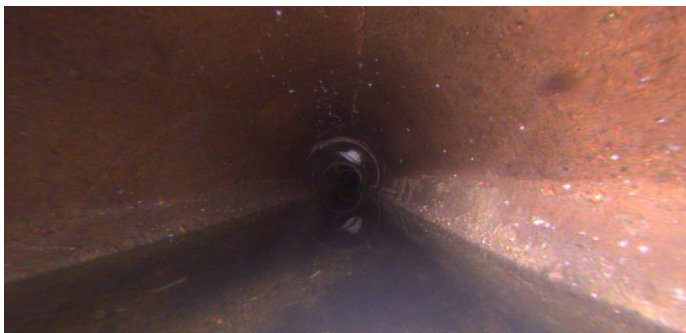
Code: **AMH**
Description: **Manhole**

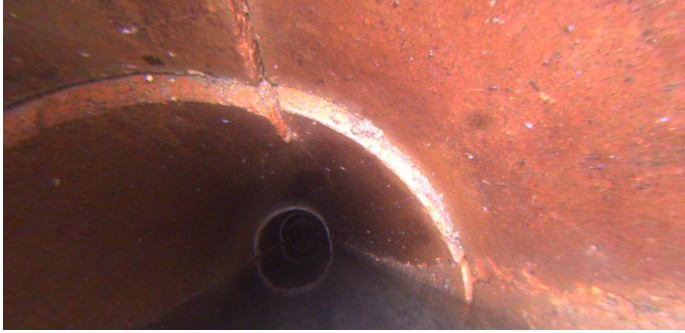
Code: **MGO**
Description: **General Observation**

Distance (ft): **9.7**
Structural Grade: **0**
O&M Grade: **0**
Clock Start/From:
Clock To:
1st Value:
2nd Value:
Value Percent:
Continuous Index:
Within 8" of Joint: **NO**
Remarks: **END SURVEY**

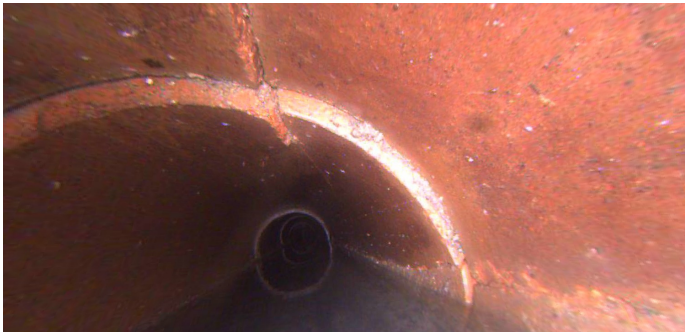
Code: **AMH**
Description: **Manhole**

Distance (ft): **9.7**
Structural Grade: **0**
O&M Grade: **0**
Clock Start/From:
Clock To:
1st Value:
2nd Value:
Value Percent:
Continuous Index:
Within 8" of Joint: **NO**
Remarks: **M-504-057**
