Profile/Photo Observation Report

Street:	North Wilson Street	Flow Control:	Not Controlled
City:	Hobart, IN	Year Renewed:	
Location:	Alley	Tape/Media #:	
Purpose:	Routine Assessment	Dia/Height:	12"
Use:	Sanitary Sewage Pipe	Material:	VCP
Drain Area:		Lining:	None
Category:	NA		
Comment:			
Location Details:		Direction of Survey:	Upstream
US MH:	M-504-056	DS MH:	M-504-057
		Total Length Surveyed (ft):	103.5

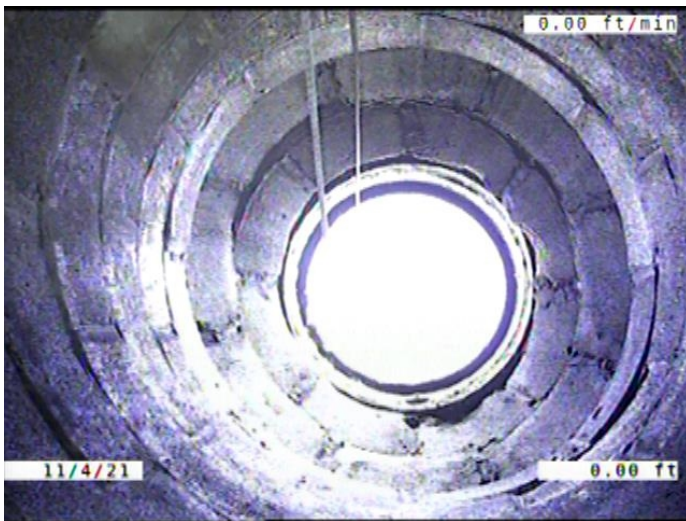
Code: **AMH**
Description: **Manhole**

Distance (ft): **.0**
Structural Grade: **0**
O&M Grade: **0**
Clock Start/From:
Clock To:
1st Value:
2nd Value:
Value Percent:
Continuous Index:
Within 8" of Joint: **NO**
Remarks: **M-504-057**

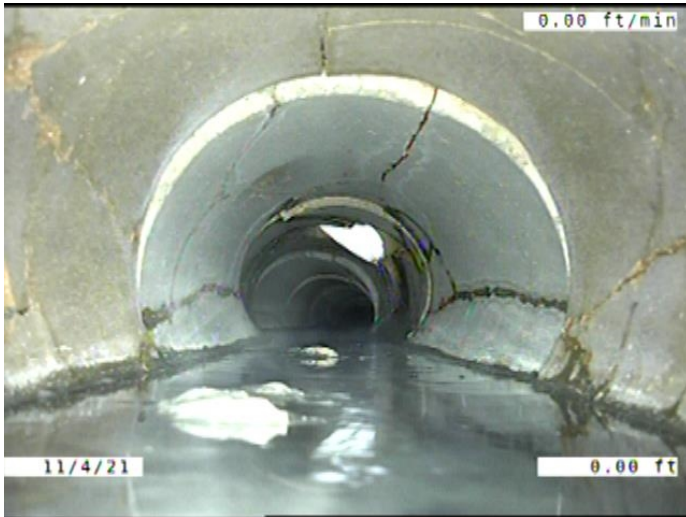
Code: **MWL**
 Description: **Miscellaneous Water Level**

Distance (ft): **.0**
 Structural Grade: **0**
 O&M Grade: **0**
 Clock Start/From:
 Clock To:
 1st Value:
 2nd Value:
 Value Percent: **15.000**
 Continuous Index:
 Within 8" of Joint: **NO**
 Remarks:

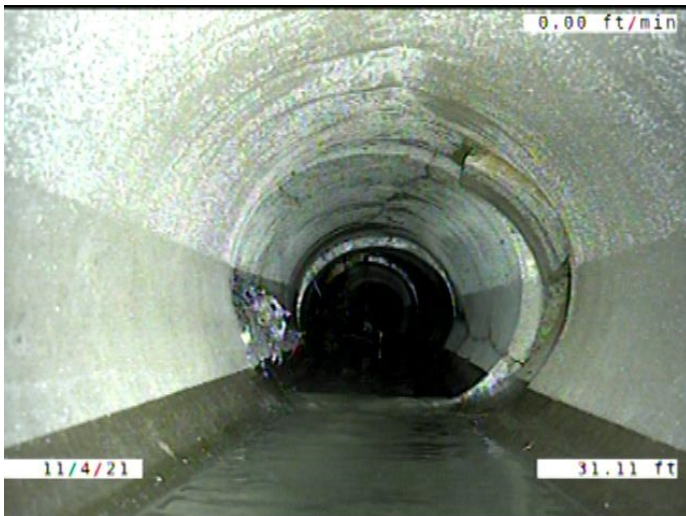
Code: **MWL**
 Description: **Miscellaneous Water Level**

Distance (ft): **31.1**
 Structural Grade: **0**
 O&M Grade: **0**
 Clock Start/From:
 Clock To:
 1st Value:
 2nd Value:
 Value Percent: **5.000**
 Continuous Index:
 Within 8" of Joint: **NO**
 Remarks:
