Profile/Photo Observation Report

Date:	11/05/2021	Weather:		Coding:	PACP 7.0
Pipe Length (ft):	330.0	Owner:	City of Hobart	Pre Clean:	Heavy Cleaning
P.O.#:	YES502259	Surveyor:	S. Bucklin	PSR:	P-504-057-056
Customer:	City of Hobart	Clean Date:	11/04/2021	Shape:	C

Street:	North Wilson Street	Flow Control:	Not Controlled
City:	Hobart, IN	Year Renewed:	
Location:	Alley	Tape/Media #:	
Purpose:	Routine Assessment	Dia/Height:	12"
Use:	Sanitary Sewage Pipe	Material:	VCP
Drain Area:		Lining:	None
Category:	NA		
Comment:			
Location Details:		Direction of Survey:	Downstream
US MH:	M-504-057	DS MH:	M-504-056
		Total Length Surveyed (ft):	233.0

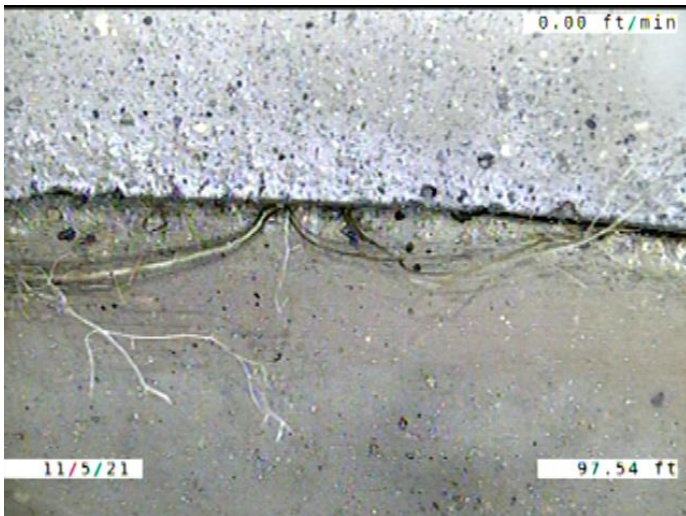
Code: **RMJ**
 Description: **Roots Medium Joint**

Distance (ft): **94.4**
 Structural Grade: **0**
 O&M Grade: **3**
 Clock Start/From: **9**
 Clock To: **4**
 1st Value:
 2nd Value:
 Value Percent: **10.000**
 Continuous Index:
 Within 8" of Joint: **YES**
 Remarks:

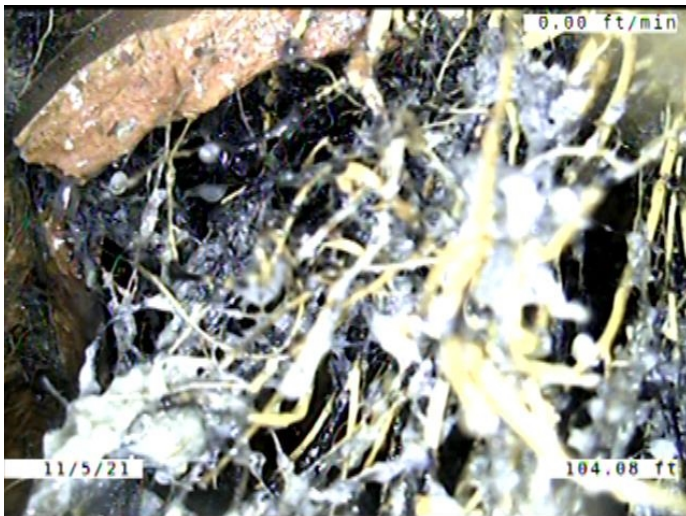
Code: **RMC**
Description: **Roots Medium Connection**

Distance (ft): **104.1**
Structural Grade: **0**
O&M Grade: **3**
Clock Start/From: **8**
Clock To: **4**
1st Value:
2nd Value:
Value Percent: **50.000**
Continuous Index:
Within 8" of Joint: **NO**
Remarks:
