Profile/Photo Observation Report

Date:	09/13/2021	Weather:		Coding:	PACP 7.0
Pipe Length (ft):	311.0	Owner:	City of Hobart	Pre Clean:	Light Cleaning
P.O.#:	YES502259	Surveyor:	S. Bucklin	PSR:	P-504-059-058
Customer:	City of Hobart	Clean Date:	09/07/2021	Shape:	C

Street:	North Wilson Street	Flow Control:	Not Controlled
City:	Hobart, IN	Year Renewed:	
Location:		Tape/Media #:	
Purpose:	Routine Assessment	Dia/Height:	10"
Use:	Sanitary Sewage Pipe	Material:	VCP
Drain Area:		Lining:	None
Category:	NA		
Comment:			
Location Details:		Direction of Survey:	Downstream
US MH:	M-504-058	DS MH:	M-504-059
		Total Length Surveyed (ft):	311.0

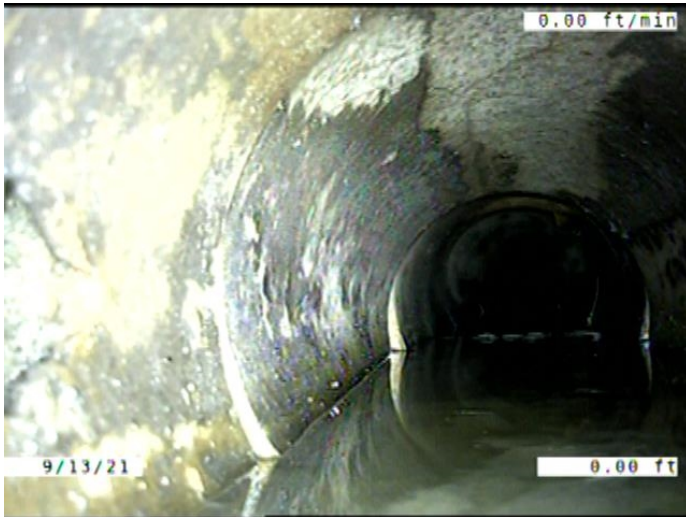
Code: **AMH**
Description: **Manhole**

Distance (ft): **.0**
Structural Grade: **0**
O&M Grade: **0**
Clock Start/From:
Clock To:
1st Value:
2nd Value:
Value Percent:
Continuous Index:
Within 8" of Joint: **NO**
Remarks: **M-504-058**

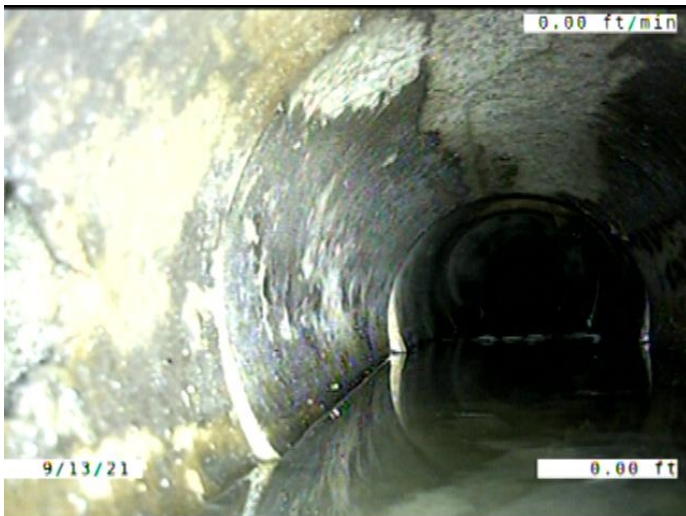
Code: **MWL**
 Description: **Miscellaneous Water Level**

Distance (ft): **.0**
 Structural Grade: **0**
 O&M Grade: **0**
 Clock Start/From:
 Clock To:
 1st Value:
 2nd Value:
 Value Percent: **10.000**
 Continuous Index:
 Within 8" of Joint: **NO**
 Remarks:

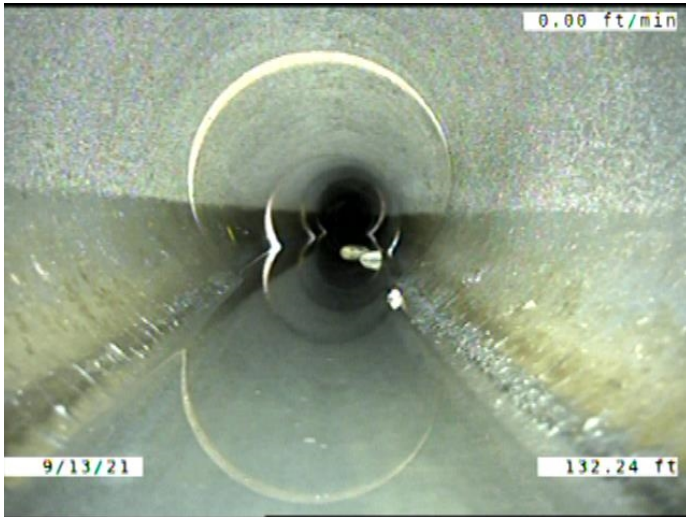
Code: **FM**
 Description: **Fracture Multiple**

Distance (ft): **131.7**
 Structural Grade: **4**
 O&M Grade: **0**
 Clock Start/From: **11**
 Clock To: **2**
 1st Value:
 2nd Value:
 Value Percent:
 Continuous Index:
 Within 8" of Joint: **YES**
 Remarks:

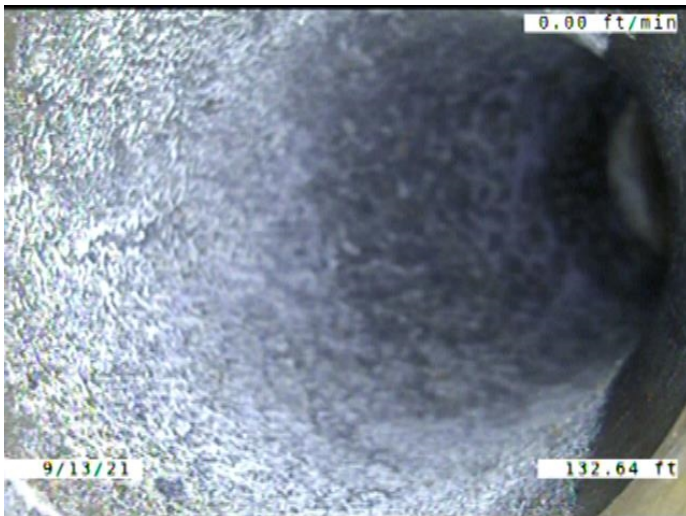
Code: **MWLS**
 Description: **Miscellaneous Water Level Sag**

Distance (ft): **132.2**
 Structural Grade: **2**
 O&M Grade: **0**
 Clock Start/From:
 Clock To:
 1st Value:
 2nd Value:
 Value Percent: **5.000**
 Continuous Index: **F03**
 Within 8" of Joint: **NO**
 Remarks:

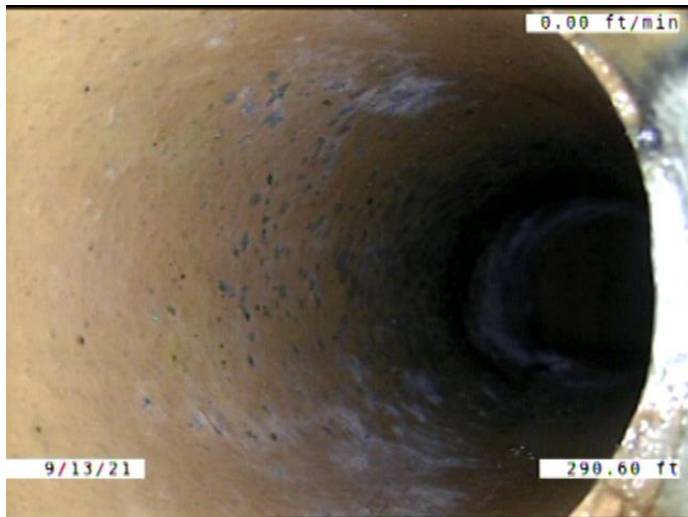
Code: **B**
Description: **Broken**

Distance (ft): **285.0**
Structural Grade: **4**
O&M Grade: **0**
Clock Start/From: **8**
Clock To: **12**
1st Value:
2nd Value:
Value Percent:
Continuous Index:
Within 8" of Joint: **YES**
Remarks:

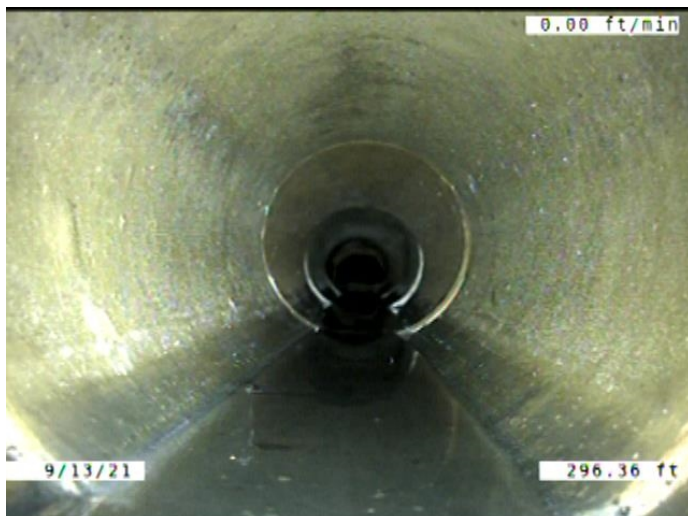
Code: **TBI**
 Description: **Tap Break-in Intruding**

Distance (ft): **290.6**
 Structural Grade: **0**
 O&M Grade: **2**
 Clock Start/From: **1**
 Clock To:
 1st Value: **4.000**
 2nd Value: **1.000**
 Value Percent:
 Continuous Index:
 Within 8" of Joint: **YES**
 Remarks:
