# Profile/Photo Observation Report

Date:	09/13/2021	Weather:		Coding:	PACP 7.0
Pipe Length (ft):	311.0	Owner:	City of Hobart	Pre Clean:	Light Cleaning
P.O.#:	YES502259	Surveyor:	S. Bucklin	PSR:	P-504-059-058
Customer:	City of Hobart	Clean Date:	09/07/2021	Shape:	C

Street:	North Wilson Street	Flow Control:	Not Controlled
City:	Hobart, IN	Year Renewed:	
Location:		Tape/Media #:	
Purpose:	Routine Assessment	Dia/Height:	10"
Use:	Sanitary Sewage Pipe	Material:	VCP
Drain Area:		Lining:	None
Category:	NA		
Comment:			
Location Details:		Direction of Survey:	Downstream
US MH:	M-504-058	DS MH:	M-504-059
		Total Length Surveyed (ft):	311.0

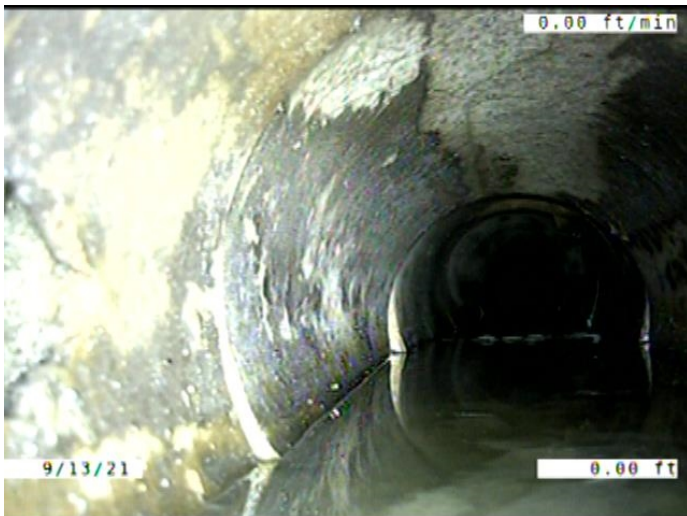
Code: **MWL**  
 Description: **Miscellaneous Water Level**

Distance (ft): **.0**  
 Structural Grade: **0**  
 O&M Grade: **0**  
 Clock Start/From:  
 Clock To:  
 1st Value:  
 2nd Value:  
 Value Percent: **10.000**  
 Continuous Index:  
 Within 8" of Joint: **NO**  
 Remarks:

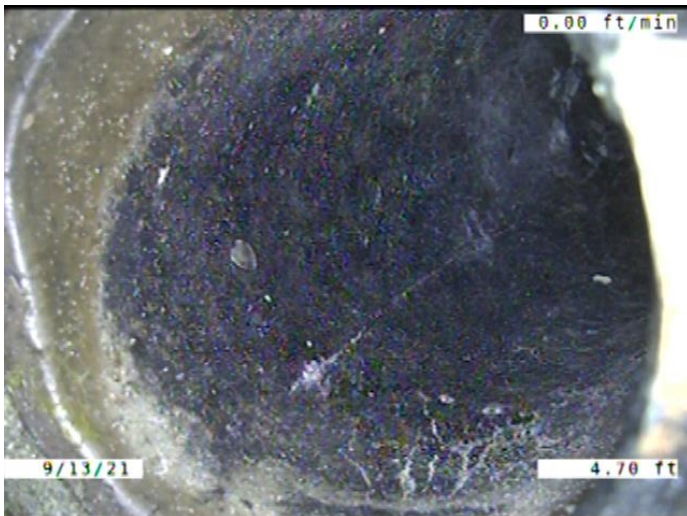
Code: **JAM**  
 Description: **Joint Angular Medium**

Distance (ft): **3.0**  
 Structural Grade: **3**  
 O&M Grade: **0**  
 Clock Start/From:  
 Clock To:  
 1st Value:  
 2nd Value:  
 Value Percent:  
 Continuous Index:  
 Within 8" of Joint: **NO**  
 Remarks:

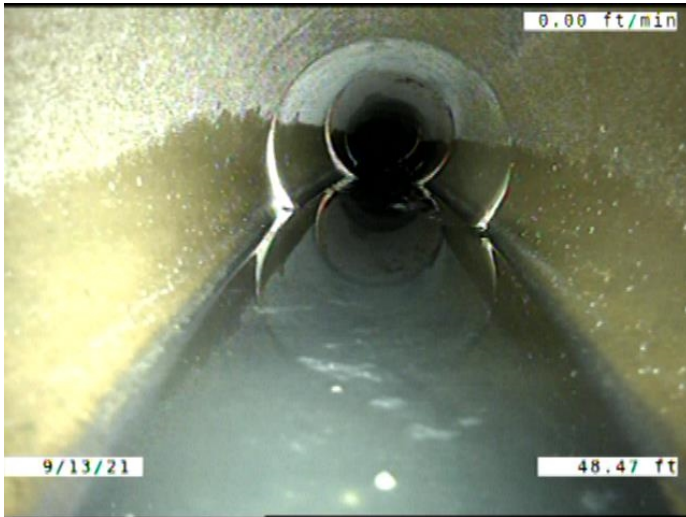
Code: **CL**  
Description: **Crack Longitudinal**

Distance (ft): **34.4**  
Structural Grade: **2**  
O&M Grade: **0**  
Clock Start/From: **1**  
Clock To:  
1st Value:  
2nd Value:  
Value Percent:  
Continuous Index:  
Within 8" of Joint: **YES**  
Remarks:

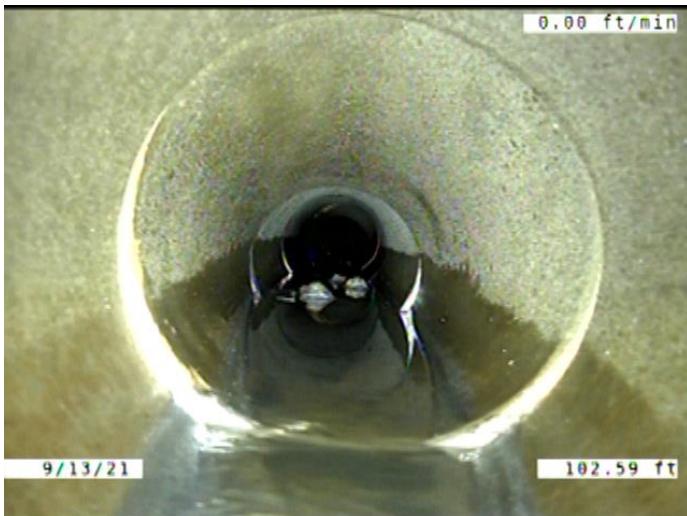
Code: **TBI**  
 Description: **Tap Break-in Intruding**

Distance (ft): **82.0**  
 Structural Grade: **0**  
 O&M Grade: **2**  
 Clock Start/From: **1**  
 Clock To:  
 1st Value: **4.000**  
 2nd Value: **1.000**  
 Value Percent:  
 Continuous Index:  
 Within 8" of Joint: **NO**  
 Remarks:

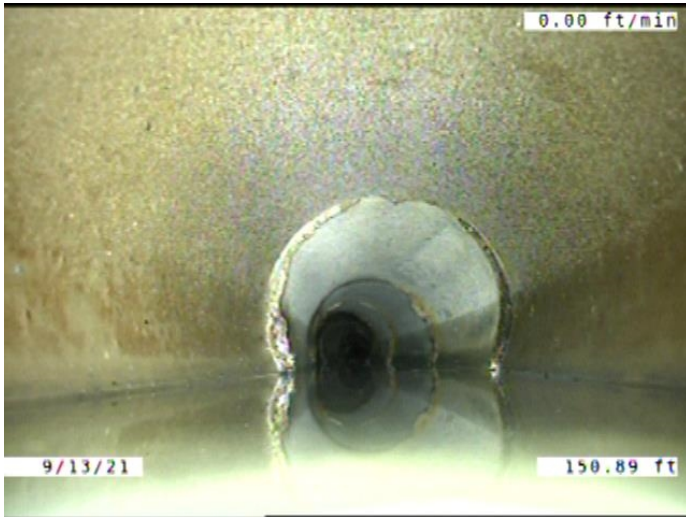
Code: **CM**  
 Description: **Crack Multiple**

Distance (ft): **147.8**  
 Structural Grade: **3**  
 O&M Grade: **0**  
 Clock Start/From: **3**  
 Clock To: **4**  
 1st Value:  
 2nd Value:  
 Value Percent:  
 Continuous Index:  
 Within 8" of Joint: **YES**  
 Remarks:

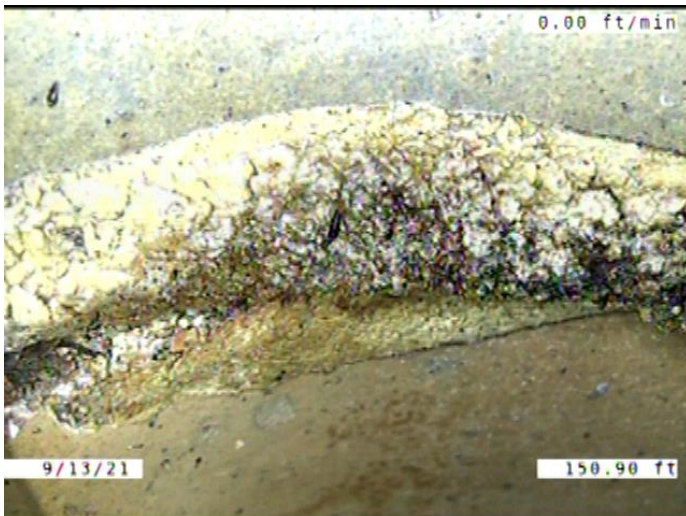
Code: **MWLS**  
 Description: **Miscellaneous Water Level Sag**

Distance (ft): **150.9**  
 Structural Grade: **2**  
 O&M Grade: **0**  
 Clock Start/From:  
 Clock To:  
 1st Value:  
 2nd Value:  
 Value Percent: **15.000**  
 Continuous Index: **S04**  
 Within 8" of Joint: **NO**  
 Remarks:

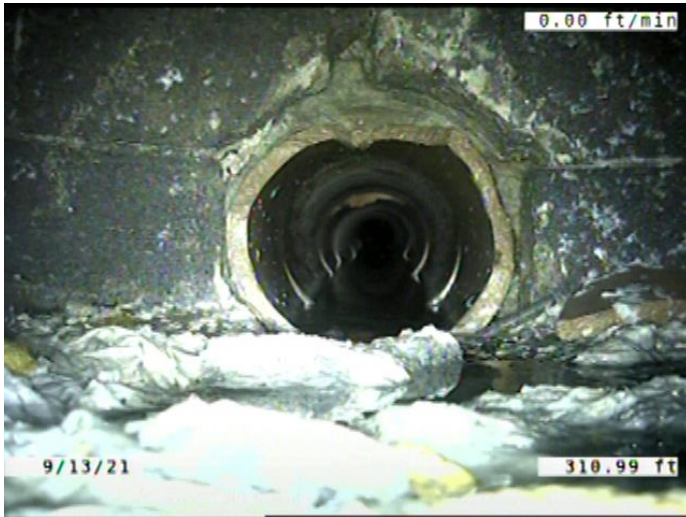
Code: **DAE**  
 Description: **Deposits Attached Encrustation**

Distance (ft): **296.4**  
 Structural Grade: **0**  
 O&M Grade: **2**  
 Clock Start/From: **7**  
 Clock To: **5**  
 1st Value:  
 2nd Value:  
 Value Percent: **5.000**  
 Continuous Index: **F05**  
 Within 8" of Joint: **YES**  
 Remarks:
