Profile/Photo Observation Report

Date:	04/20/2018	Weather:		Coding:	PACP 6.0
Pipe Length (ft):	211.5	Owner:	NA	Pre Clean:	Not Known
P.O.#:		Surveyor:	Byrd Fitzgerald	PSR:	P-504-080-068
Customer:		Clean Date:	01/01/1900	Shape:	C

Street:	Summerlin	Flow Control:	Not Controlled
City:	Hobart, IN	Year Renewed:	
Location:	Light Highway	Tape/Media #:	
Purpose:	Not Known	Dia/Height:	12"
Use:	Sanitary	Material:	VCP
Drain Area:	NA	Lining:	
Category:	NA		
Comment:

Location Details:		Direction of Survey:	Upstream
US MH:	M-504-068	DS MH:	M-504-080
		Total Length Surveyed (ft):	206.5

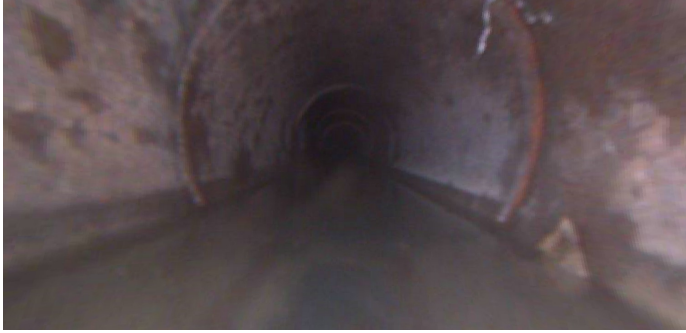
Code: **AMH**
Description: **Manhole**

Distance (ft): **.0**
Structural Grade: **0**
O&M Grade: **0**
Clock Start/From:
Clock To:
1st Value:
2nd Value:
Value Percent:
Continuous Index:
Within 8" of Joint: **NO**
Remarks: **M-504-068**

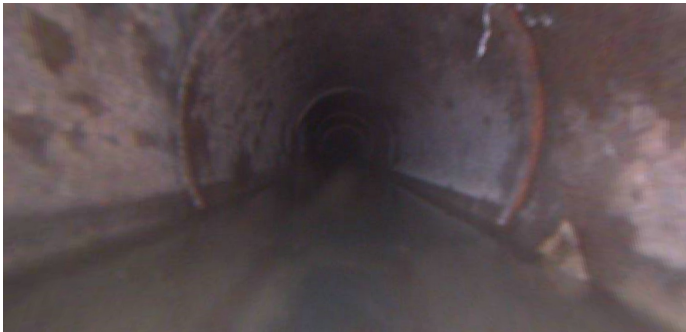
Code: **MWL**
Description: **Water Level**

Distance (ft): **.0**
Structural Grade: **0**
O&M Grade: **0**
Clock Start/From:
Clock To:
1st Value:
2nd Value:
Value Percent: **5.000**
Continuous Index:
Within 8" of Joint: **NO**
Remarks:

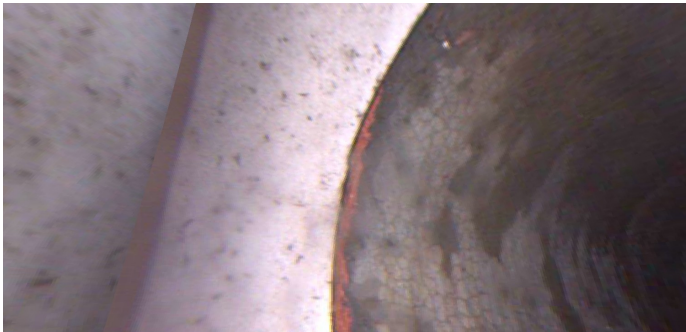
Code: **MMC**
Description: **Material Change**

Distance (ft): **8.1**
Structural Grade: **0**
O&M Grade: **0**
Clock Start/From:
Clock To:
1st Value:
2nd Value:
Value Percent:
Continuous Index:
Within 8" of Joint: **NO**
Remarks: **pvc**

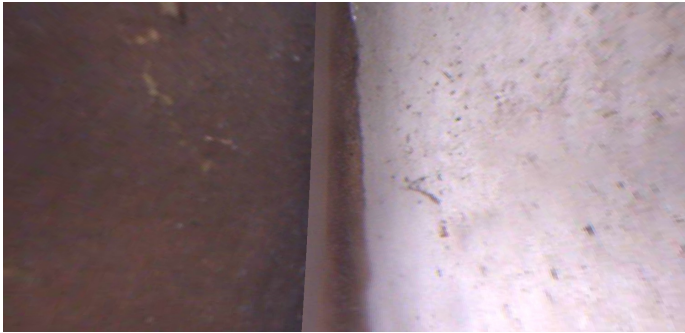
Code: **MMC**
Description: **Material Change**

Distance (ft): **27.9**
Structural Grade: **0**
O&M Grade: **0**
Clock Start/From:
Clock To:
1st Value:
2nd Value:
Value Percent:
Continuous Index:
Within 8" of Joint: **NO**
Remarks: **vcp**

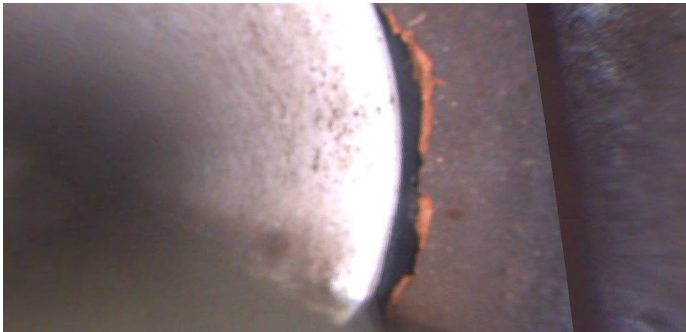
Code: **MMC**
Description: **Material Change**

Distance (ft): **47.6**
Structural Grade: **0**
O&M Grade: **0**
Clock Start/From:
Clock To:
1st Value:
2nd Value:
Value Percent:
Continuous Index:
Within 8" of Joint: **NO**
Remarks: **pvc**

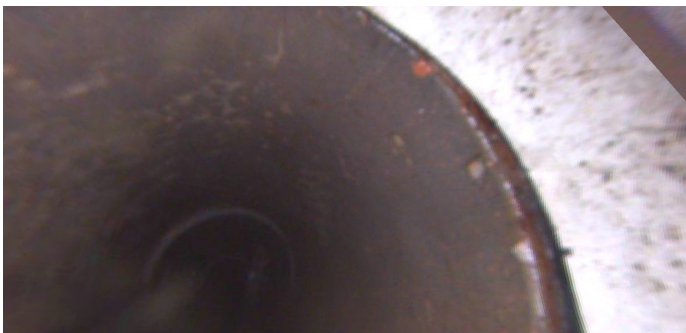
Code: **MMC**
Description: **Material Change**

Distance (ft): **60.1**
Structural Grade: **0**
O&M Grade: **0**
Clock Start/From:
Clock To:
1st Value:
2nd Value:
Value Percent:
Continuous Index:
Within 8" of Joint: **NO**
Remarks: **vcp**

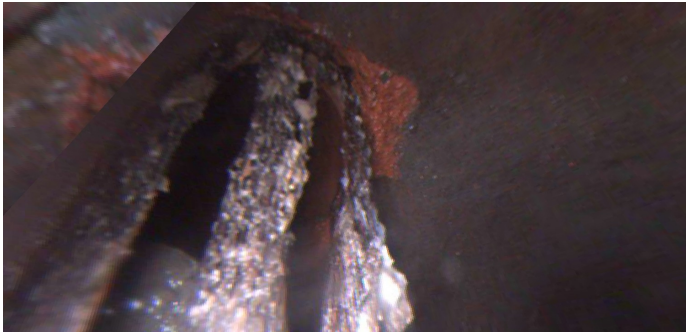
Code: **TB**
Description: **Tap Break-in**

Distance (ft): **64.2**
Structural Grade: **0**
O&M Grade: **0**
Clock Start/From: **2**
Clock To:
1st Value: **4.000**
2nd Value:
Value Percent:
Continuous Index:
Within 8" of Joint:
Remarks:

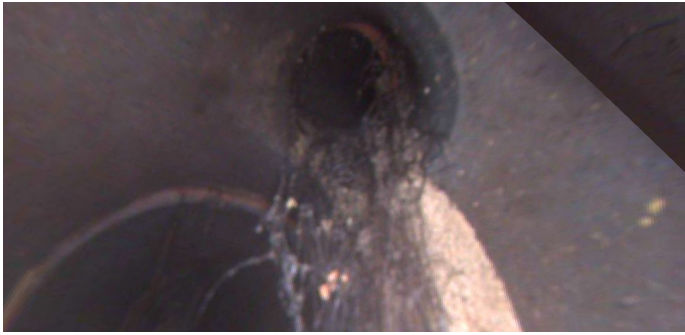
Code: **TF**
Description: **Tap Factory**

Distance (ft): **73.2**
Structural Grade: **0**
O&M Grade: **0**
Clock Start/From: **1**
Clock To:
1st Value: **4.000**
2nd Value:
Value Percent:
Continuous Index:
Within 8" of Joint: **YES**
Remarks:

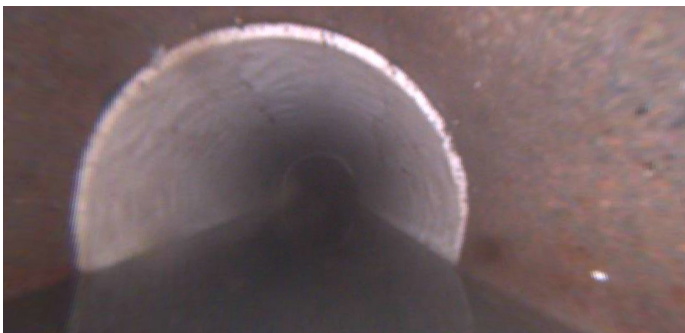
Code: **MMC**
Description: **Material Change**

Distance (ft): **121.9**
Structural Grade: **0**
O&M Grade: **0**
Clock Start/From:
Clock To:
1st Value:
2nd Value:
Value Percent:
Continuous Index:
Within 8" of Joint: **NO**
Remarks: **pvc**

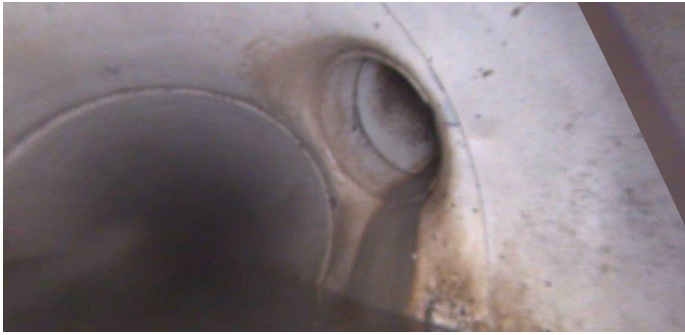
Code: **TF**
Description: **Tap Factory**

Distance (ft): **124.9**
Structural Grade: **0**
O&M Grade: **0**
Clock Start/From: **2**
Clock To:
1st Value: **4.000**
2nd Value:
Value Percent:
Continuous Index:
Within 8" of Joint: **YES**
Remarks:

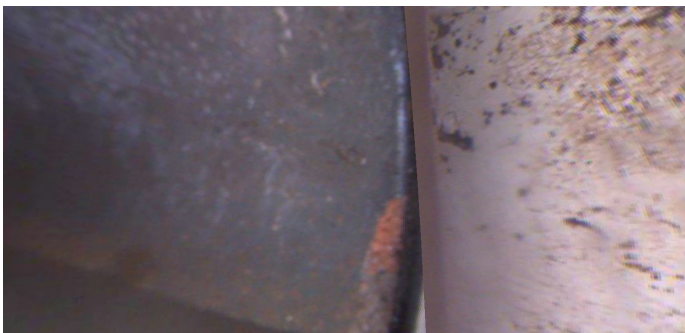
Code: **MMC**
Description: **Material Change**

Distance (ft): **141.1**
Structural Grade: **0**
O&M Grade: **0**
Clock Start/From:
Clock To:
1st Value:
2nd Value:
Value Percent:
Continuous Index:
Within 8" of Joint: **NO**
Remarks: **vcp**

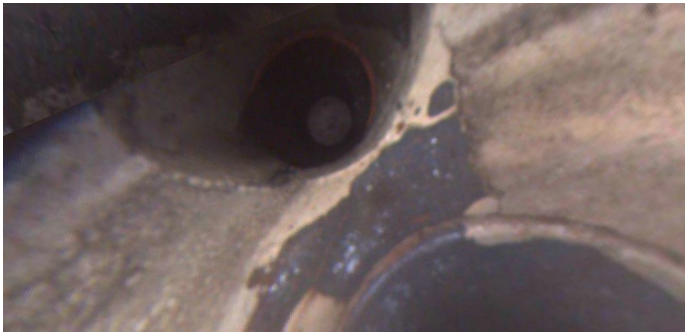
Code: **TF**
Description: **Tap Factory**

Distance (ft): **150.5**
Structural Grade: **0**
O&M Grade: **0**
Clock Start/From: **11**
Clock To:
1st Value: **4.000**
2nd Value:
Value Percent:
Continuous Index:
Within 8" of Joint: **YES**
Remarks:

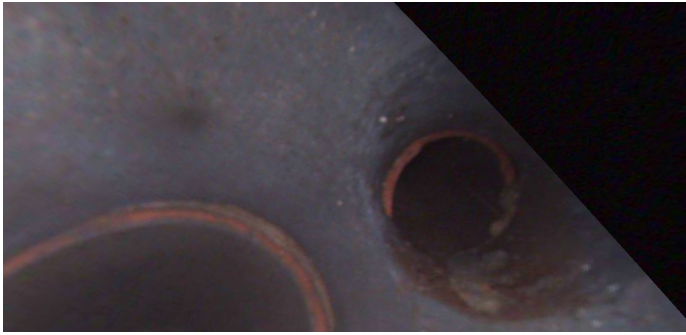
Code: **TF**
Description: **Tap Factory**

Distance (ft): **160.3**
Structural Grade: **0**
O&M Grade: **0**
Clock Start/From: **2**
Clock To:
1st Value: **4.000**
2nd Value:
Value Percent:
Continuous Index:
Within 8" of Joint: **YES**
Remarks:

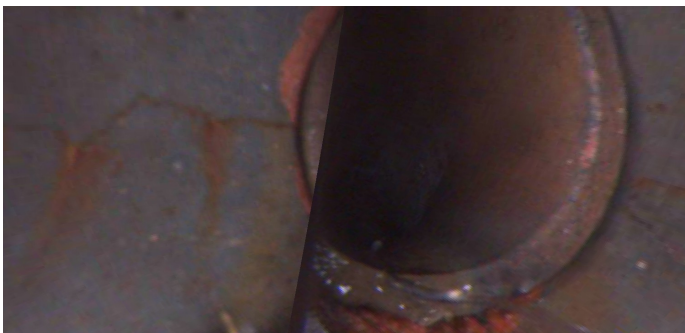
Code: **TB**
Description: **Tap Break-in**

Distance (ft): **176.3**
Structural Grade: **0**
O&M Grade: **0**
Clock Start/From: **1**
Clock To:
1st Value: **4.000**
2nd Value:
Value Percent:
Continuous Index:
Within 8" of Joint:
Remarks:

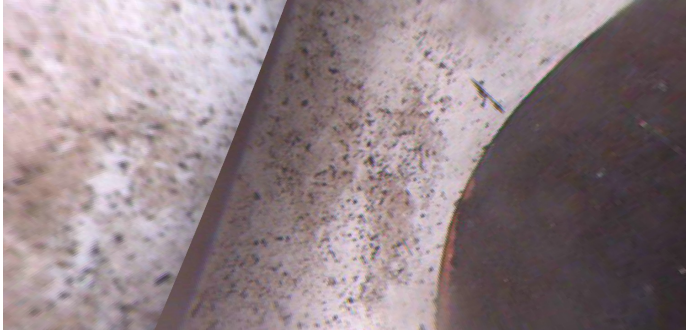
Code: **MMC**
Description: **Material Change**

Distance (ft): **191.8**
Structural Grade: **0**
O&M Grade: **0**
Clock Start/From:
Clock To:
1st Value:
2nd Value:
Value Percent:
Continuous Index:
Within 8" of Joint: **NO**
Remarks: **pvc**

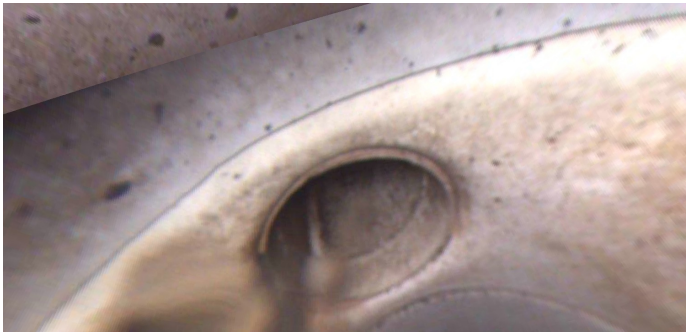
Code: **TF**
Description: **Tap Factory**

Distance (ft): **194.3**
Structural Grade: **0**
O&M Grade: **0**
Clock Start/From: **11**
Clock To:
1st Value: **4.000**
2nd Value:
Value Percent:
Continuous Index:
Within 8" of Joint: **YES**
Remarks:

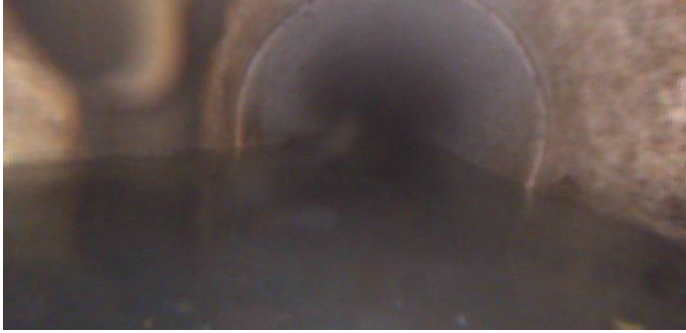
Code: **MWL**
Description: **Water Level**

Distance (ft): **194.3**
Structural Grade: **0**
O&M Grade: **0**
Clock Start/From:
Clock To:
1st Value:
2nd Value:
Value Percent: **25.000**
Continuous Index:
Within 8" of Joint: **NO**
Remarks:

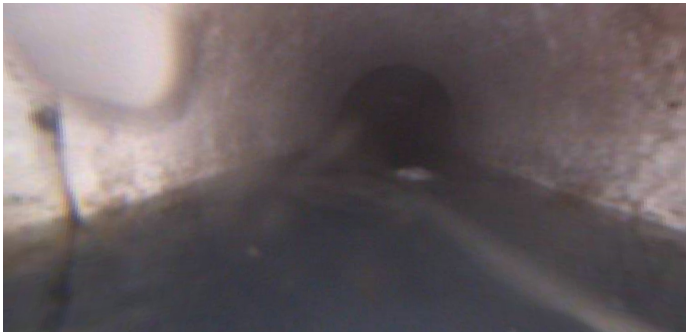
Code: **MSA**
Description: **Abandoned Survey**

Distance (ft): **206.5**
Structural Grade: **0**
O&M Grade: **0**
Clock Start/From:
Clock To:
1st Value:
2nd Value:
Value Percent:
Continuous Index:
Within 8" of Joint: **NO**
Remarks: **no blockage**
