RedZone
ROBOTICS

Total Length Surveyed (ft): **207.1**

M-504-072

M-504-101

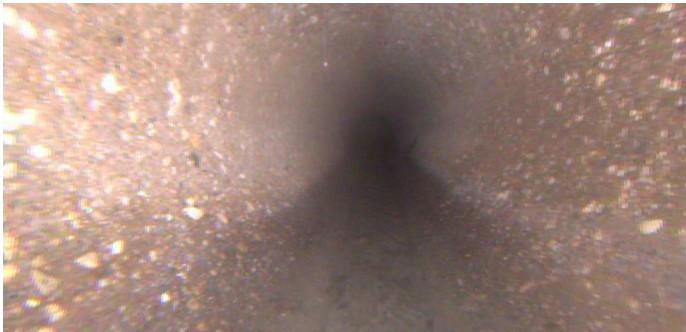
Code: **AMH**
Description: **Manhole**

Distance (ft): **.0**
Structural Grade: **0**
O&M Grade: **0**
Clock Start/From:
Clock To:
1st Value:
2nd Value:
Value Percent:
Continuous Index:
Within 8" of Joint: **NO**
Remarks: **M-504-072**

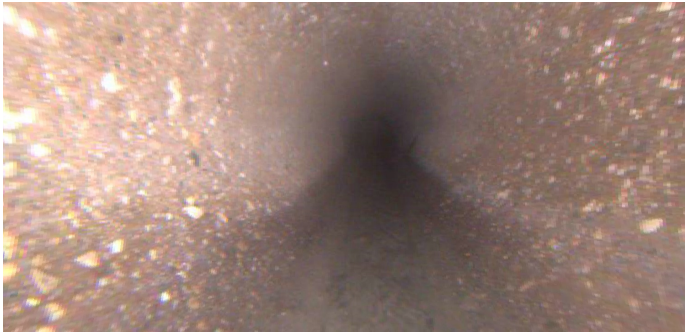
Code: **MWL**
Description: **Water Level**

Distance (ft): **.0**
Structural Grade: **0**
O&M Grade: **0**
Clock Start/From:
Clock To:
1st Value:
2nd Value:
Value Percent: **5.000**
Continuous Index:
Within 8" of Joint: **NO**
Remarks:

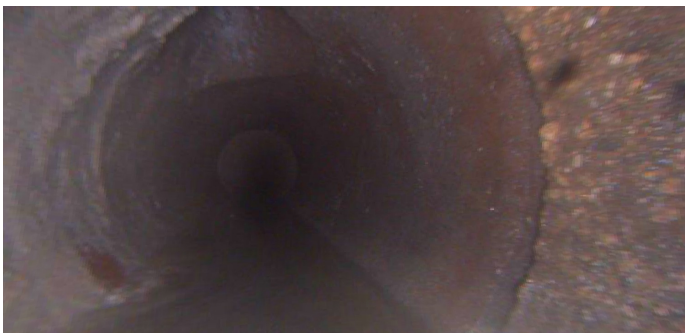
Code: **MMC**
Description: **Material Change**

Distance (ft): **15.9**
Structural Grade: **0**
O&M Grade: **0**
Clock Start/From:
Clock To:
1st Value:
2nd Value:
Value Percent:
Continuous Index:
Within 8" of Joint: **NO**
Remarks: **CP TP VCP**

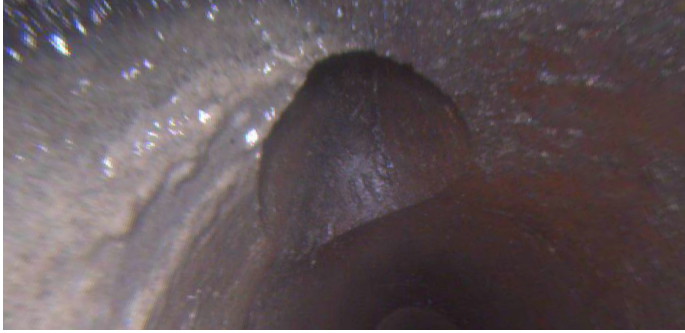
Code: **TF**
Description: **Tap Factory**

Distance (ft): **16.3**
Structural Grade: **0**
O&M Grade: **0**
Clock Start/From: **11**
Clock To:
1st Value: **4.000**
2nd Value:
Value Percent:
Continuous Index:
Within 8" of Joint:
Remarks:

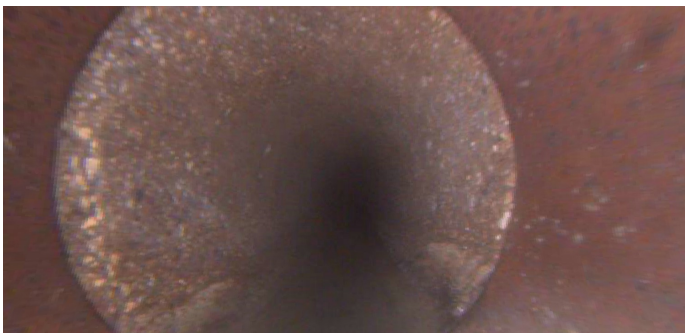
Code: **MMC**
Description: **Material Change**

Distance (ft): **18.7**
Structural Grade: **0**
O&M Grade: **0**
Clock Start/From:
Clock To:
1st Value:
2nd Value:
Value Percent:
Continuous Index:
Within 8" of Joint: **NO**
Remarks: **VCP TO CP**

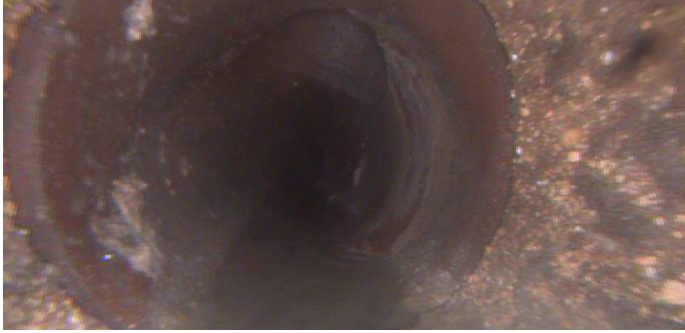
Code: **MMC**
Description: **Material Change**

Distance (ft): **48.3**
Structural Grade: **0**
O&M Grade: **0**
Clock Start/From:
Clock To:
1st Value:
2nd Value:
Value Percent:
Continuous Index:
Within 8" of Joint: **NO**
Remarks: **CP TO VCP**

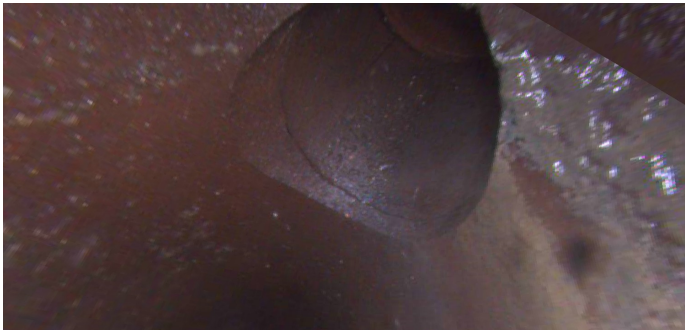
Code: **TF**
Description: **Tap Factory**

Distance (ft): **49.0**
Structural Grade: **0**
O&M Grade: **0**
Clock Start/From: **1**
Clock To:
1st Value: **4.000**
2nd Value:
Value Percent:
Continuous Index:
Within 8" of Joint:
Remarks:

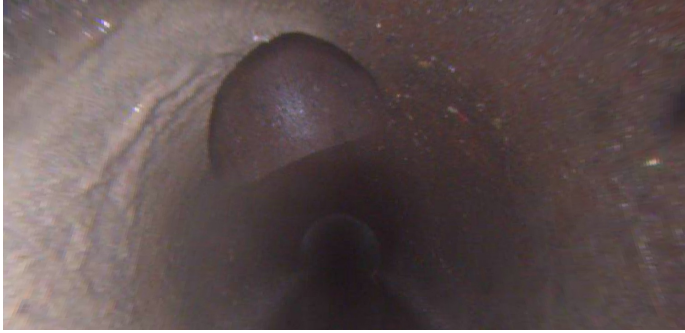
Code: **TF**
Description: **Tap Factory**

Distance (ft): **51.6**
Structural Grade: **0**
O&M Grade: **0**
Clock Start/From: **11**
Clock To:
1st Value: **4.000**
2nd Value:
Value Percent:
Continuous Index:
Within 8" of Joint:
Remarks:

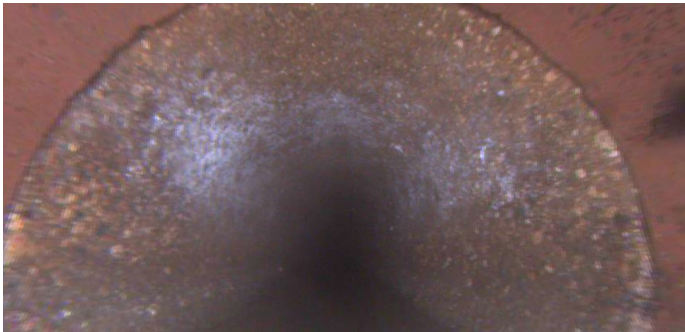
Code: **MMC**
Description: **Material Change**

Distance (ft): **54.4**
Structural Grade: **0**
O&M Grade: **0**
Clock Start/From:
Clock To:
1st Value:
2nd Value:
Value Percent:
Continuous Index:
Within 8" of Joint: **NO**
Remarks: **CP TO VCP**

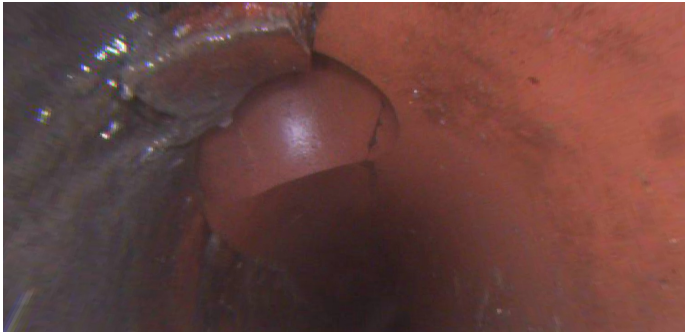
Code: **TF**
Description: **Tap Factory**

Distance (ft): **99.4**
Structural Grade: **0**
O&M Grade: **0**
Clock Start/From: **11**
Clock To:
1st Value: **4.000**
2nd Value:
Value Percent:
Continuous Index:
Within 8" of Joint:
Remarks:

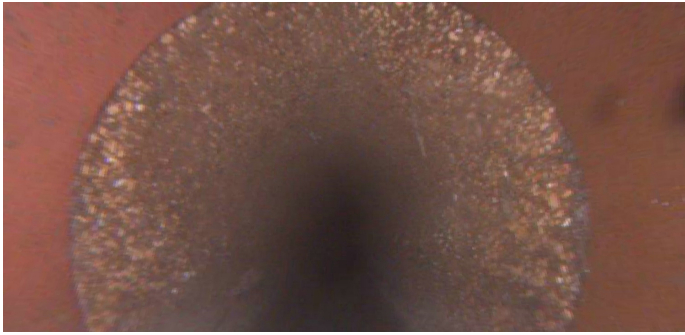
Code: **MMC**
Description: **Material Change**

Distance (ft): **104.8**
Structural Grade: **0**
O&M Grade: **0**
Clock Start/From:
Clock To:
1st Value:
2nd Value:
Value Percent:
Continuous Index:
Within 8" of Joint: **NO**
Remarks: **VCP**

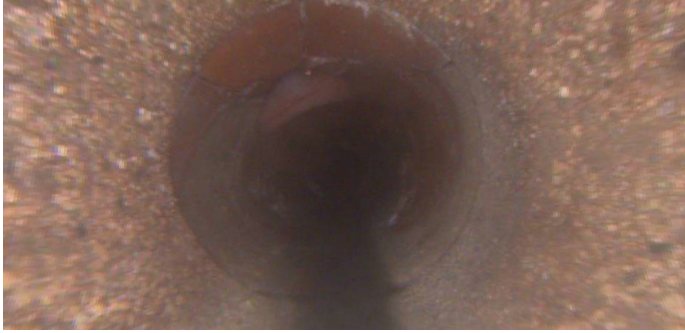
Code: **MMC**
Description: **Material Change**

Distance (ft): **144.8**
Structural Grade: **0**
O&M Grade: **0**
Clock Start/From:
Clock To:
1st Value:
2nd Value:
Value Percent:
Continuous Index:
Within 8" of Joint: **NO**
Remarks: **CP TO VCP**

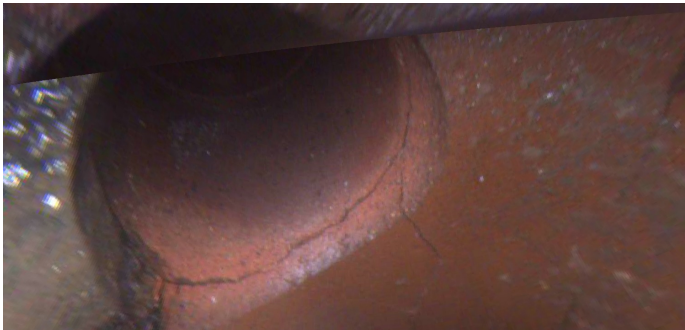
Code: **TF**
Description: **Tap Factory**

Distance (ft): **146.0**
Structural Grade: **0**
O&M Grade: **0**
Clock Start/From: **10**
Clock To:
1st Value: **4.000**
2nd Value:
Value Percent:
Continuous Index:
Within 8" of Joint:
Remarks:

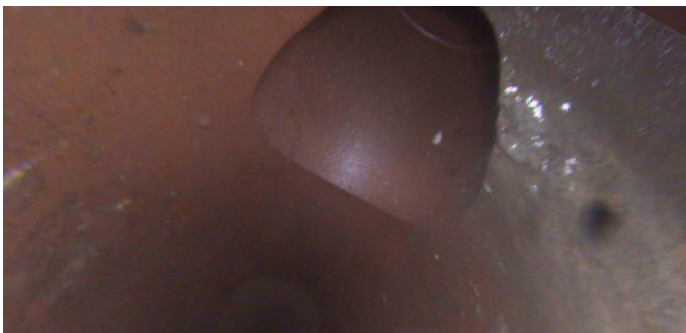
Code: **TF**
Description: **Tap Factory**

Distance (ft): **148.8**
Structural Grade: **0**
O&M Grade: **0**
Clock Start/From: **1**
Clock To:
1st Value: **4.000**
2nd Value:
Value Percent:
Continuous Index:
Within 8" of Joint:
Remarks:

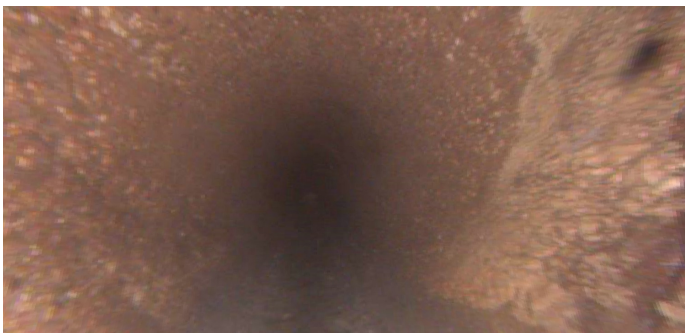
Code: **MMC**
Description: **Material Change**

Distance (ft): **151.4**
Structural Grade: **0**
O&M Grade: **0**
Clock Start/From:
Clock To:
1st Value:
2nd Value:
Value Percent:
Continuous Index:
Within 8" of Joint: **NO**
Remarks: **VCP TO CP**

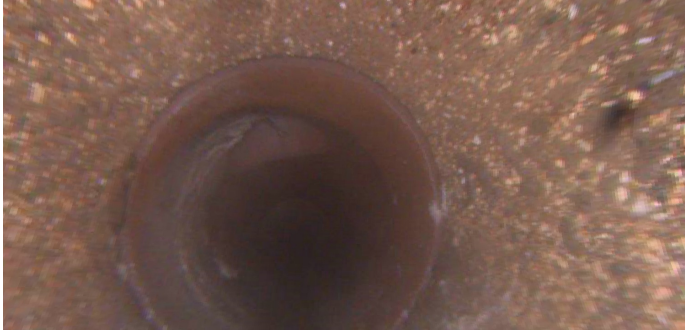
Code: **MMC**
Description: **Material Change**

Distance (ft): **177.6**
Structural Grade: **0**
O&M Grade: **0**
Clock Start/From:
Clock To:
1st Value:
2nd Value:
Value Percent:
Continuous Index:
Within 8" of Joint: **NO**
Remarks: **VCP TO CP**

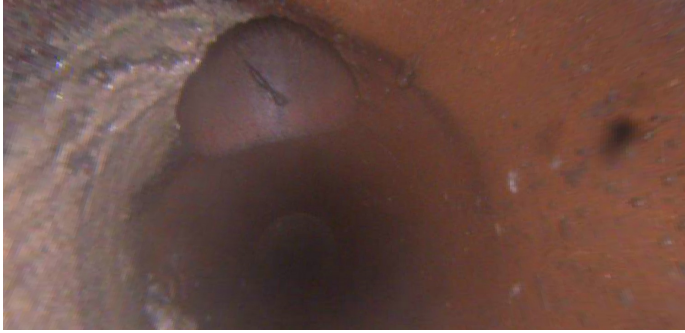
Code: **TF**
Description: **Tap Factory**

Distance (ft): **178.3**
Structural Grade: **0**
O&M Grade: **0**
Clock Start/From: **11**
Clock To:
1st Value: **4.000**
2nd Value:
Value Percent:
Continuous Index:
Within 8" of Joint:
Remarks:

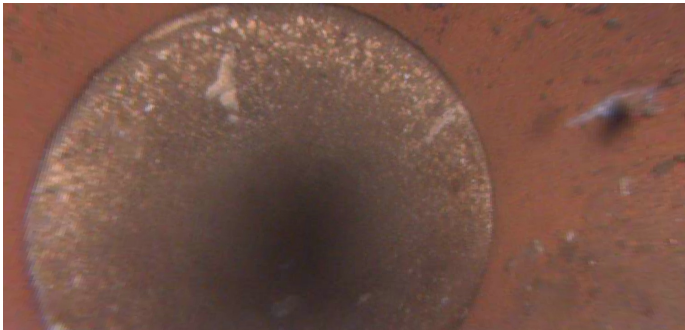
Code: **MMC**
Description: **Material Change**

Distance (ft): **180.8**
Structural Grade: **0**
O&M Grade: **0**
Clock Start/From:
Clock To:
1st Value:
2nd Value:
Value Percent:
Continuous Index:
Within 8" of Joint: **NO**
Remarks: **VCP TO CP**

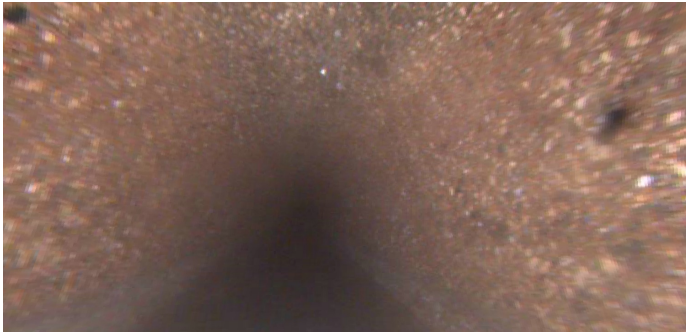
Code: **MWL**
Description: **Water Level**

Distance (ft): **197.1**
Structural Grade: **0**
O&M Grade: **0**
Clock Start/From:
Clock To:
1st Value:
2nd Value:
Value Percent: **10.000**
Continuous Index:
Within 8" of Joint: **NO**
Remarks:

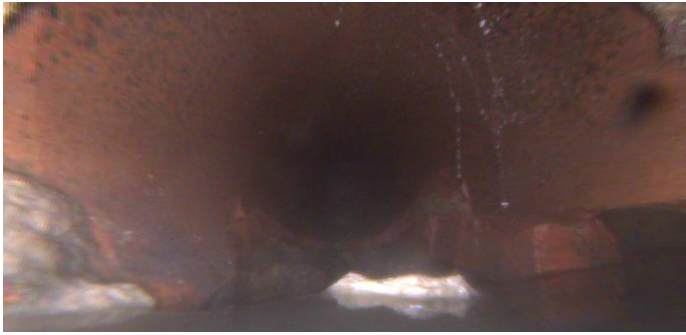
Code: **MMC**
Description: **Material Change**

Distance (ft): **205.2**
Structural Grade: **0**
O&M Grade: **0**
Clock Start/From:
Clock To:
1st Value:
2nd Value:
Value Percent:
Continuous Index:
Within 8" of Joint: **NO**
Remarks: **CP TO VCP**
