Profile/Photo Observation Report

Date:	04/17/2018	Weather:		Coding:	PACP 6.0
Pipe Length (ft):	208.7	Owner:	NA	Pre Clean:	Not Known
P.O.#:		Surveyor:	Justin Gonzales	PSR:	P-504-101-072
Customer:		Clean Date:	01/01/1900	Shape:	C

Street:	Summerlin	Flow Control:	Not Controlled
City:	Hobart, IN	Year Renewed:	
Location:	Light Highway	Tape/Media #:	
Purpose:	Not Known	Dia/Height:	10"
Use:	Sanitary	Material:	CP
Drain Area:	NA	Lining:	
Category:	NA		
Comment:			
Location Details:		Direction of Survey:	Downstream
US MH:	M-504-072	DS MH:	M-504-101
		Total Length Surveyed (ft):	207.1

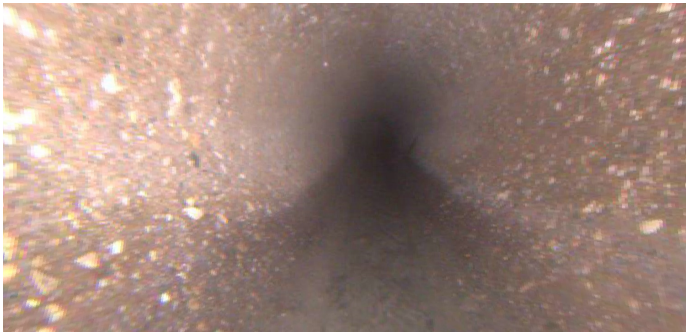
Code: **AMH**
Description: **Manhole**

Distance (ft): **.0**
Structural Grade: **0**
O&M Grade: **0**
Clock Start/From:
Clock To:
1st Value:
2nd Value:
Value Percent:
Continuous Index:
Within 8" of Joint: **NO**
Remarks: **M-504-072**

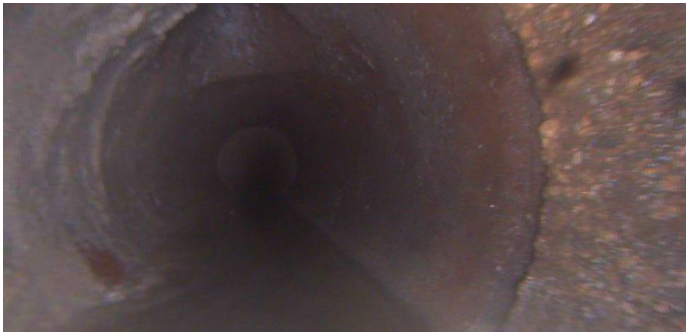
Code: **MMC**
Description: **Material Change**

Distance (ft): **15.9**
Structural Grade: **0**
O&M Grade: **0**
Clock Start/From:
Clock To:
1st Value:
2nd Value:
Value Percent:
Continuous Index:
Within 8" of Joint: **NO**
Remarks: **CP TP VCP**

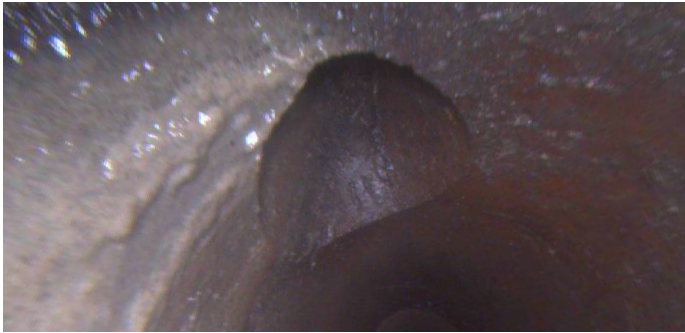
Code: **TF**
Description: **Tap Factory**

Distance (ft): **16.3**
Structural Grade: **0**
O&M Grade: **0**
Clock Start/From: **11**
Clock To:
1st Value: **4.000**
2nd Value:
Value Percent:
Continuous Index:
Within 8" of Joint:
Remarks:

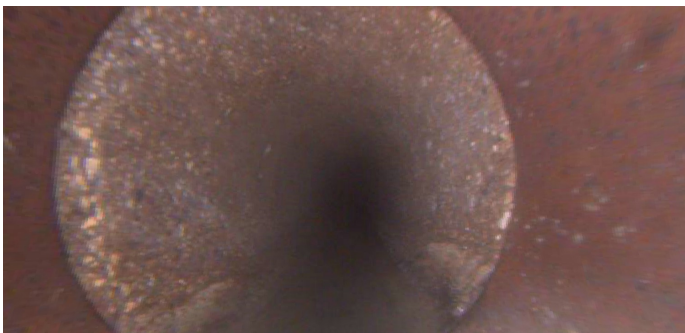
Code: **MMC**
Description: **Material Change**

Distance (ft): **18.7**
Structural Grade: **0**
O&M Grade: **0**
Clock Start/From:
Clock To:
1st Value:
2nd Value:
Value Percent:
Continuous Index:
Within 8" of Joint: **NO**
Remarks: **VCP TO CP**

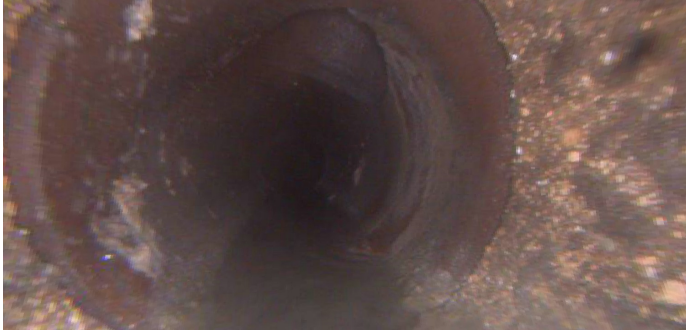
Code: **MMC**
Description: **Material Change**

Distance (ft): **48.3**
Structural Grade: **0**
O&M Grade: **0**
Clock Start/From:
Clock To:
1st Value:
2nd Value:
Value Percent:
Continuous Index:
Within 8" of Joint: **NO**
Remarks: **CP TO VCP**

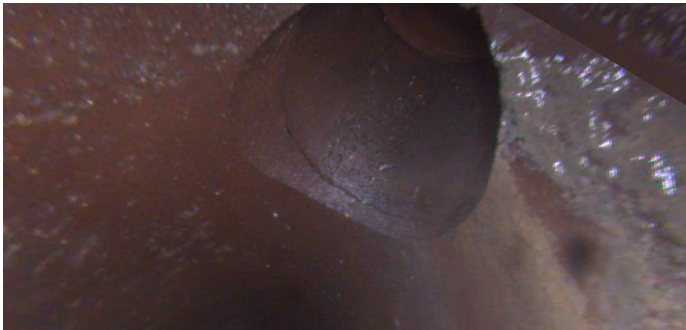
Code: **TF**
Description: **Tap Factory**

Distance (ft): **49.0**
Structural Grade: **0**
O&M Grade: **0**
Clock Start/From: **1**
Clock To:
1st Value: **4.000**
2nd Value:
Value Percent:
Continuous Index:
Within 8" of Joint:
Remarks:

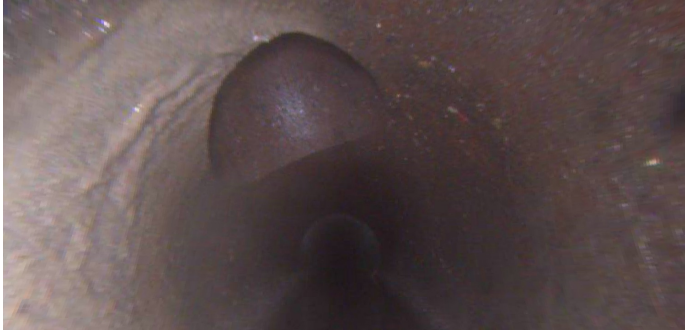
Code: **TF**
Description: **Tap Factory**

Distance (ft): **51.6**
Structural Grade: **0**
O&M Grade: **0**
Clock Start/From: **11**
Clock To:
1st Value: **4.000**
2nd Value:
Value Percent:
Continuous Index:
Within 8" of Joint:
Remarks:

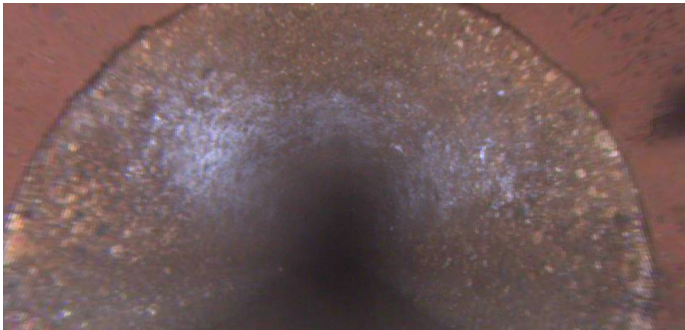
Code: **MMC**
Description: **Material Change**

Distance (ft): **54.4**
Structural Grade: **0**
O&M Grade: **0**
Clock Start/From:
Clock To:
1st Value:
2nd Value:
Value Percent:
Continuous Index:
Within 8" of Joint: **NO**
Remarks: **CP TO VCP**

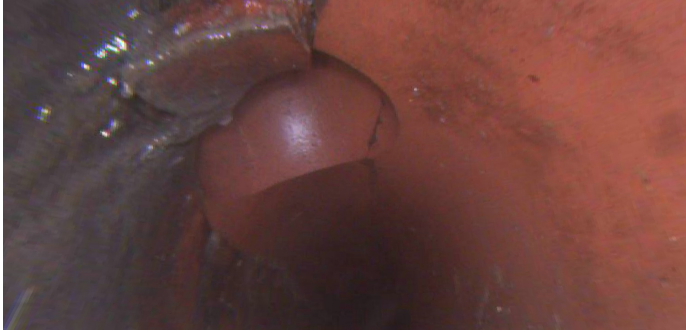
Code: **TF**
Description: **Tap Factory**

Distance (ft): **99.4**
Structural Grade: **0**
O&M Grade: **0**
Clock Start/From: **11**
Clock To:
1st Value: **4.000**
2nd Value:
Value Percent:
Continuous Index:
Within 8" of Joint:
Remarks:

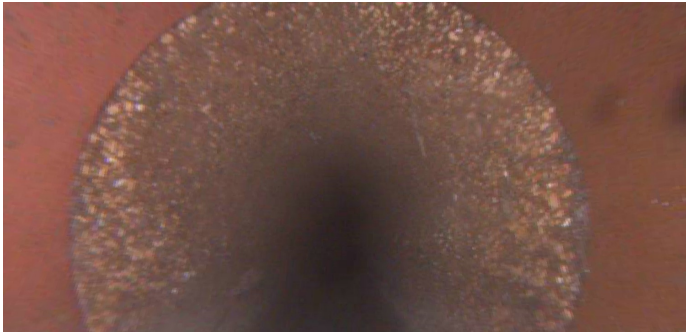
Code: **MMC**
Description: **Material Change**

Distance (ft): **104.8**
Structural Grade: **0**
O&M Grade: **0**
Clock Start/From:
Clock To:
1st Value:
2nd Value:
Value Percent:
Continuous Index:
Within 8" of Joint: **NO**
Remarks: **VCP**

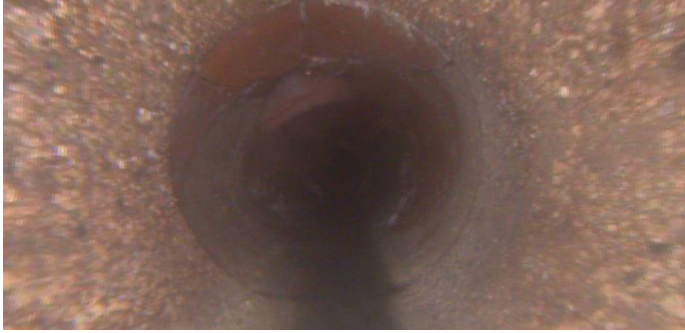
Code: **MMC**
Description: **Material Change**

Distance (ft): **144.8**
Structural Grade: **0**
O&M Grade: **0**
Clock Start/From:
Clock To:
1st Value:
2nd Value:
Value Percent:
Continuous Index:
Within 8" of Joint: **NO**
Remarks: **CP TO VCP**

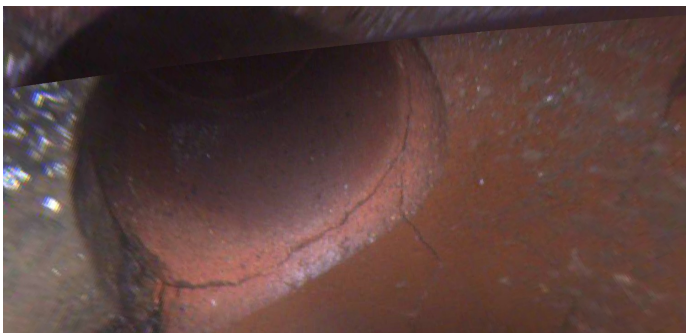
Code: **TF**
Description: **Tap Factory**

Distance (ft): **146.0**
Structural Grade: **0**
O&M Grade: **0**
Clock Start/From: **10**
Clock To:
1st Value: **4.000**
2nd Value:
Value Percent:
Continuous Index:
Within 8" of Joint:
Remarks:

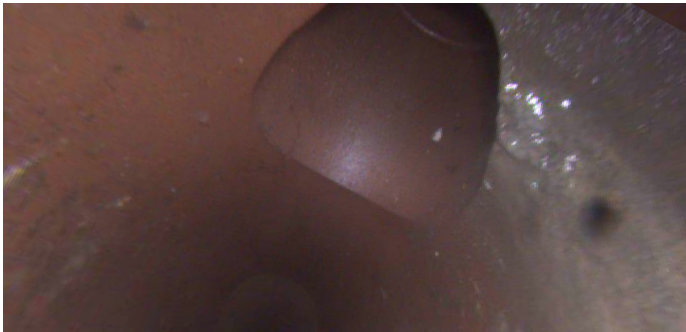
Code: **TF**
Description: **Tap Factory**

Distance (ft): **148.8**
Structural Grade: **0**
O&M Grade: **0**
Clock Start/From: **1**
Clock To:
1st Value: **4.000**
2nd Value:
Value Percent:
Continuous Index:
Within 8" of Joint:
Remarks:

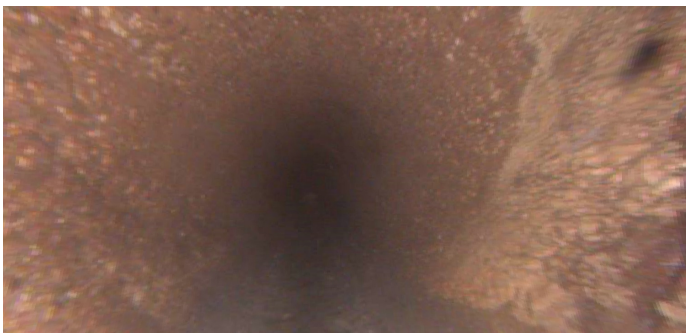
Code: **MMC**
Description: **Material Change**

Distance (ft): **151.4**
Structural Grade: **0**
O&M Grade: **0**
Clock Start/From:
Clock To:
1st Value:
2nd Value:
Value Percent:
Continuous Index:
Within 8" of Joint: **NO**
Remarks: **VCP TO CP**

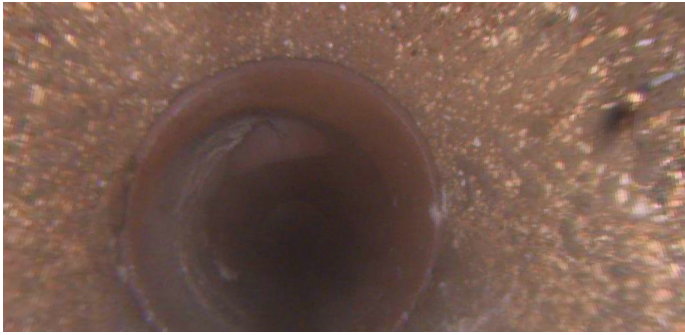
Code: **MMC**
Description: **Material Change**

Distance (ft): **177.6**
Structural Grade: **0**
O&M Grade: **0**
Clock Start/From:
Clock To:
1st Value:
2nd Value:
Value Percent:
Continuous Index:
Within 8" of Joint: **NO**
Remarks: **VCP TO CP**

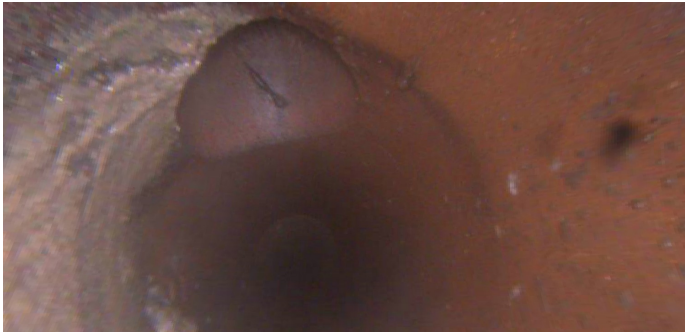
Code: **TF**
Description: **Tap Factory**

Distance (ft): **178.3**
Structural Grade: **0**
O&M Grade: **0**
Clock Start/From: **11**
Clock To:
1st Value: **4.000**
2nd Value:
Value Percent:
Continuous Index:
Within 8" of Joint:
Remarks:

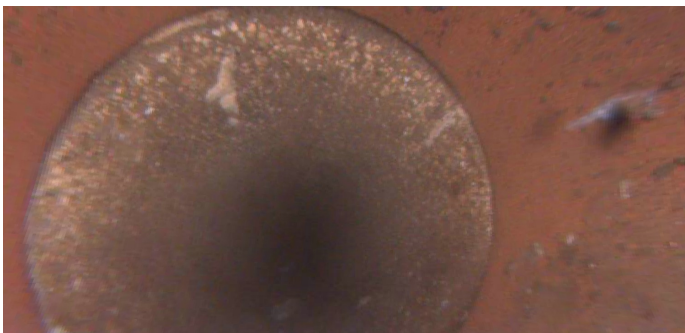
Code: **MMC**
Description: **Material Change**

Distance (ft): **180.8**
Structural Grade: **0**
O&M Grade: **0**
Clock Start/From:
Clock To:
1st Value:
2nd Value:
Value Percent:
Continuous Index:
Within 8" of Joint: **NO**
Remarks: **VCP TO CP**

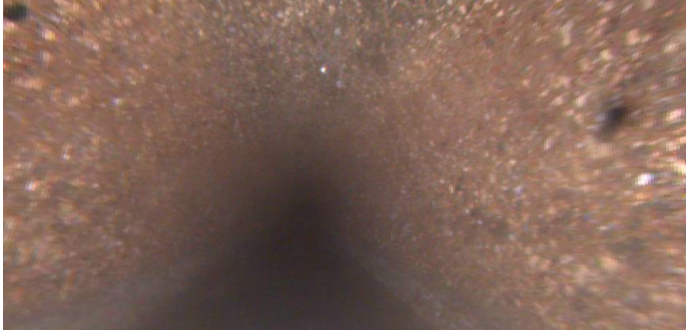
Code: **MWL**
Description: **Water Level**

Distance (ft): **197.1**
Structural Grade: **0**
O&M Grade: **0**
Clock Start/From:
Clock To:
1st Value:
2nd Value:
Value Percent: **10.000**
Continuous Index:
Within 8" of Joint: **NO**
Remarks:

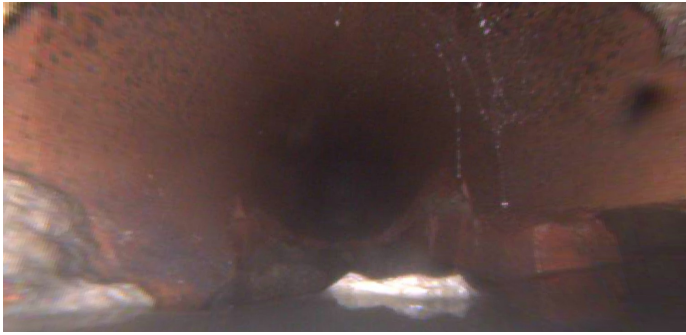
Code: **MMC**
Description: **Material Change**

Distance (ft): **205.2**
Structural Grade: **0**
O&M Grade: **0**
Clock Start/From:
Clock To:
1st Value:
2nd Value:
Value Percent:
Continuous Index:
Within 8" of Joint: **NO**
Remarks: **CP TO VCP**
