# Profile/Photo Observation Report

Date:	<b>09/05/2021</b>	Weather:		Coding:	<b>PACP 7.0</b>
Pipe Length (ft):	<b>195.3</b>	Owner:	<b>City of Hobart</b>	Pre Clean:	<b>Heavy Cleaning</b>
P.O.#:	<b>YES502259</b>	Surveyor:	<b>S. Bucklin</b>	PSR:	<b>P-504-077-076</b>
Customer:	<b>City of Hobart</b>	Clean Date:	<b>09/02/2021</b>	Shape:	<b>C</b>

Street:	<b>North Cavender Street</b>	Flow Control:	<b>Not Controlled</b>
City:	<b>Hobart, IN</b>	Year Renewed:	
Location:	<b>Alley</b>	Tape/Media #:	
Purpose:	<b>Routine Assessment</b>	Dia/Height:	<b>12"</b>
Use:	<b>Sanitary Sewage Pipe</b>	Material:	<b>VCP</b>
Drain Area:		Lining:	
Category:	<b>NA</b>		
Comment:			
Location Details:		Direction of Survey:	<b>Downstream</b>
US MH:	<b>M-504-077</b>	DS MH:	<b>M-504-076</b>
		Total Length Surveyed (ft):	<b>195.3</b>

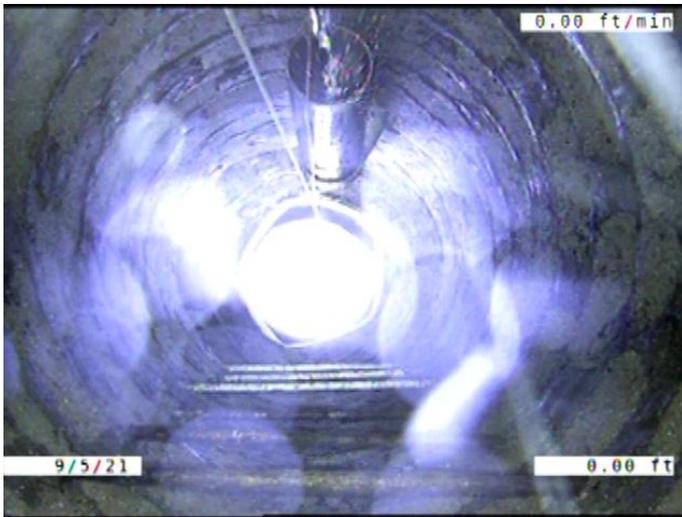
Code: **AMH**  
 Description: **Manhole**

Distance (ft): **.0**  
 Structural Grade: **0**  
 O&M Grade: **0**  
 Clock Start/From:  
 Clock To:  
 1st Value:  
 2nd Value:  
 Value Percent:  
 Continuous Index:  
 Within 8" of Joint: **NO**  
 Remarks: **M-504-077**

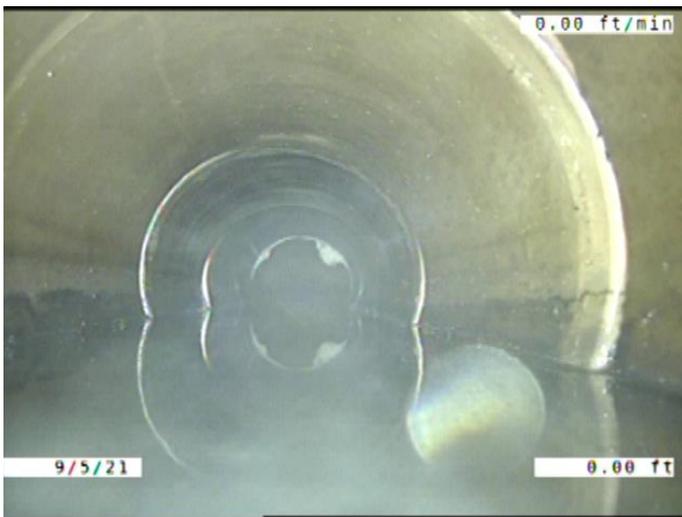
Code: **MWL**  
 Description: **Miscellaneous Water Level**

Distance (ft): **.0**  
 Structural Grade: **0**  
 O&M Grade: **0**  
 Clock Start/From:  
 Clock To:  
 1st Value:  
 2nd Value:  
 Value Percent: **10.000**  
 Continuous Index:  
 Within 8" of Joint: **NO**  
 Remarks:

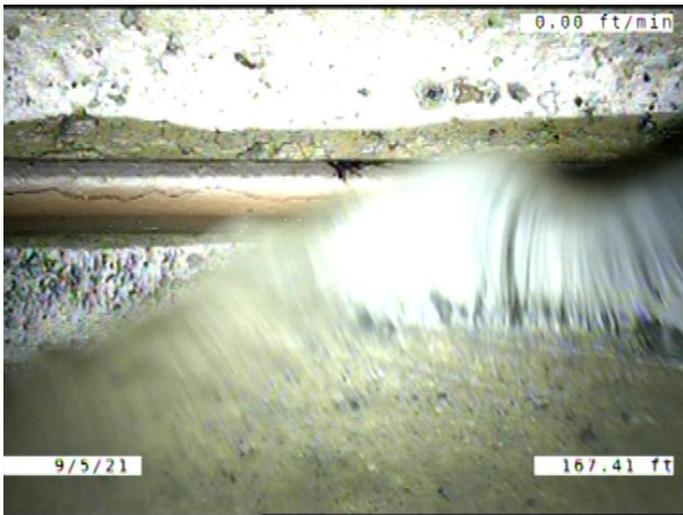
Code: **MWL**  
 Description: **Miscellaneous Water Level**

Distance (ft): **167.4**  
 Structural Grade: **0**  
 O&M Grade: **0**  
 Clock Start/From:  
 Clock To:  
 1st Value:  
 2nd Value:  
 Value Percent: **25.000**  
 Continuous Index:  
 Within 8" of Joint: **NO**  
 Remarks:

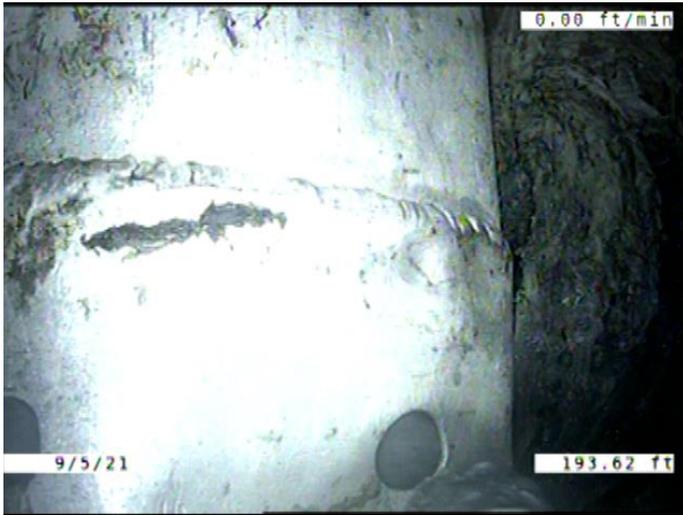
Code: **DSF**  
 Description: **Deposits Settled Fine**

Distance (ft): **193.6**  
 Structural Grade: **0**  
 O&M Grade: **2**  
 Clock Start/From: **5**  
 Clock To: **7**  
 1st Value:  
 2nd Value:  
 Value Percent: **5.000**  
 Continuous Index: **F01**  
 Within 8" of Joint: **YES**  
 Remarks:

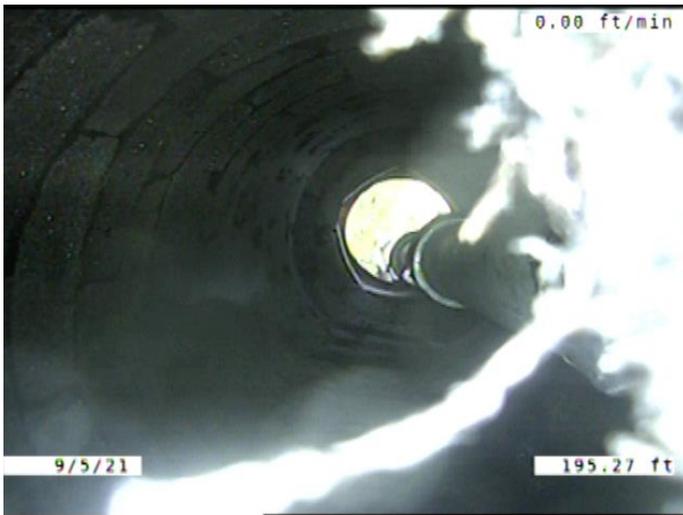
Code: **AMH**  
 Description: **Manhole**

Distance (ft): **195.3**  
 Structural Grade: **0**  
 O&M Grade: **0**  
 Clock Start/From:  
 Clock To:  
 1st Value:  
 2nd Value:  
 Value Percent:  
 Continuous Index:  
 Within 8" of Joint: **NO**  
 Remarks: **M-504-076**
