# Profile/Photo Observation Report

Date:	09/05/2021	Weather:		Coding:	PACP 7.0
Pipe Length (ft):	195.3	Owner:	City of Hobart	Pre Clean:	Heavy Cleaning
P.O.#:	YES502259	Surveyor:	S. Bucklin	PSR:	P-504-077-076
Customer:	City of Hobart	Clean Date:	09/02/2021	Shape:	C

Street:	North Cavender Street	Flow Control:	Not Controlled
City:	Hobart, IN	Year Renewed:	
Location:	Alley	Tape/Media #:	
Purpose:	Routine Assessment	Dia/Height:	12"
Use:	Sanitary Sewage Pipe	Material:	VCP
Drain Area:		Lining:	
Category:	NA		
Comment:			
Location Details:		Direction of Survey:	Downstream
US MH:	M-504-077	DS MH:	M-504-076
		Total Length Surveyed (ft):	195.3

O&M Index:	2.08	O&M Quick:	4336	O&M Rating:	154.00
Structural Index:	3.11	Structural Quick:	4A3A	Structural Rating:	84.00
Overall Index:	2.36	Overall Quick:	4A3B	Overall Rating:	238.00

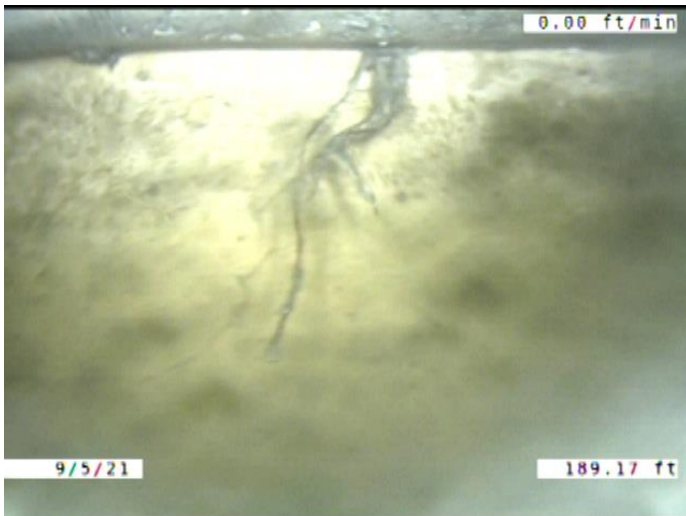
Code: **JAL**  
 Description: **Joint Angular Large**

Distance (ft): **186.8**  
 Structural Grade: **4**  
 O&M Grade: **0**  
 Clock Start/From:  
 Clock To:  
 1st Value:  
 2nd Value:  
 Value Percent:  
 Continuous Index:  
 Within 8" of Joint: **NO**  
 Remarks:

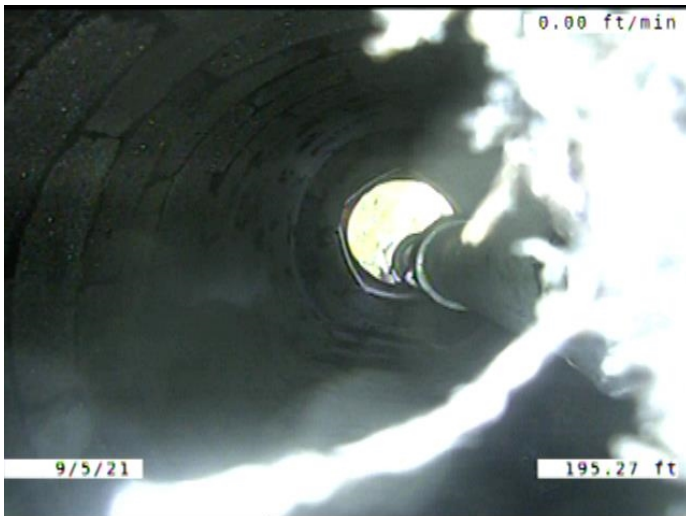
Code: **AMH**  
 Description: **Manhole**

Distance (ft): **195.3**  
 Structural Grade: **0**  
 O&M Grade: **0**  
 Clock Start/From:  
 Clock To:  
 1st Value:  
 2nd Value:  
 Value Percent:  
 Continuous Index:  
 Within 8" of Joint: **NO**  
 Remarks: **M-504-076**
