Profile/Photo Observation Report

Date:	04/17/2018	Weather:		Coding:	PACP 6.0
Pipe Length (ft):	190.7	Owner:	NA	Pre Clean:	Not Known
P.O.#:		Surveyor:	Justin Gonzales	PSR:	P-504-078-077
Customer:		Clean Date:	01/01/1900	Shape:	C

Street:	Summerlin	Flow Control:	Not Controlled
City:	Hobart, IN	Year Renewed:	
Location:	Light Highway	Tape/Media #:	
Purpose:	Not Known	Dia/Height:	12"
Use:	Sanitary	Material:	VCP
Drain Area:	NA	Lining:	
Category:	NA		
Comment:

Location Details:		Direction of Survey:	Downstream
US MH:	M-504-078	DS MH:	M-504-077
		Total Length Surveyed (ft):	159.7

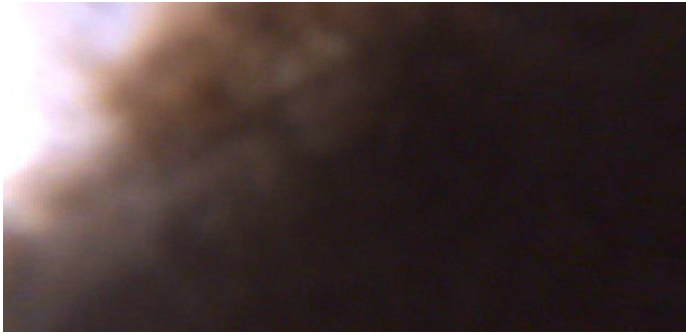
Code: **AMH**
Description: **Manhole**

Distance (ft): **.0**
Structural Grade: **0**
O&M Grade: **0**
Clock Start/From:
Clock To:
1st Value:
2nd Value:
Value Percent:
Continuous Index:
Within 8" of Joint: **NO**
Remarks: **M-504-078**

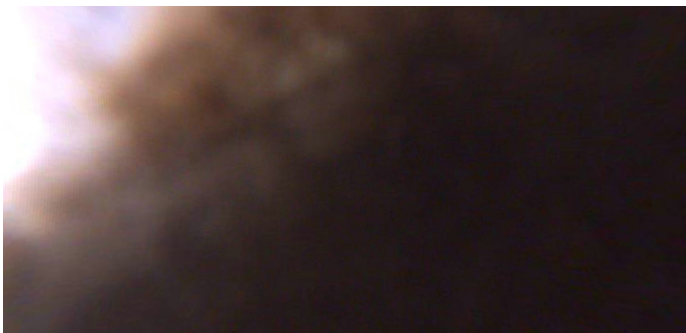
Code: **MWL**
Description: **Water Level**

Distance (ft): **.0**
Structural Grade: **0**
O&M Grade: **0**
Clock Start/From:
Clock To:
1st Value:
2nd Value:
Value Percent: **100.000**
Continuous Index:
Within 8" of Joint: **NO**
Remarks:

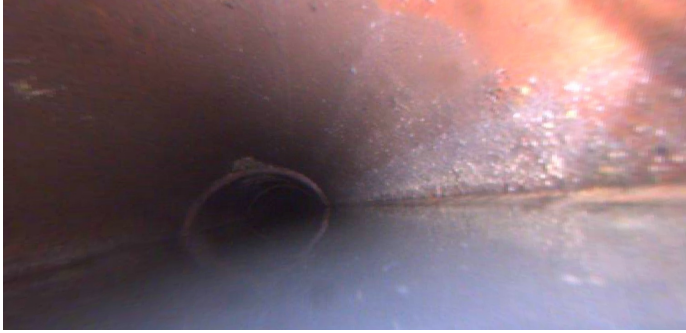
Code: **MWL**
Description: **Water Level**

Distance (ft): **4.7**
Structural Grade: **0**
O&M Grade: **0**
Clock Start/From:
Clock To:
1st Value:
2nd Value:
Value Percent: **15.000**
Continuous Index:
Within 8" of Joint: **NO**
Remarks:

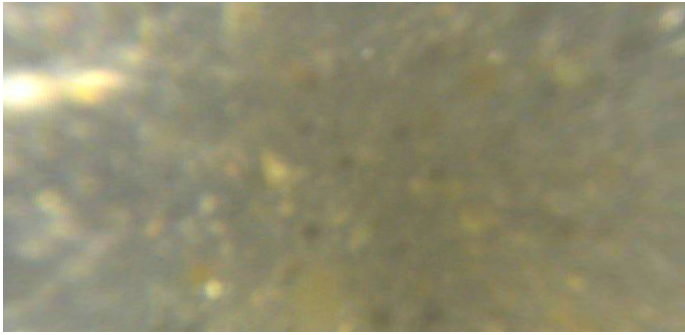
Code:	MGO
Description:	General Observation
Distance (ft):	7.8
Structural Grade:	0
O&M Grade:	0
Clock Start/From:	
Clock To:	
1st Value:	
2nd Value:	
Value Percent:	
Continuous Index:	
Within 8" of Joint:	NO
Remarks:	MCU REAR CAMERA

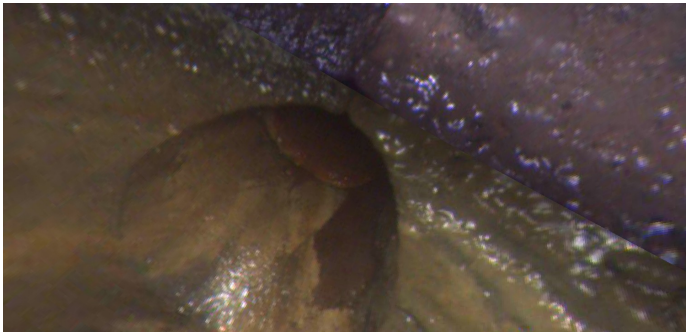
Code: **TFA**
Description: **Tap Factory Active**

Distance (ft): **56.0**
Structural Grade: **0**
O&M Grade: **0**
Clock Start/From: **11**
Clock To:
1st Value: **4.000**
2nd Value:
Value Percent:
Continuous Index:
Within 8" of Joint:
Remarks:

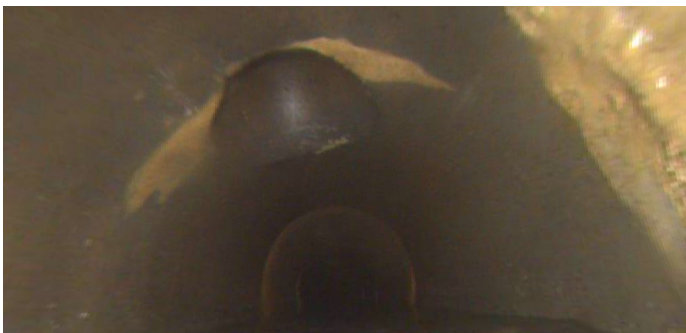
Code: **TF**
Description: **Tap Factory**

Distance (ft): **73.2**
Structural Grade: **0**
O&M Grade: **0**
Clock Start/From: **1**
Clock To:
1st Value: **4.000**
2nd Value:
Value Percent:
Continuous Index:
Within 8" of Joint:
Remarks:

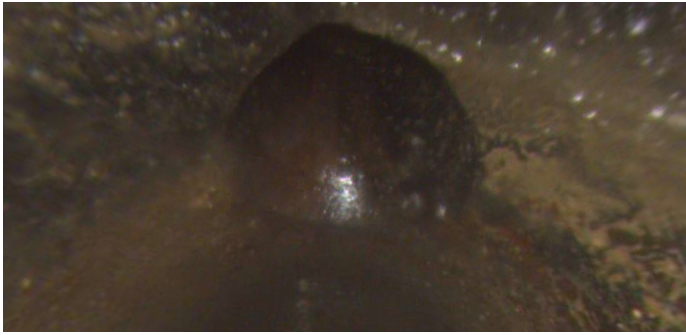
Code: **TFA**
Description: **Tap Factory Active**

Distance (ft): **97.8**
Structural Grade: **0**
O&M Grade: **0**
Clock Start/From: **12**
Clock To:
1st Value: **4.000**
2nd Value:
Value Percent:
Continuous Index:
Within 8" of Joint:
Remarks:

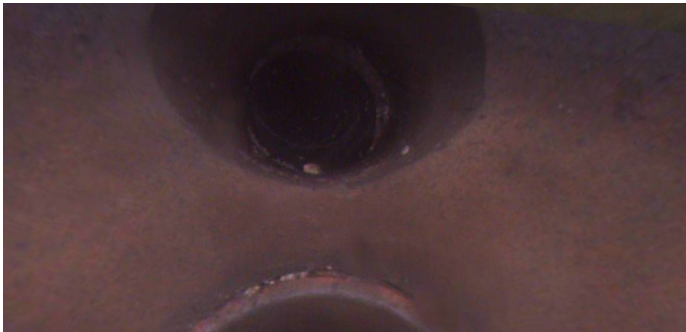
Code: **TF**
Description: **Tap Factory**

Distance (ft): **126.4**
Structural Grade: **0**
O&M Grade: **0**
Clock Start/From: **12**
Clock To:
1st Value: **4.000**
2nd Value:
Value Percent:
Continuous Index:
Within 8" of Joint:
Remarks:
